**AYUGUTHI SATTAL**  
PATAN DARBAR SQUARE, WARD 11

**HISTORIC STRUCTURE REPORT**  
**JANUARY, 1996**

**KATHMANDU VALLEY PRESERVATION TRUST**  
**IN COOPERATION WITH**  
**HMG DEPARTMENT OF ARCHAEOLOGY**

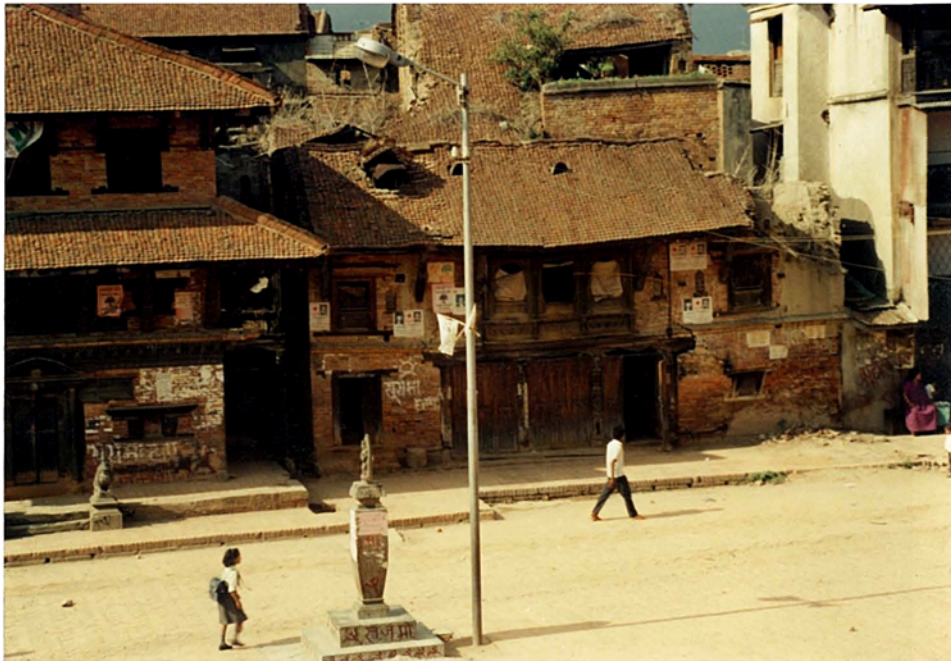
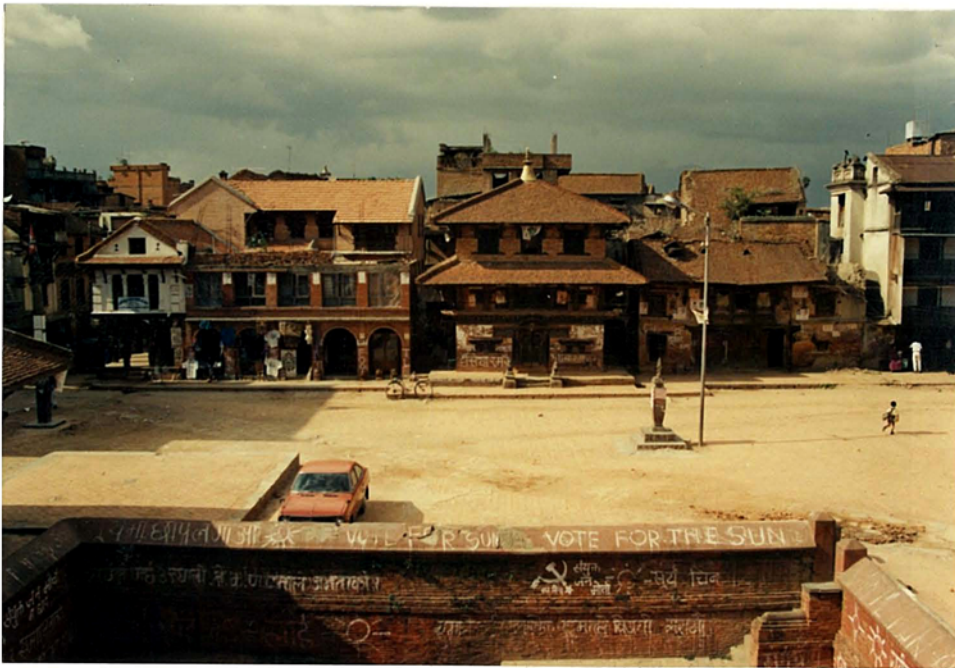
Above: spring 1991 before emergency shoring up. Below: north elevation of Patan Darbar (Sekler 1979)..

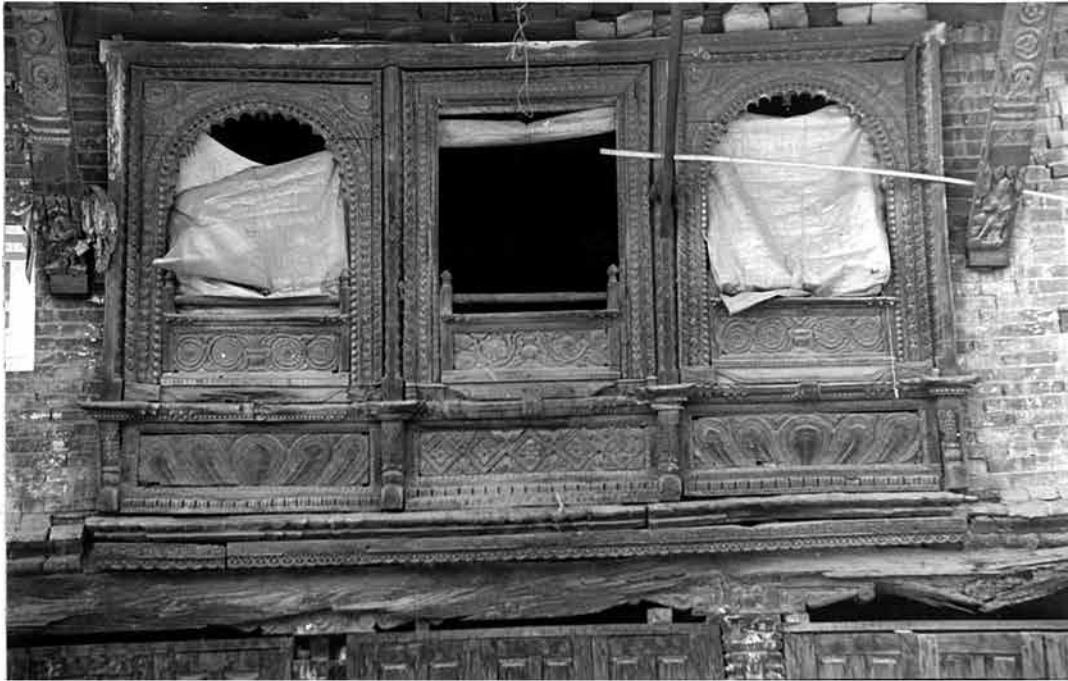
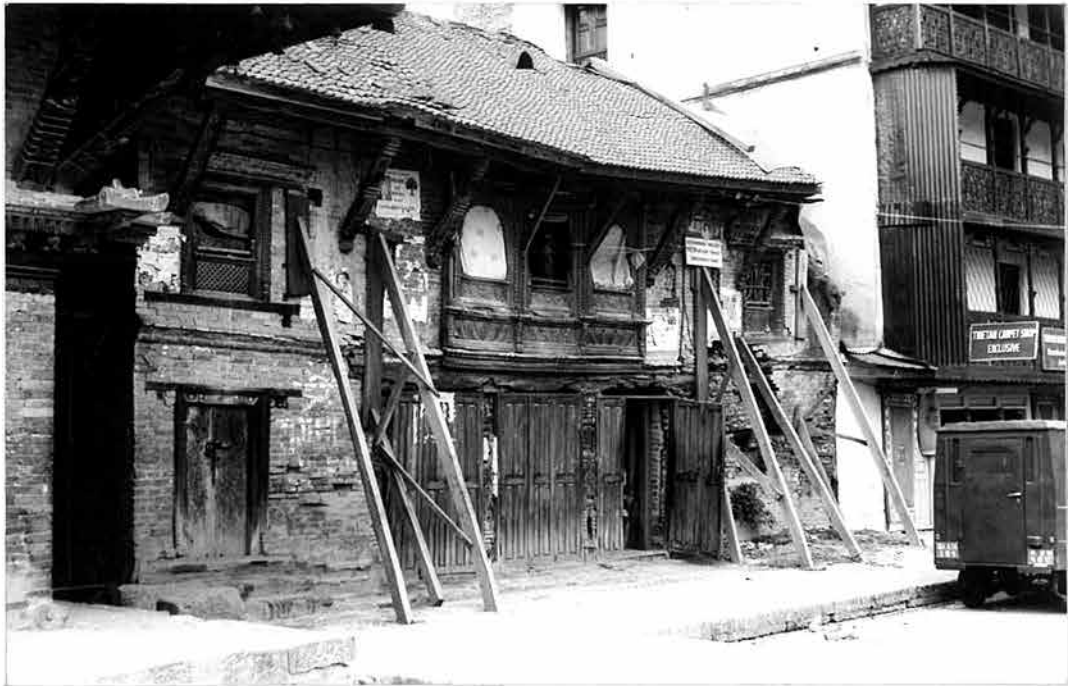
Above: multi-bay window or san jhyah of principal facade, fall, 1993. Below: principal facade spring, 1994. Notice additional wall damage at far right.

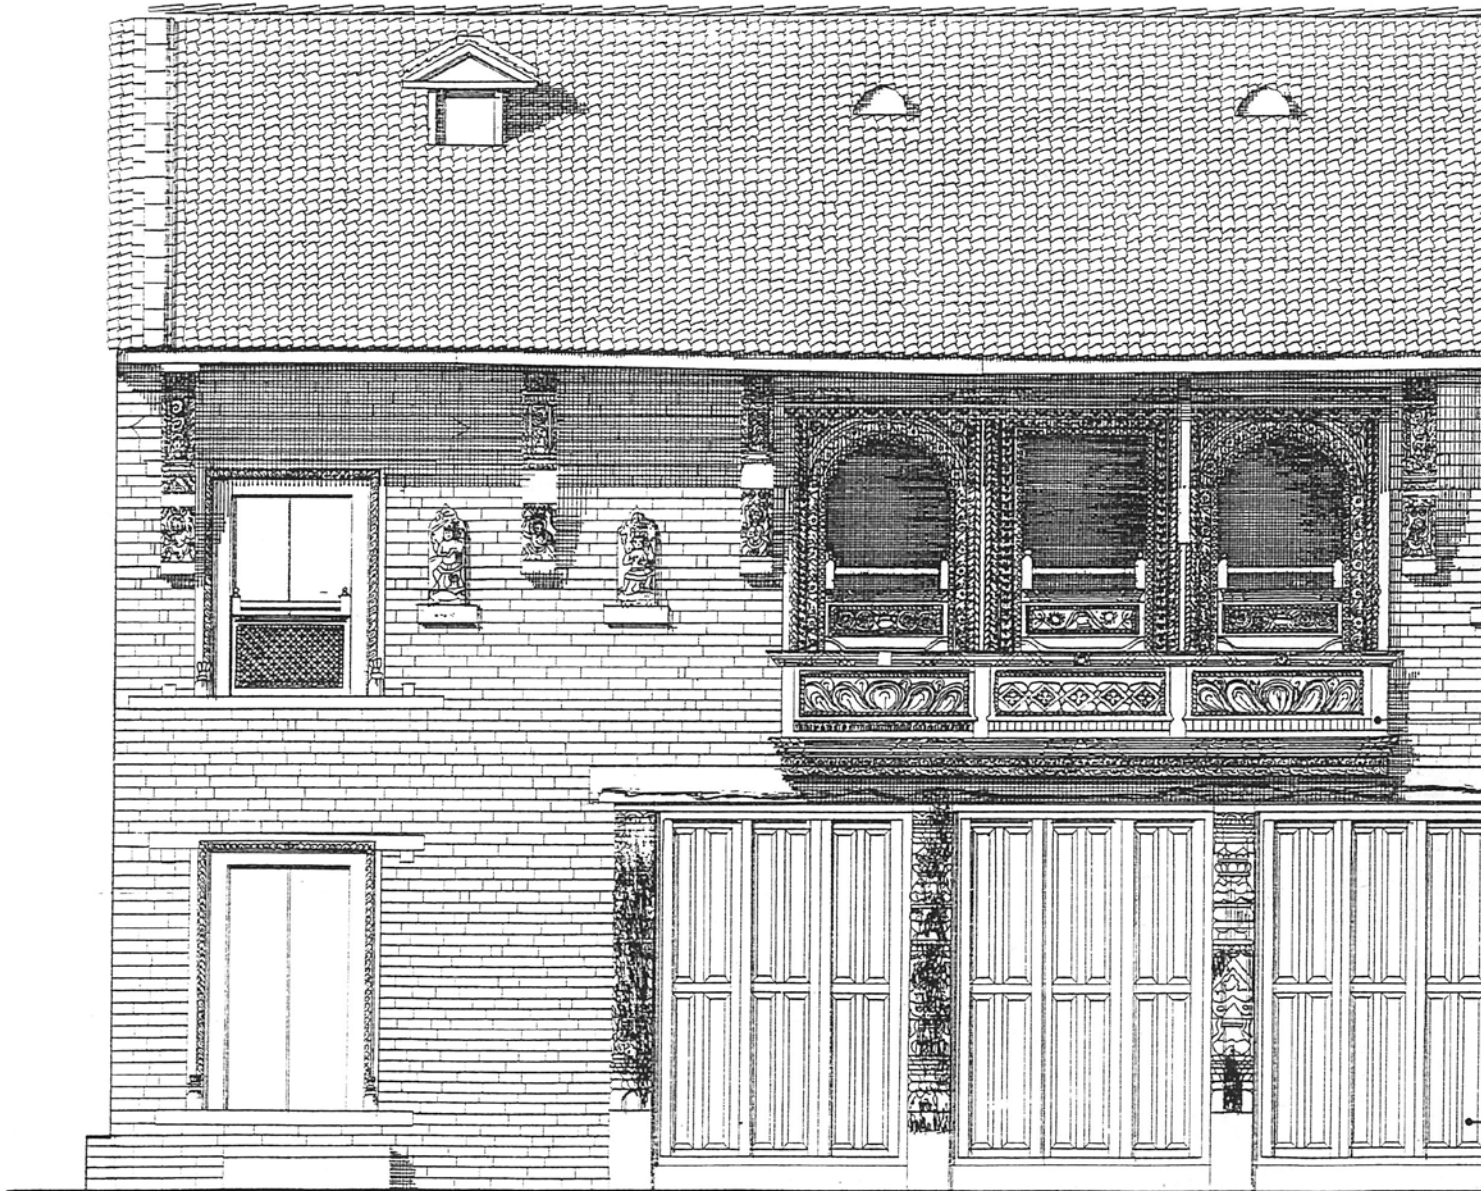
PRINCIPAL ELEVATION: EXISTING CONDITION

The entire facade to the right of ground floor *dalan* has deteriorated over the last seven years, in the last year the veneer brick or *daci apa* has fallen out. Photos of 1988 show a stepping crack travelling 28 courses up, just touching the right end of the *dalan's* lintel beam. The crack appears not to have been larger than one half inch, but water penetration from the damaged roof above caused the individual layers of the wall to separate, the outer veneer splaying out. This is a typical problem in the traditional buildings of the Kathmandu Valley.

Extensive damage to the *dalan* beam by termites has put further stresses on the wall: the pine timber lintel, completely denatured by the insects, has allowed the upper floor joists and facade to settle six inches.

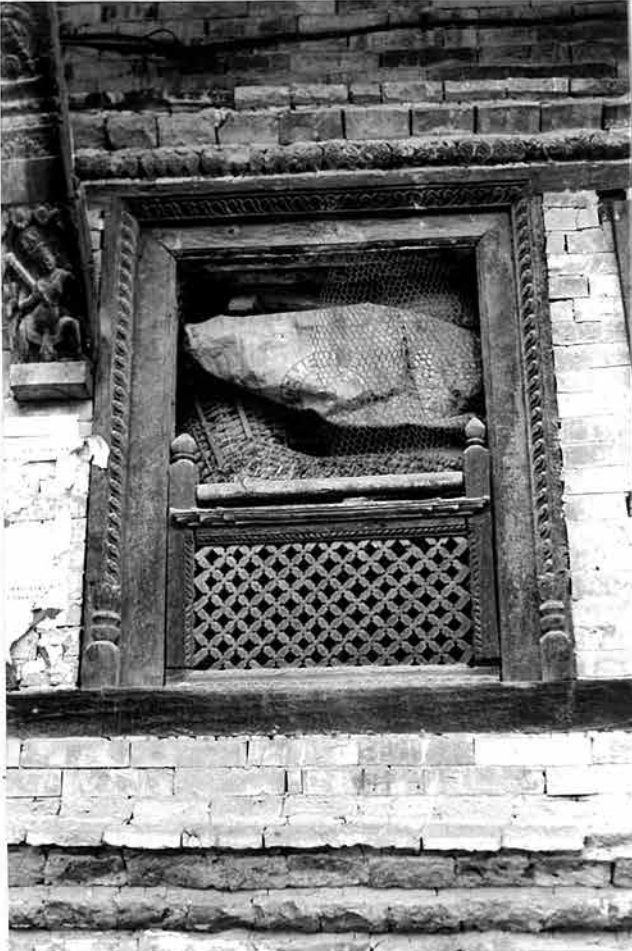
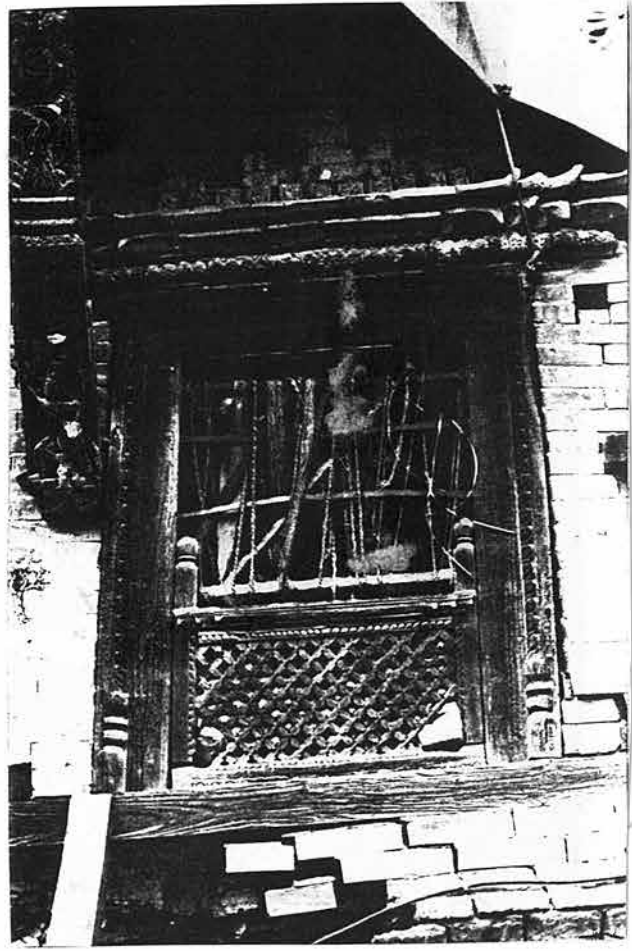
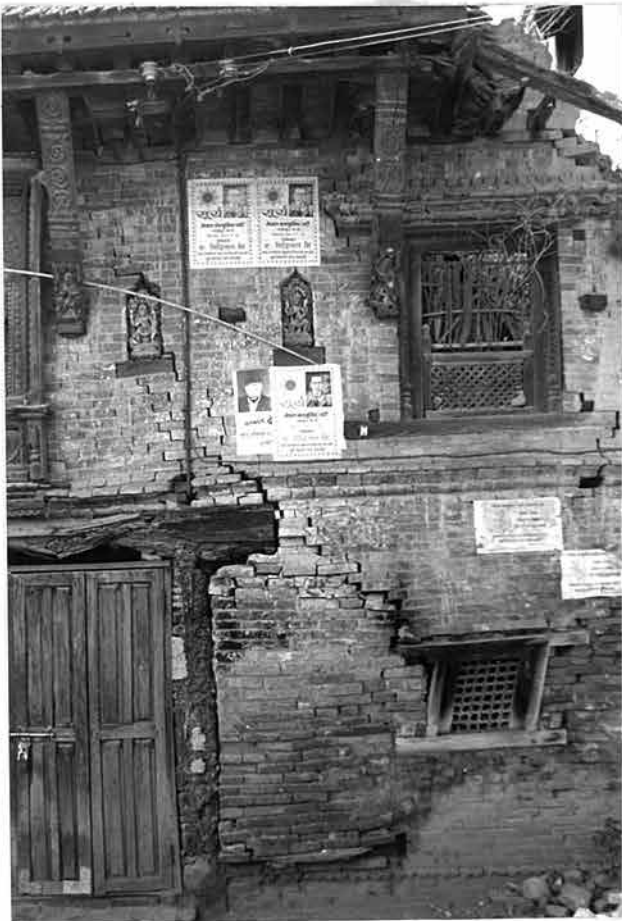
Above, the two upper story windows left and right are in good condition missing only their shutters and small portions of lattice. There are no signs of termite damage. Below the roofless southeast corner of the building with latticed window. This window has since fallen out due to wall damage and is in storage, condition unknown .

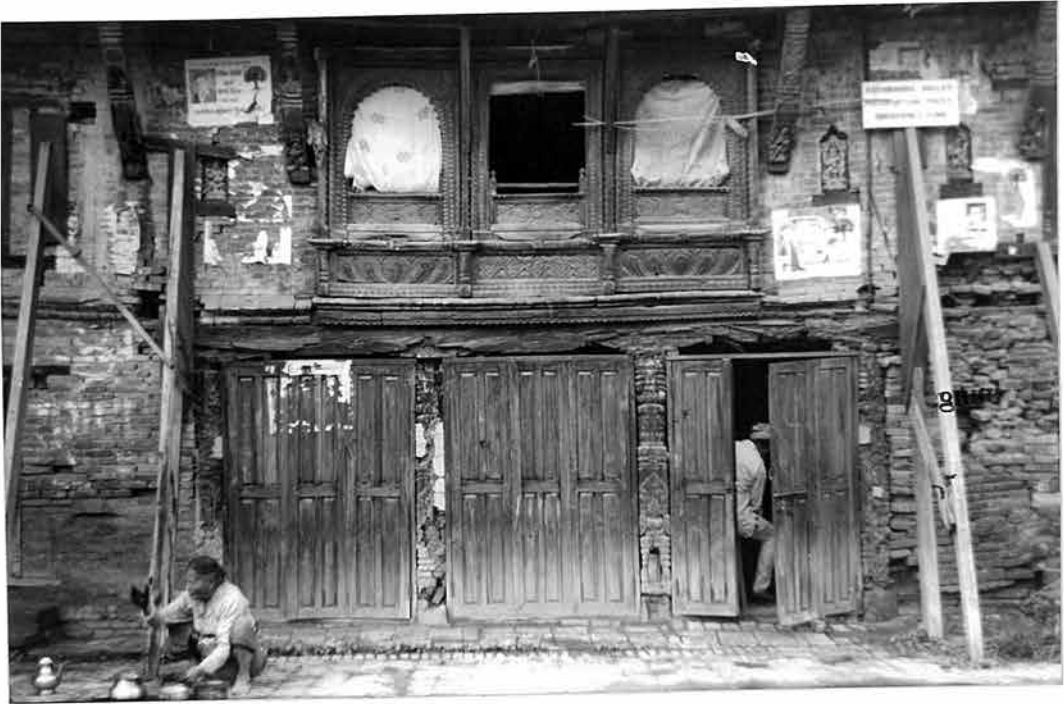
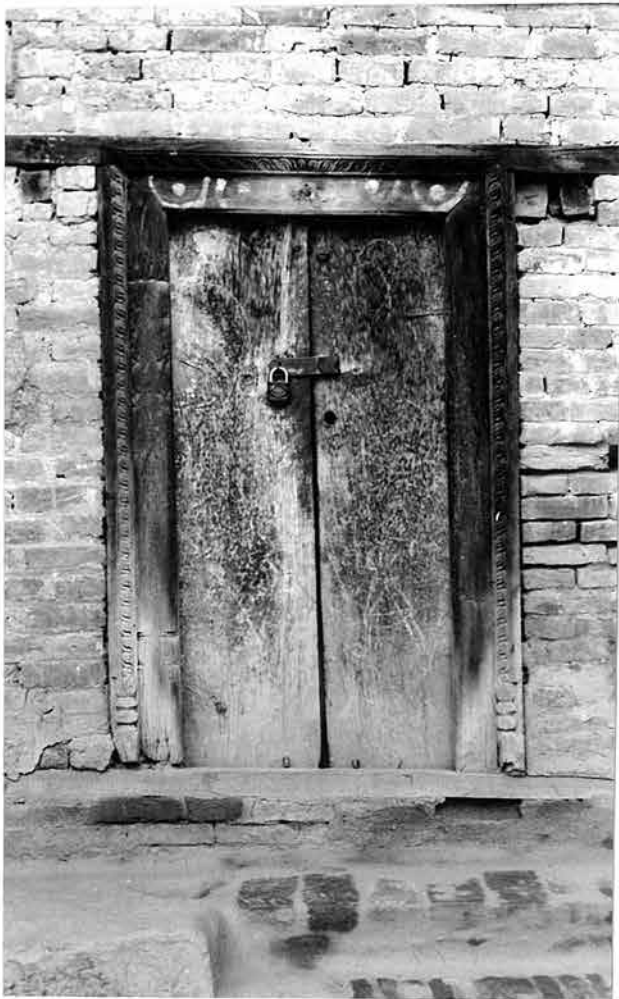
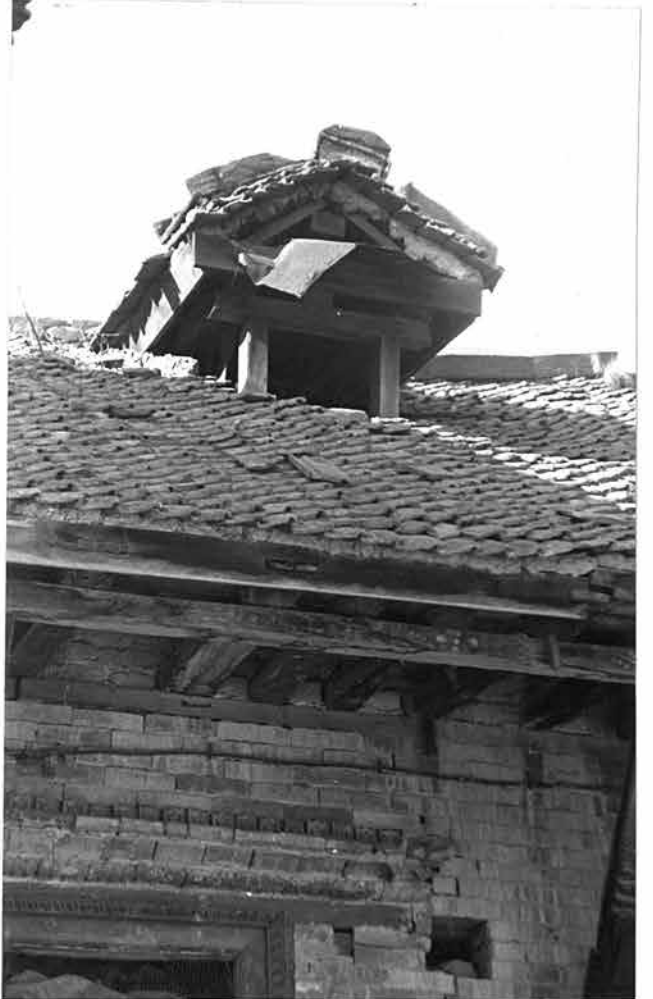
All four historical oversized and carved timber posts in sal wood are completely structurally denatured by drywood termite infestation. This infestation was diagnosed by visiting expert Sir Bernard Feilden (based on the pest's visible mud tracks). The column capitals (Newari: *meth*) are damaged to varying degrees by the termite infestation as well, the outer of four capitals severely denatured, the central two capitals appear to have only superficial damage.

The upper lintel of the *dalan* is a pine member (section 7"x6") which is also structurally denatured by termites, having collapsed into itself from the load of the walls above. This has caused settlement of the central wall ranging from 4-6".

Opposite: the central trabeate opening (Newari: *dala*) is heavily damaged by termites, the outer columns slightly more advanced in their decay than the central pair. Below: the door is in good condition, although interior lintels are termite damaged. Below left: dormered opening in pine is heavily damaged by water.

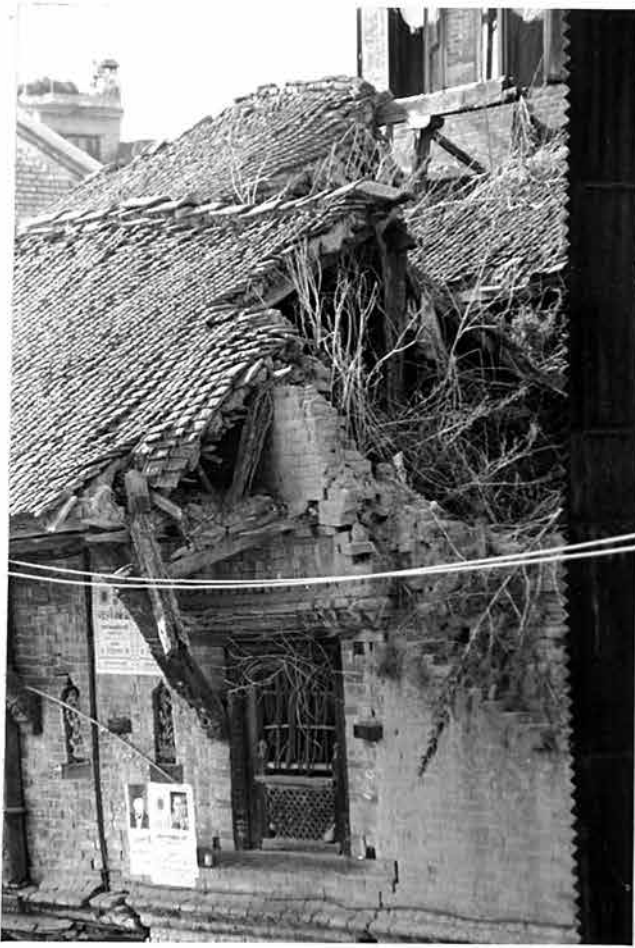
**The eastern quarter of the roof collapsed 10-15 years ago. Roof configuration is not original to the building (as discussed in construction history above). All timber rafters are heavily damaged by water, rotten except for very small areas. Two levels of floor joists--like the rafter configuration--are carelessly installed possible from post-1934 earthquake repairs. Both levels of joists are heavily damaged in all but a few locations, the lower level primarily from termites and water, the upper primarily from water.**

Collapsed roof structure at southeast corner of the building.

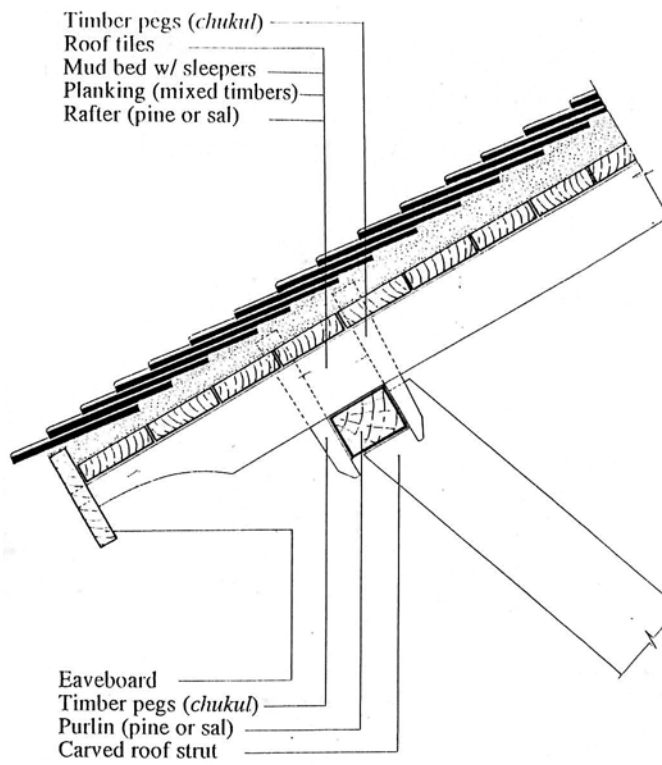
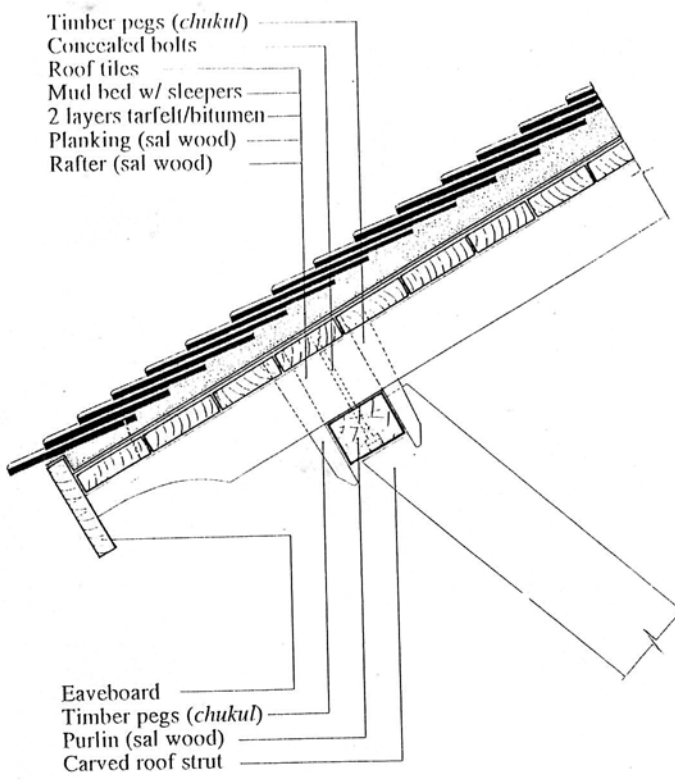
**THE "KEY" PROBLEM**

Above: Section at roof overhang: as traditionally detailed  
 Below: Section at roof overhang: Improved detailed
