# NARAYANA TEMPLE

KULIMA, PATAN

HISTORIC STRUCTURE REPORT

KATHMANDU VALLEY PRESERVATION TRUST  
MARCH, 1998

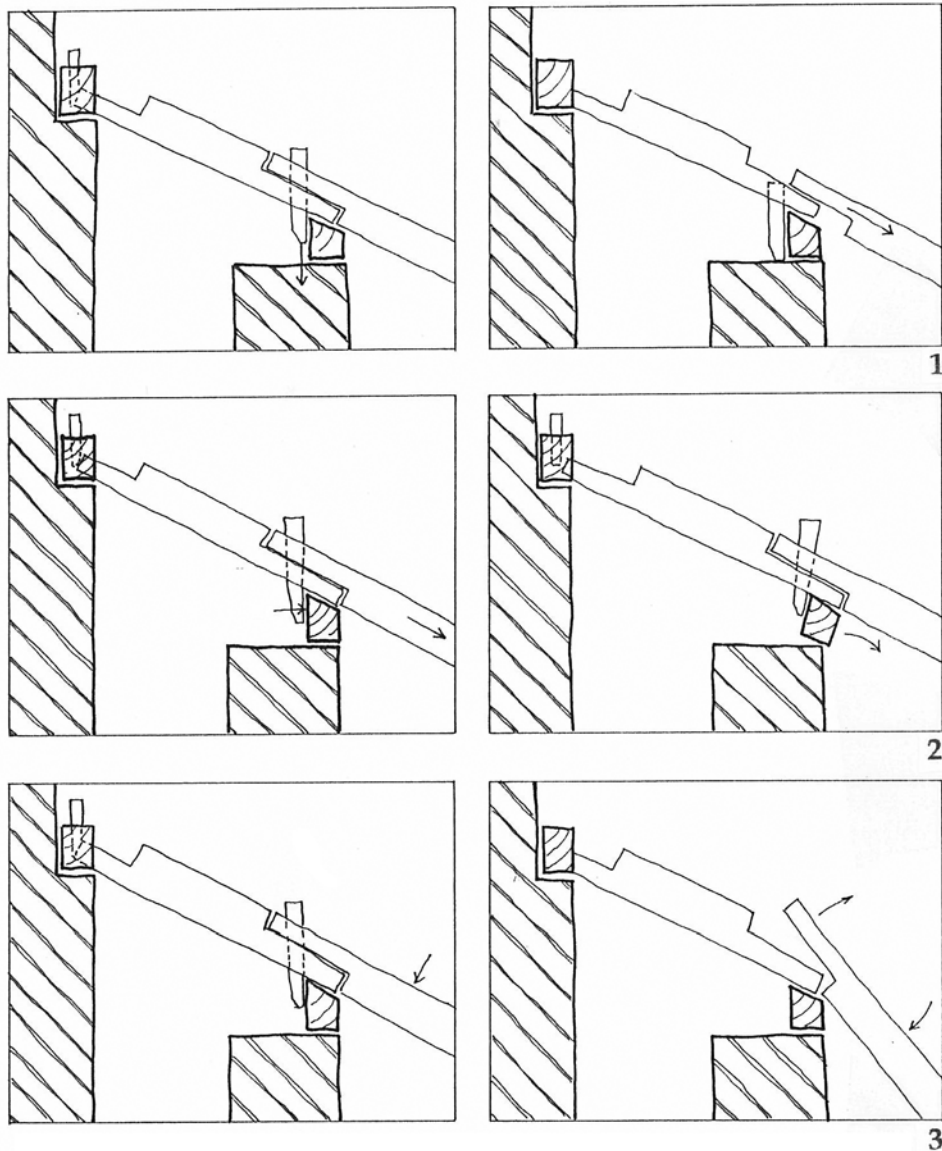
### Timber joinery: improper joinery which leads to structural failure

1. Moisture damages the wood around the peg which results in the hole become larger and weaker around the peg. This in turn causes the lower rafter to slip away.
2. If the timber peg which joins the rafter to the wall plate is not secure the rafter will have a tendency to slide. This will ultimately force the outer wall plate from its bearing on top of the outer wall.
3. The lap joint is improperly reversed where the lower rafter is held only by a smaller timber peg. The result is that the upper rafter is not sharing any of the load as it would usually when correctly lapped above the lower.

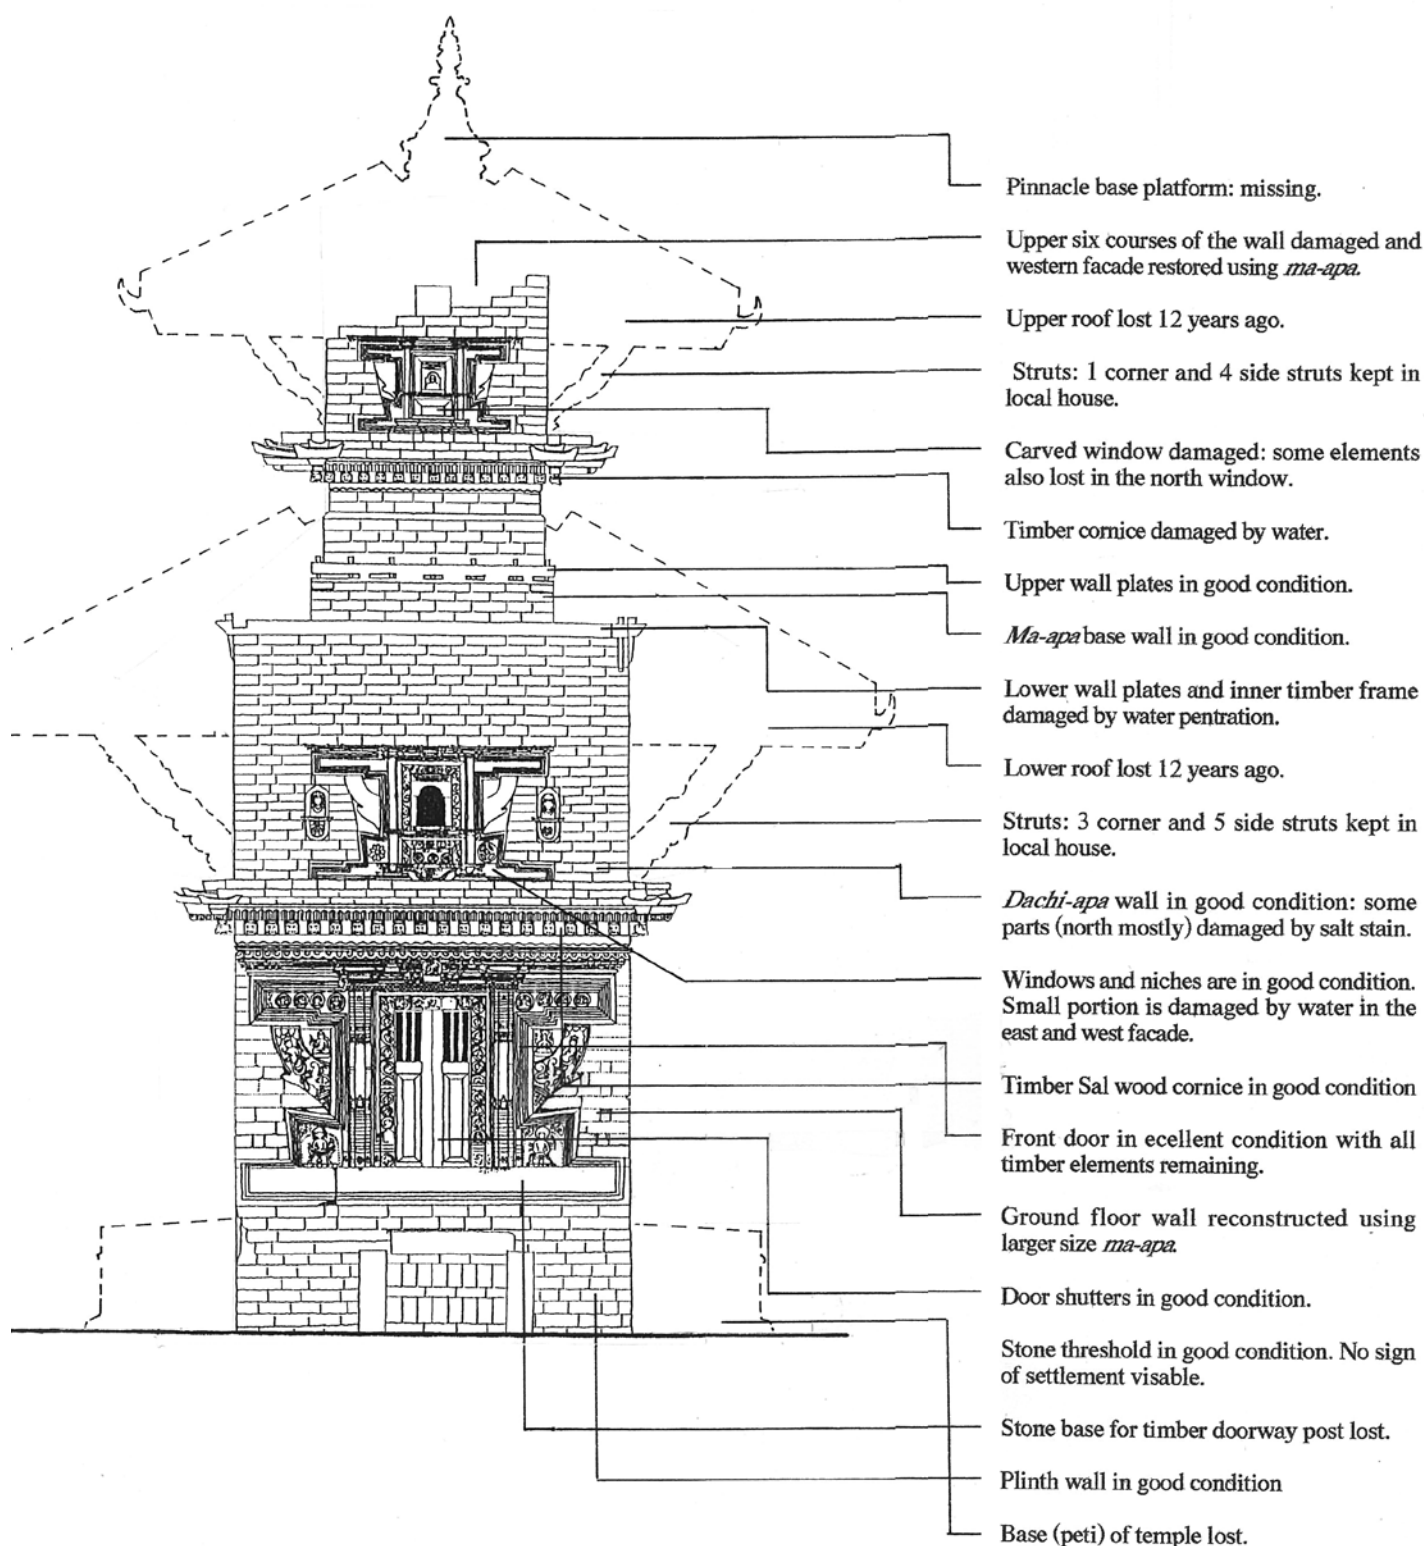
EXISTING CONDITION: WEST ( PRINCIPLE ) FACADE

85% of the historical veneer brick has been replaced with a larger common brick, *ma apa* (3" x 9") laid in cement and lime *surkhi* mortar. Almost all of these replacement bricks have spalled as a result of the bad quality and salts of the cement mortar. This is typical of all repairs since the 1950's in Nepal. In 1958 the ground floor wall fabric was refaced on each side and between this time and 1994 an approximate area of 3' x 3' of wall fabric has been sloppily 'patched' up. Approximately 30% of the wall area is in an advanced state of erosion.

In good condition, the original veneer brick or *dachi apa* wall is intact except at the upper three courses damaged by rain water. Despite the onslaught of vegetation that comes after every monsoon the wall structure has survived. Approximately 20% of the bricks have salt stain from damp.

The inappropriate *ma apa* brick shall be replaced with traditional *dachi apa* using yellow mud mortar matched to that of the upper level. All *dachi -apa* will be custom ordered to make them the same size as in the upper level of the temple.

At first floor level the three upper brick courses will be repaired using *dachi apa*. Bricks displaying salt stain shall be cleaned with water and soft brushes.

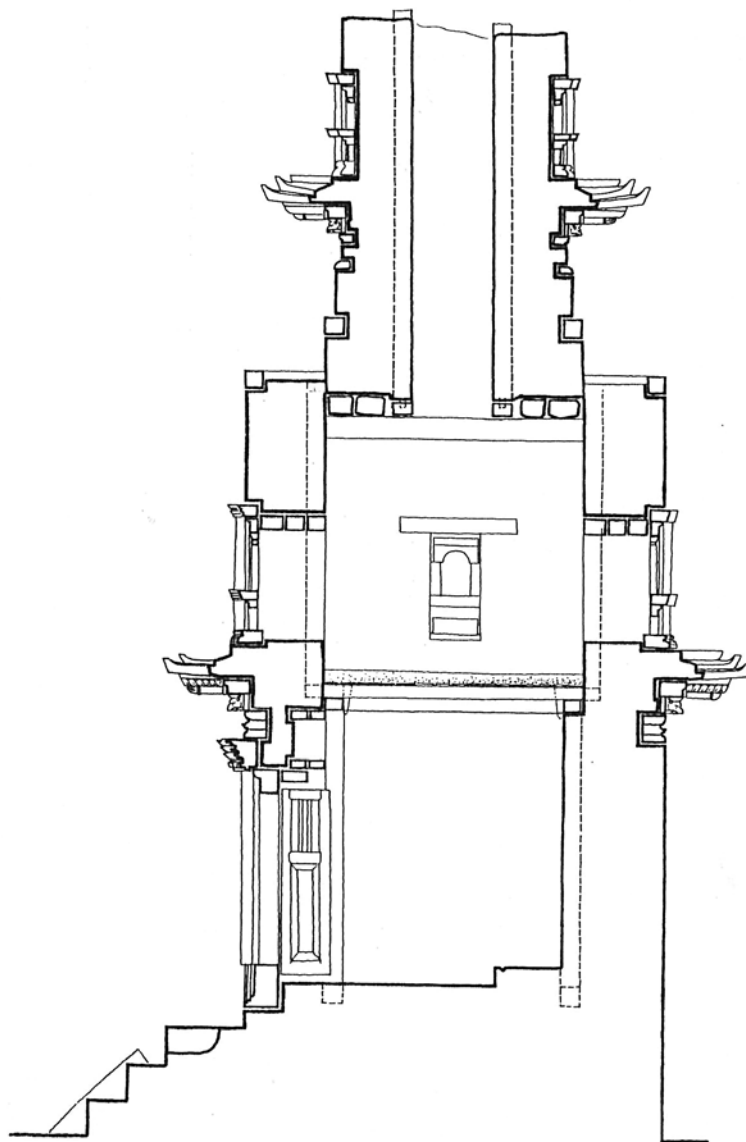
**SECTION EAST - WEST : EXISTING CONDITION**  
KATHMANDU VALLEY PRESERVATION TRUST - NOVEMBER 1998

Both roof levels have been completely lost without a single rafter remaining. The surviving sal wood wall plates have been completely damaged by water penetration, as have the timber posts inside the wall. Of the twenty four original struts thirteen survive (*see diagram on following page*), one *kusala* (corner strut) and four side struts have survived from the upper floor and three *kusala* and five side struts have survived in the lower.

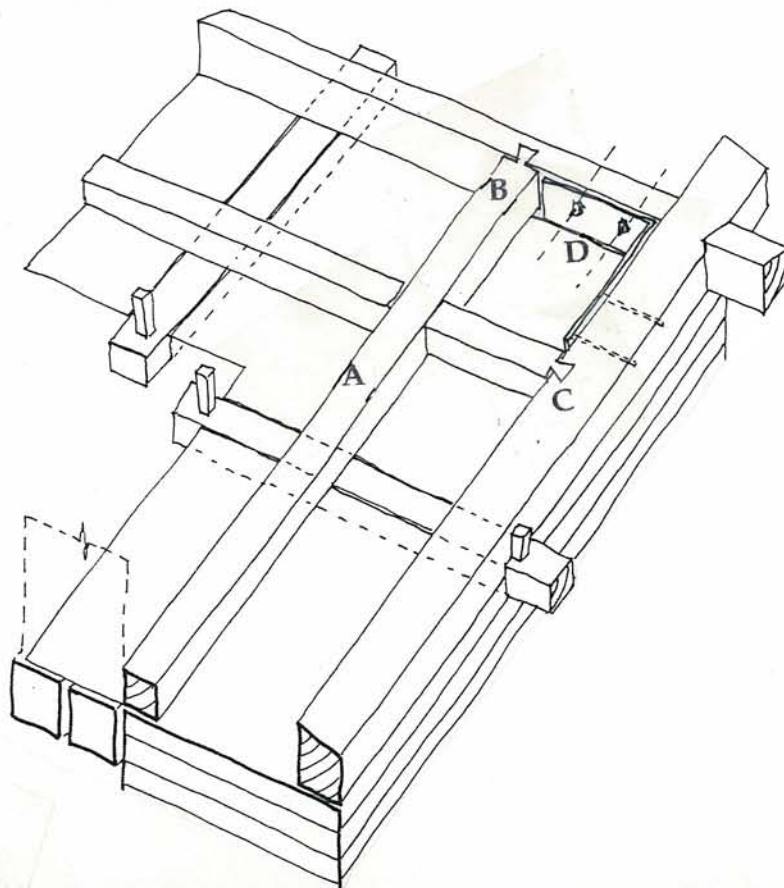
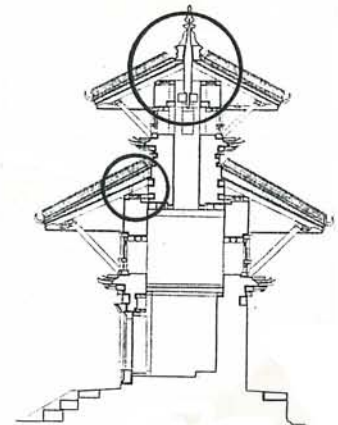
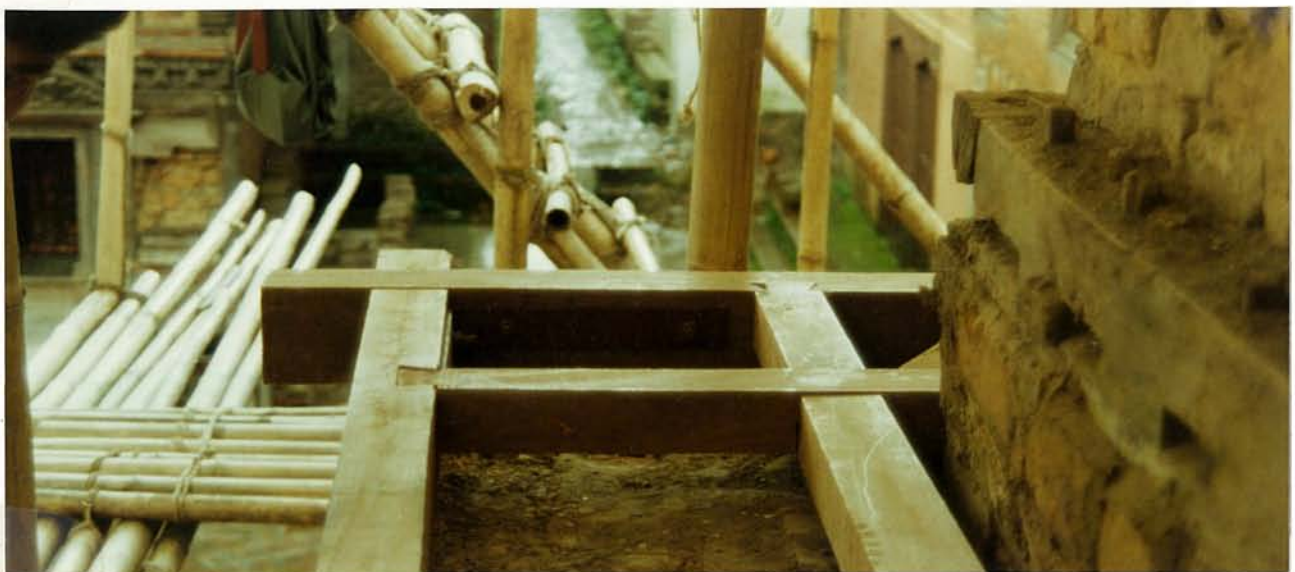
### **Tie between wall plates.**

1. The diagram shows the location of the wall plates.
2. At present the inner and outer wall plates are not connected with each other. The proposed arrangement will act as one horizontal unit. With (a) the introduction of the inner wall plate, the subsequent linking with the outer wall plate (b) using dovetailed joints (c) and steel collars (d) at the corner.
3. Photo august 1997: This technique increases the seismic strength of the temple by acting as a ring beam which ties the walls together.

*Connection between innerwall plate and outerwall plate.* The traditional configuration of double wall plates makes it easy to develop a timber horizontal ring beam of sorts by careful sizing and joinery at the corners. In this temple there was no connection between the inner and outer wall plates, because these members were already damaged. During replacement, the corner joints will be made with the traditional lap joinery but will also incorporate 3/8" thick steel "L" plates to reinforce this corner. These plates will be made of iron painted with three coats of anti-corrosive paint. The additional joints between inner and outer wall plates use dovetailed joinery.

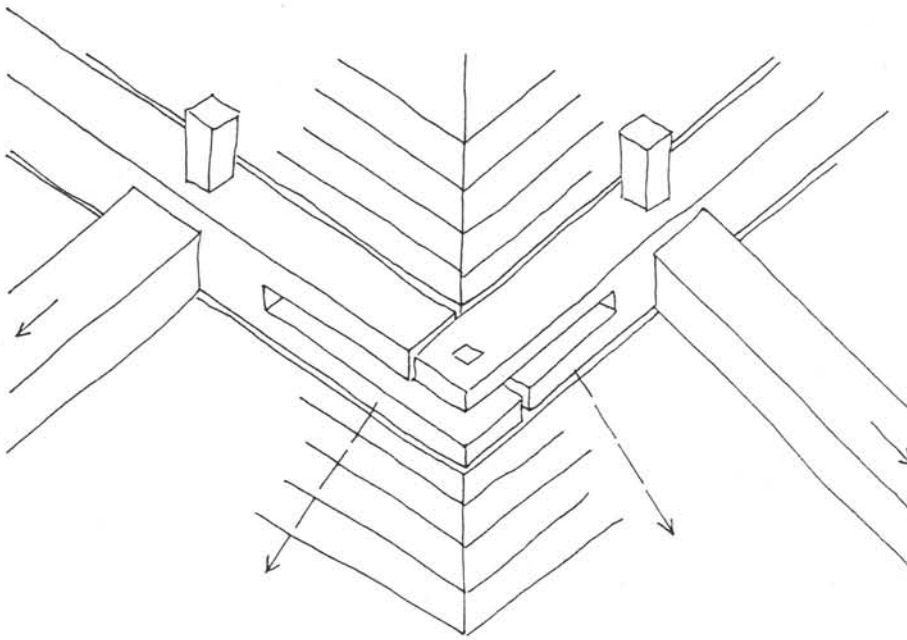
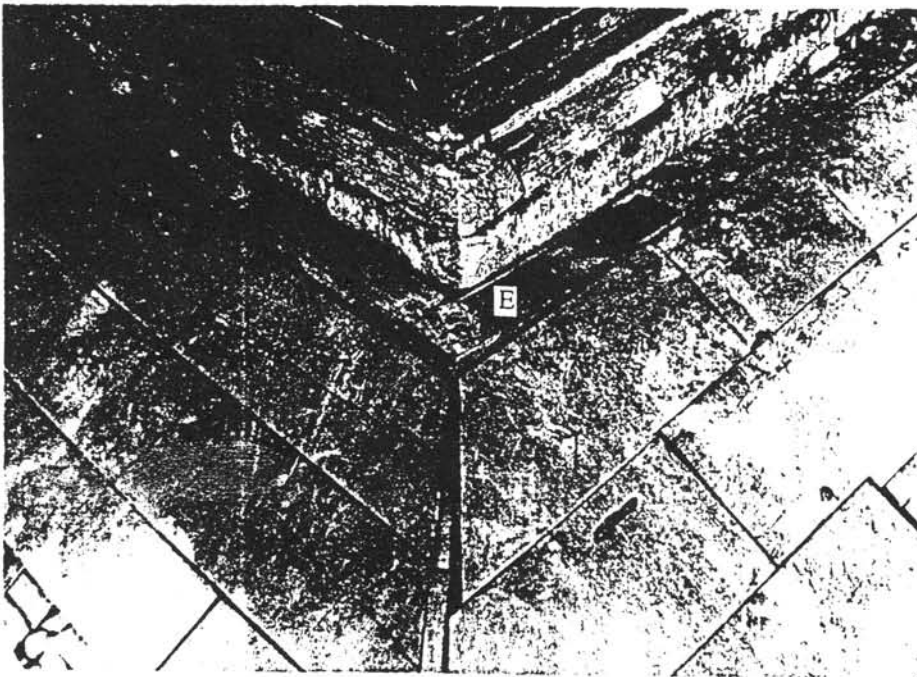
### Reinforcement of the corner lap joint

1. The corner lap joint timber section is not sufficient to bear the load of the corner strut. If the corner strut is off center it is highly probable that the protruding timber end will break off easily.
2. To prevent this kind of failure a metal cross piece is attached to the joint. This improves the strength and allows the even distribution of local forces.

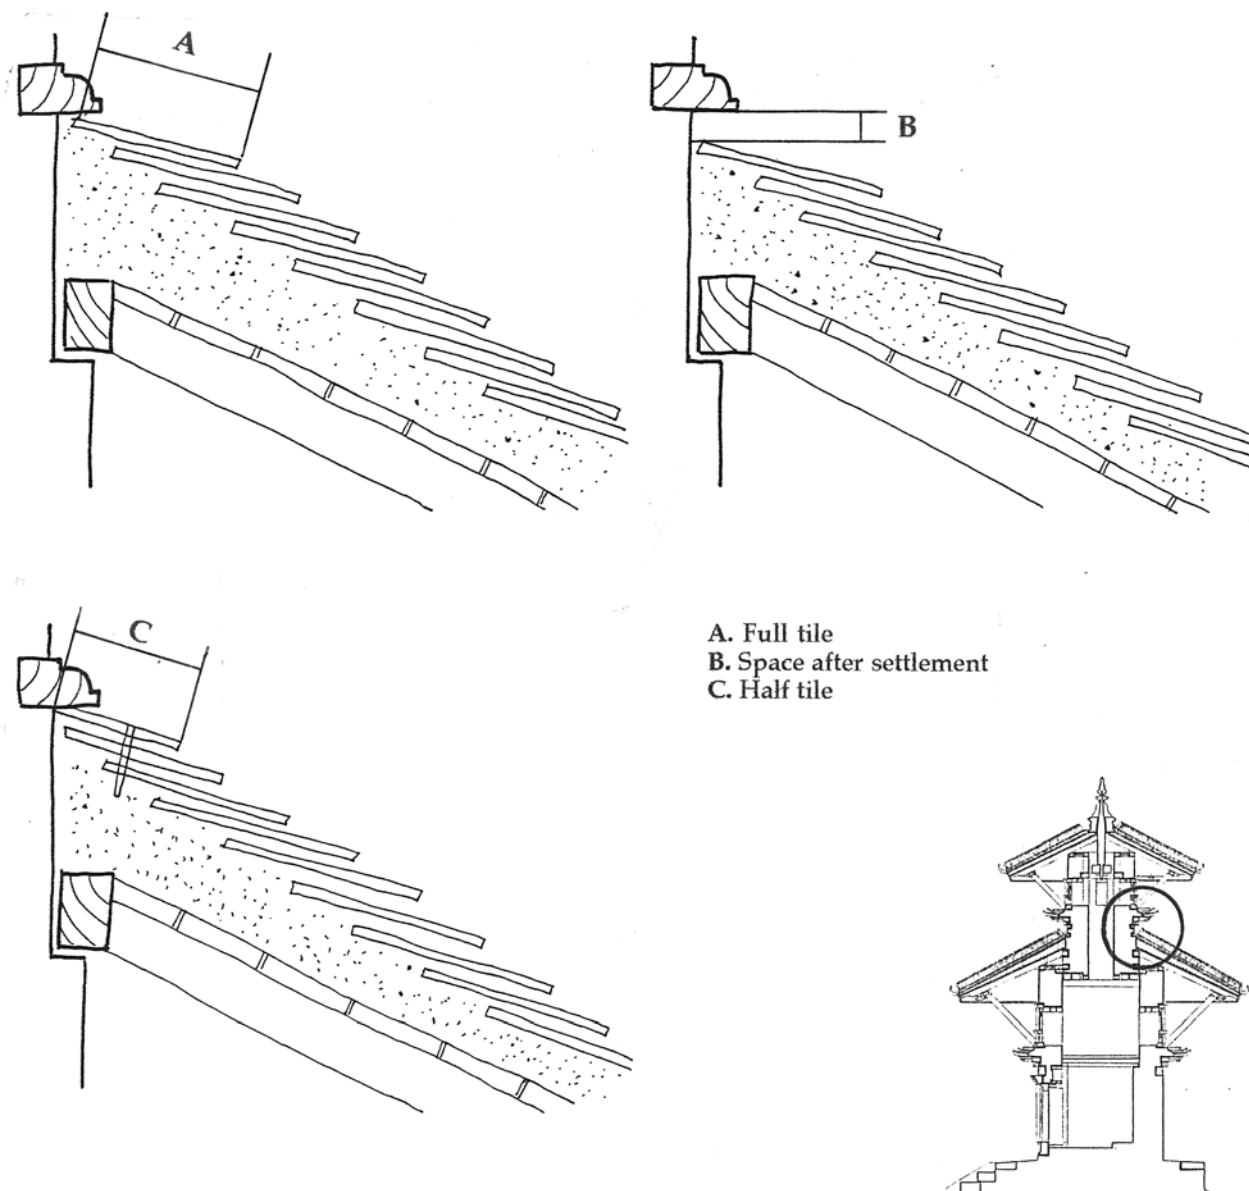
### Tile reinforcement.

1. The upper most row of the tiles are just laid below the timber cornice. During any external movements the upper row of tiles starts to slide down, this in turn the adjacent row, causing them to slide down as well.

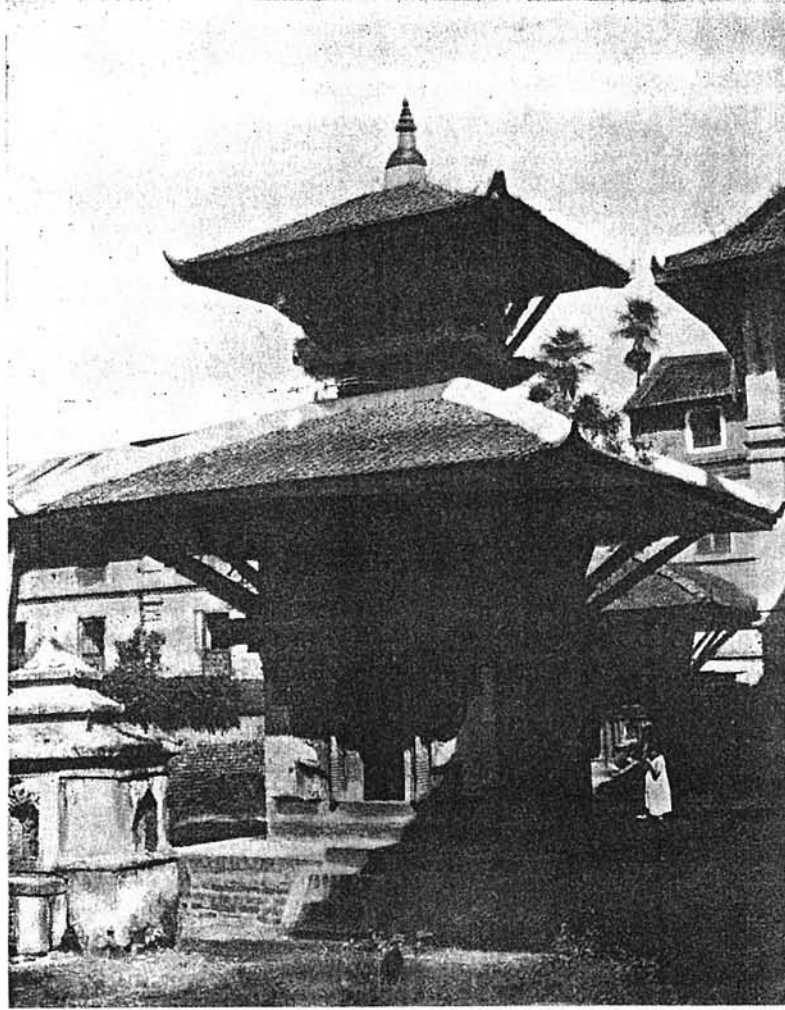
**Documentation of the temple renovation in 1958.**

*This location is situated just north of Patan Mangal Bazar, beside the road to Sankhamul. It is hard to say that this temple is of mid Malla period since there is a lack of stone inscription to tell us the exact date. In this situation the area which is constructed by the devotees was restored by His Majesty King Mahendra Bir Bikram Shah Dev by giving sufficient financial support from his own personal funding Trust to have condolence on their pure eternal artwork. At the same time Narayan and near by Bhagwan temple was also restored by His Majesty. The condition of the temple is shown by the above picture.*
