PATUKVA AGACHE PATUKVA TOL, PATAN

HISTORIC STRUCTURE REPORT JUNE, 1994

ERICH G. THEOPHILE
ROHIT K. RANJITKAR
KATHMANDU VALLEY PRESERVATION TRUST
IN COLLABORATION WITH
HIS MAJESTY'S GOVERNMENT
DEPARTMENT OF ARCHAEOLOGY

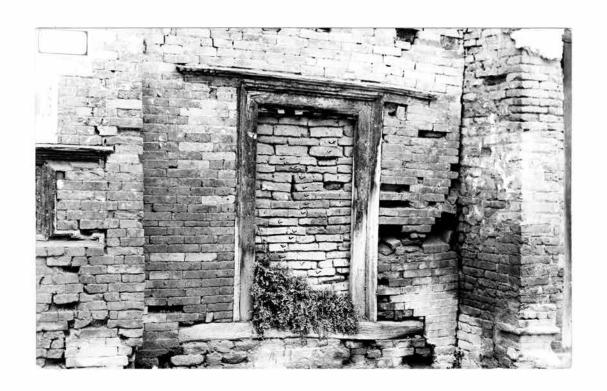
Above: Right (northern) door of principal facade: adjacent area with missing bricks.

been pulled out leaving several gaps, notably one to the right of the northern door 2'2" wide by 4 courses high. The spalling is a result of the lack of damp proof course.

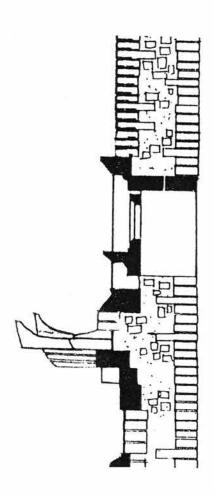
In general, the traditional masonry wall construction is structurally deficient because of minimal through-bonding between three distinct layers and settlement of the middle fill layer (see 4.1).

Below: Section through wall at upper base storey windows shows typical construction: inner and outer layers with few headers and rubble fill between. This accounts for failure in veneer brick..

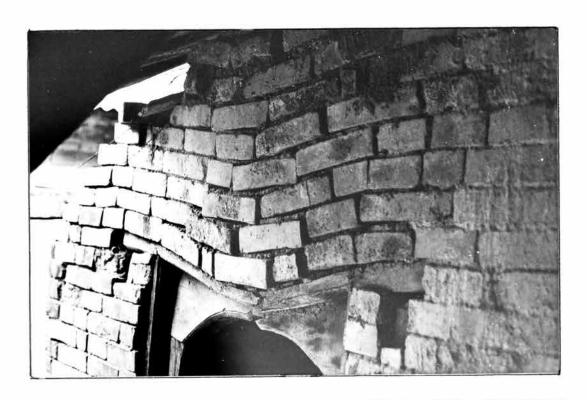
Above the second floor southern window of the principal facade, a failed timber lintel has resulted in the deflection of several masonry courses above. This failure has been caused by water damage allowed by the poor roof condition.

Above: Settlement of brick work above the second floor window resulting from roof damage and water penetration. August 1993.

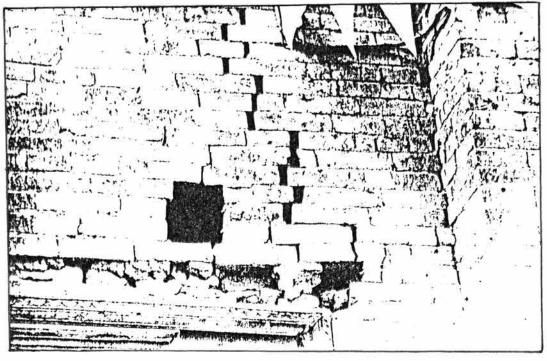
On the principal facade (south side, above first floor window) is found a structural crack 16 courses tall spreading two feet to the south with maximum gaps of 2-1/4" both inside and out. This crack again appears to result from water damage from the lost roof above, exacerbated by poor bonding at this the intersection of the old principal facade and 14 year old south wall.

Below: Wall crack above the first floor lattice window, south side principal facade. August 1993.

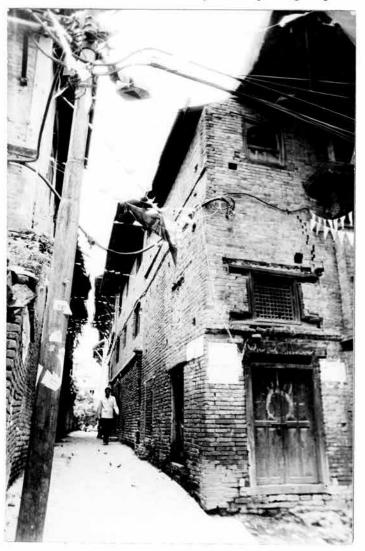
Southeast corner: notice later patch at corner at plinth level. August, 1993.

During the reconstruction of the south wall 17 years ago, the left bay of the principal facade was modified to include a quarter round cornice (just above the timber cornice of the central bay of this facade). Above this simple cornice, the face of the re-used brick was shifted some 3-4" forward. A small patched area is found at the southeast corner (see photo).

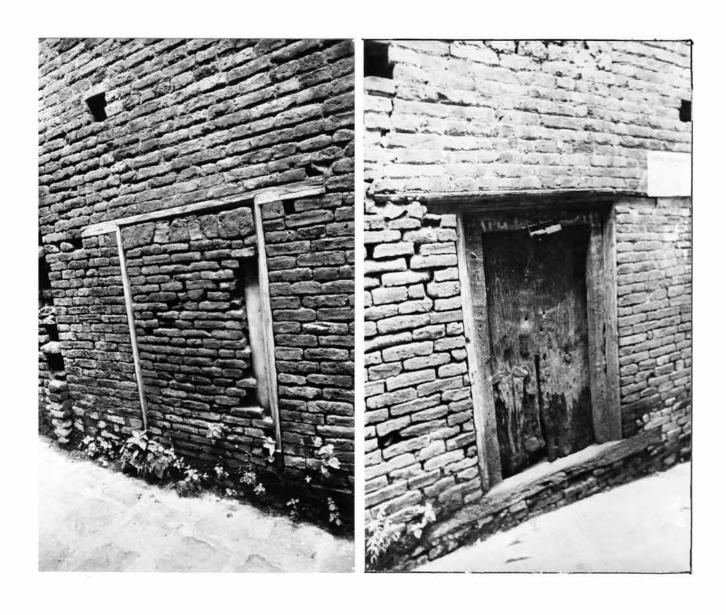
Left: Wall opening on South facade blocked by brick wall in 1977 repair.

Right: South facade: original door re-installed here from principal facade..

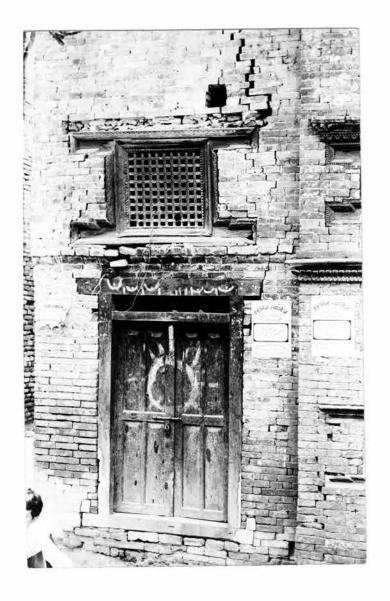
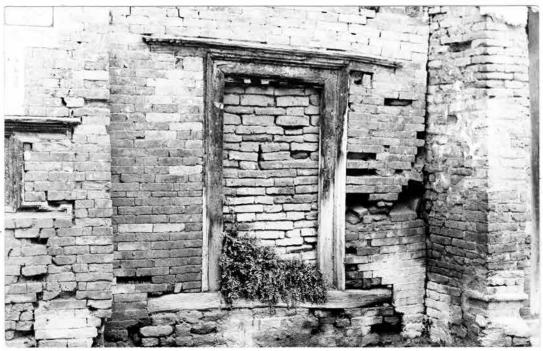
Above: New opening front facade left, from 1977 repairs.

Below: Historical door, principal facade north, blocked by brick in 1977 repairs.

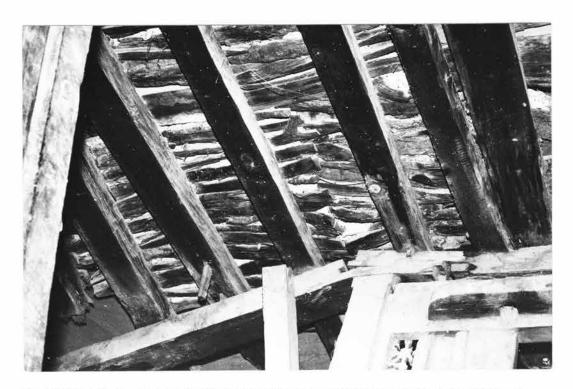
Timber lath above pine rafters has transmitted dampness from mud to rafter. Principal facade, August 1993.

The upper roof has also not been repaired since before the 1934 earthquake, as reported by Guthi elders. All of the rafters and purlins are pine (5"x 4" on average, spacing 12" o.c.at eavesboard) and in very poor condition, Several pieces of the sal eavesboards are missing, surviving portions are in poor condition. All damage is related to wet rot caused by water penetration. Source of the problem, as at other roof locations, consists of water entry via *chukuls* and general dampness transmission from mud bed to rafter via lath under the mud.

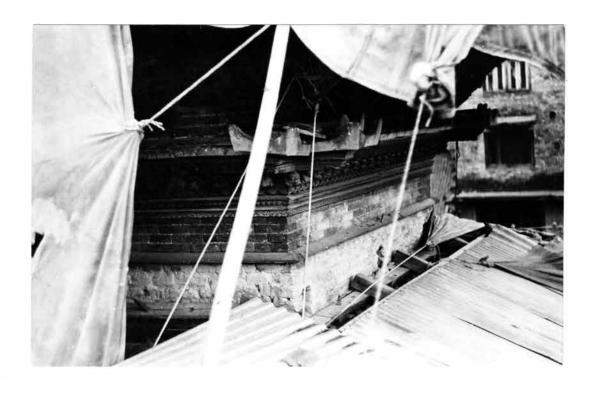
Above: Zinc roof on south side of building from 1977 repairs. Although zinc sheet is relatively easy to fix (especially in comparison with *Jhingati*), nevertheless, improperly executed repairs with zinc sheets have allowed water to enter the building.

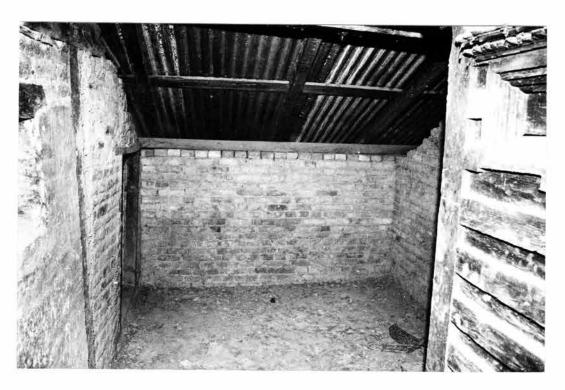
Below: Replacement with zinc sheets alllowed minimally rebuilt roof frame (rafter spacing+/- 3'7" o.c.).

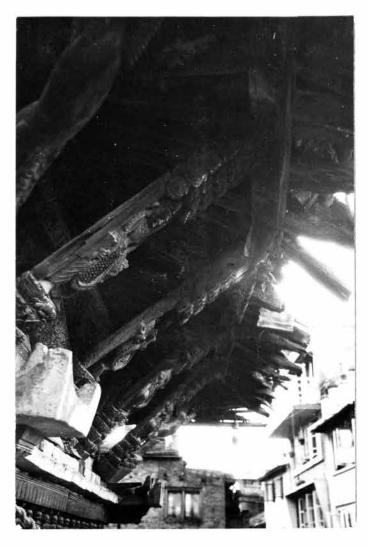
Right: Eavesboard already lost and rafter ends rotted off, Upper pagoda(lower of two roofs), south elevation. August 1993. Below: Only a few metal strips hold a damaged eavesboard on west facade, upper pagoda (lower of two roofs). August 1993.

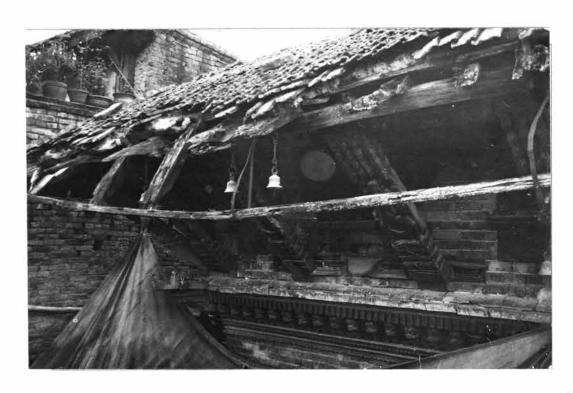
Above: Uppermost pagoda roof from west shows broken eaves on North-West corner.

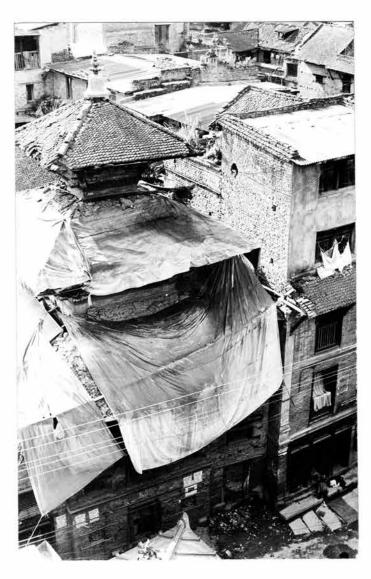
Left: Gap between bottom of pinnacle and roof tiles. August 1993.

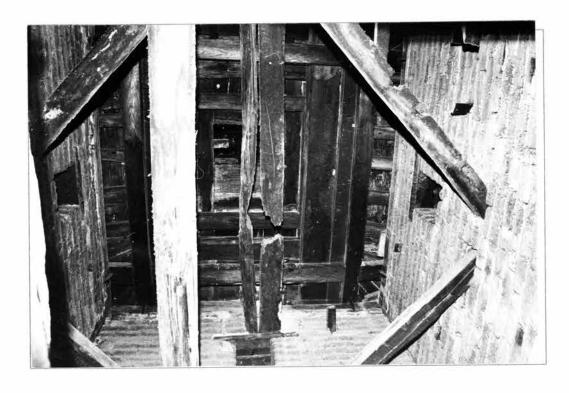
Below: Inside timber structure of upper pagoda showing damaged tie in center and corner bracing, perhaps added in 19th c. reconstruction. August 1993.

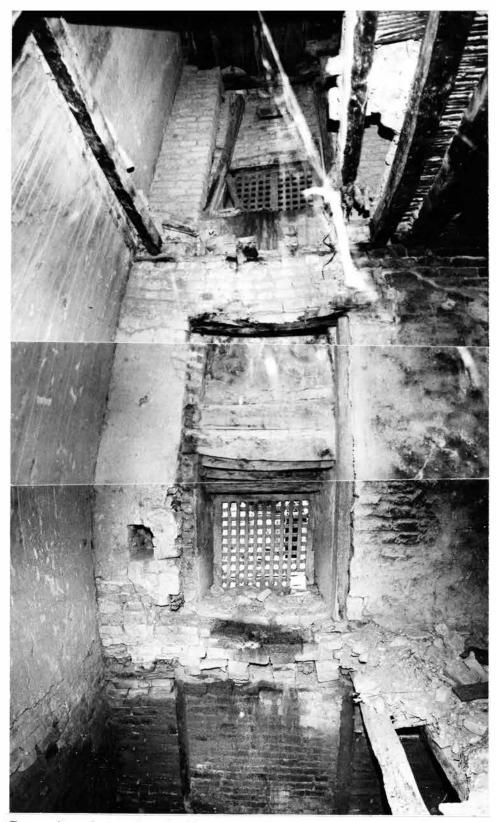
Composite photo view looking east. The three northern openings of the principle facade (blocked door below) are visible as is collapse of all floor joist in this area.

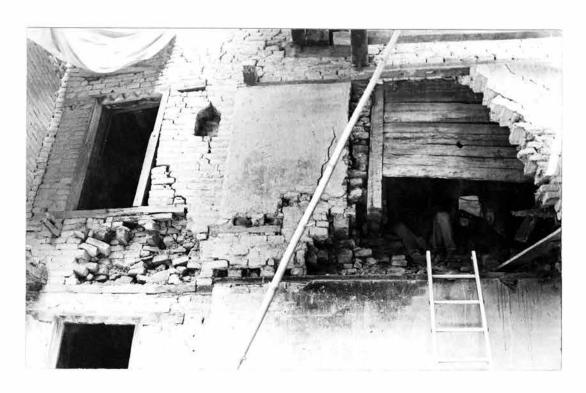
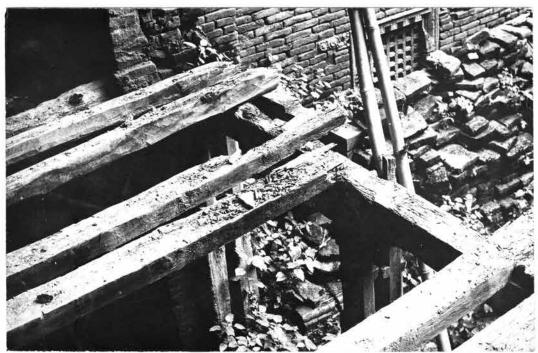
The most significant failure of the structure consists of the buckling out and collapse of a later added masonry wall directly behind the 2nd floor shrine. This 9" thick wall appears to have been added as a security precaution for the shrine (otherwise closed only by timber planking at this level). Because of insufficient support by the historical floor joists, this wall led to the collapse not only of the joists it sat on, but also of the rafters above and portions of the original middle masonry wall.

Above: Back of main building ("middle wall") showing second floor shrine location where masonry wall added behind timber partition led to structural collapse of rear gallery. Summary 1993. Below: First floor of rear gallery showing missing joist and partially collapsed adjacent masonry wall (left).

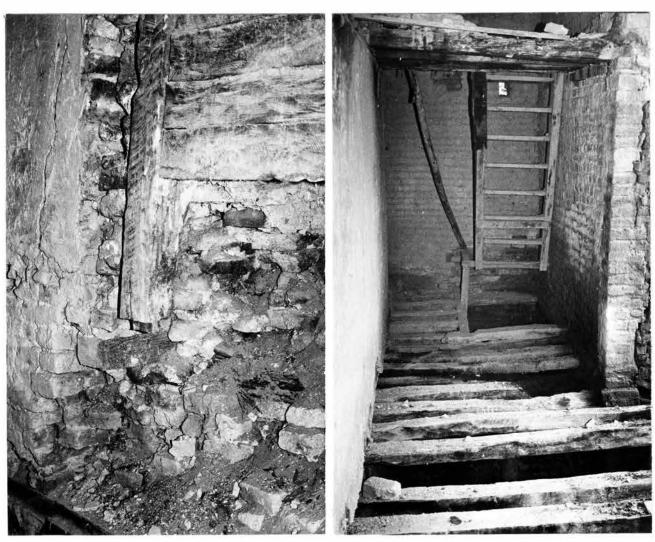
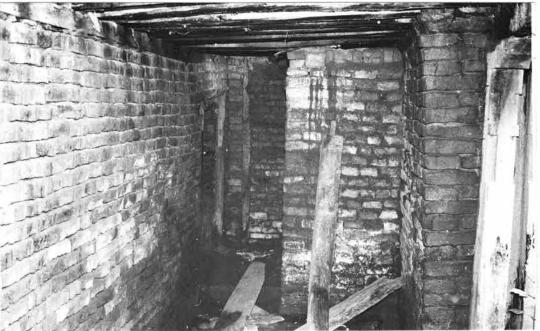
Above left: Back of esoteric shrine, second floor, showing original planking partition as well as later added and partally collapsed masonry wall behind, summer 1993. Above right: first floor level at back wing looking south to stair ladder. Below: Ground floor at back wing looking south, showing msonr stair middle, and gallery timber pier right.
