# TUM BAHA NARAYAN TEMPLE

## HISTORIC STRUCTURE REPORT

PATAN DARBAR WORLD HERITAGE SITE  
KATHMANDU VALLEY PRESERVATION TRUST

SUMMER, 2000

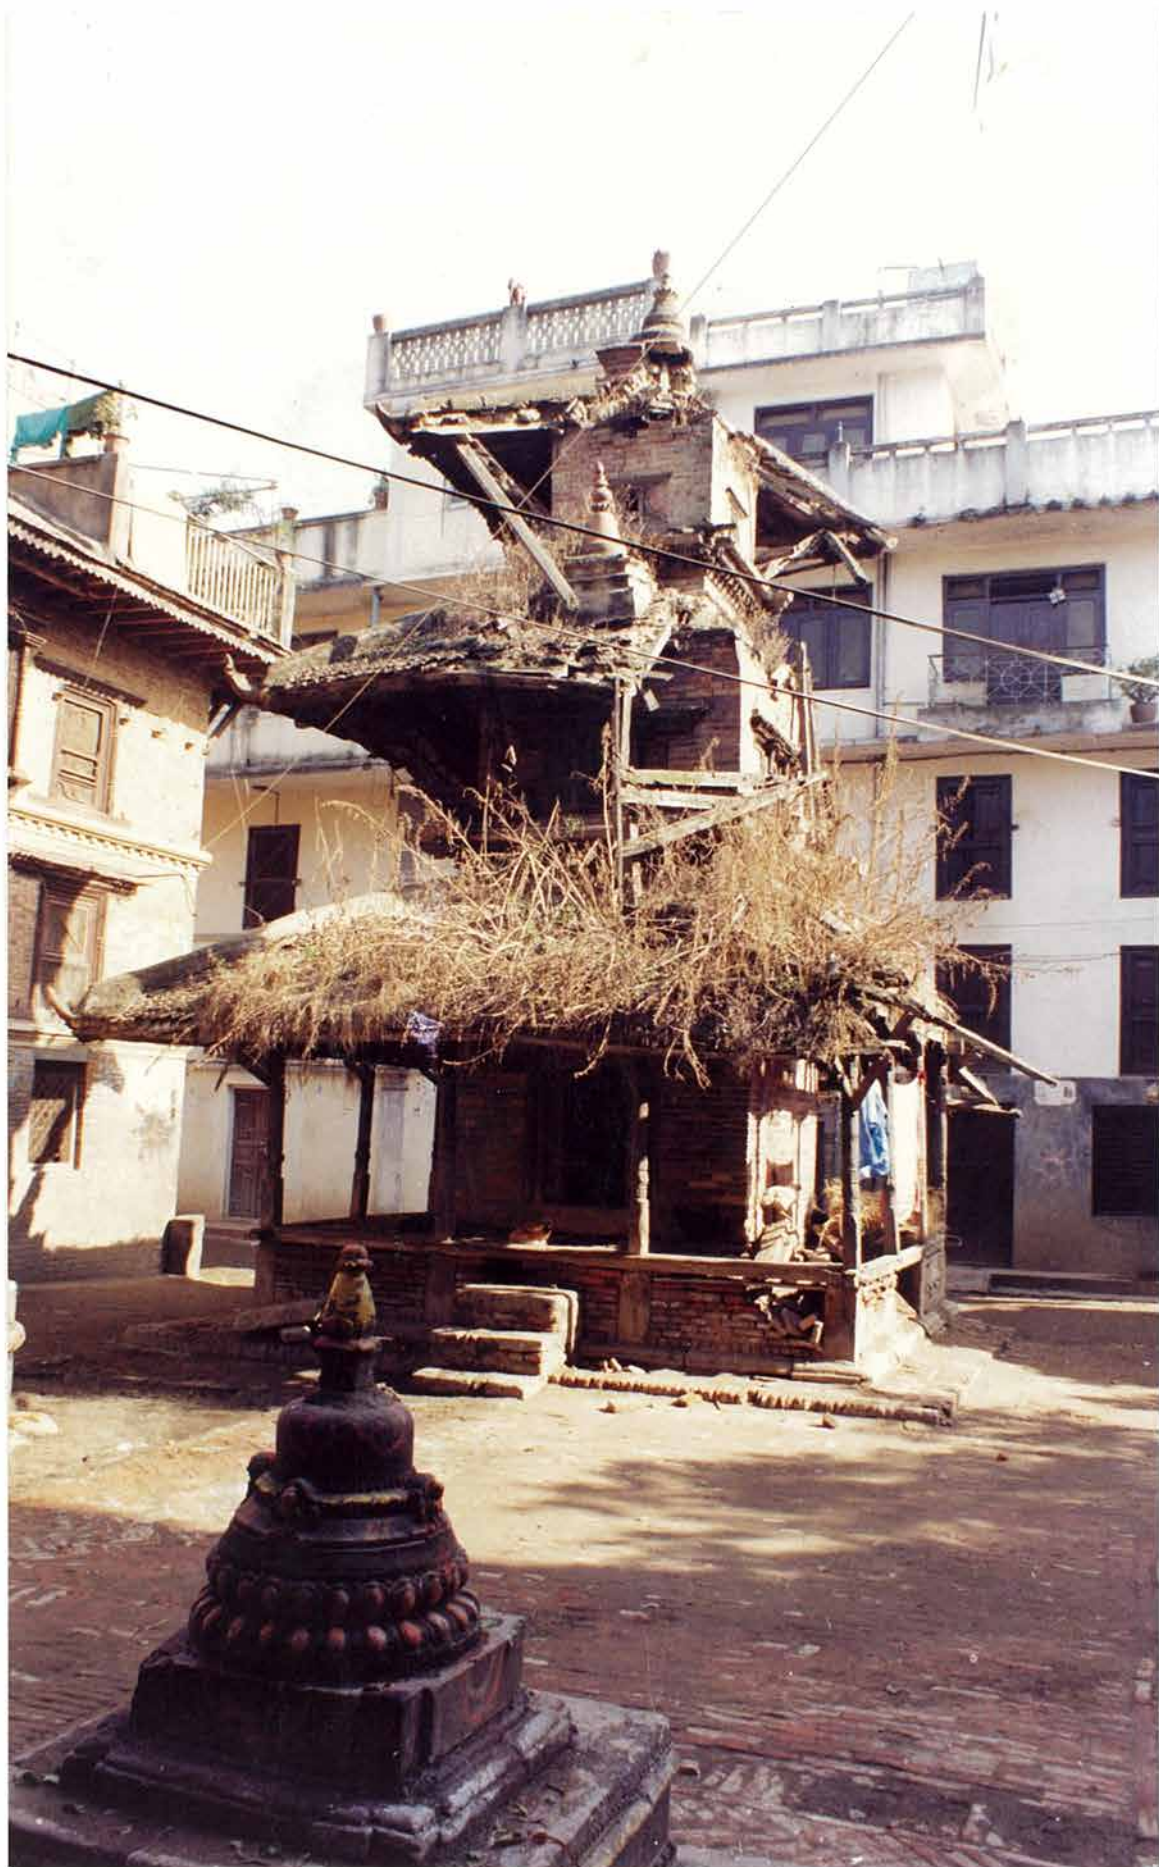
Roof largely collapsed. Seen from west. Photo 1994

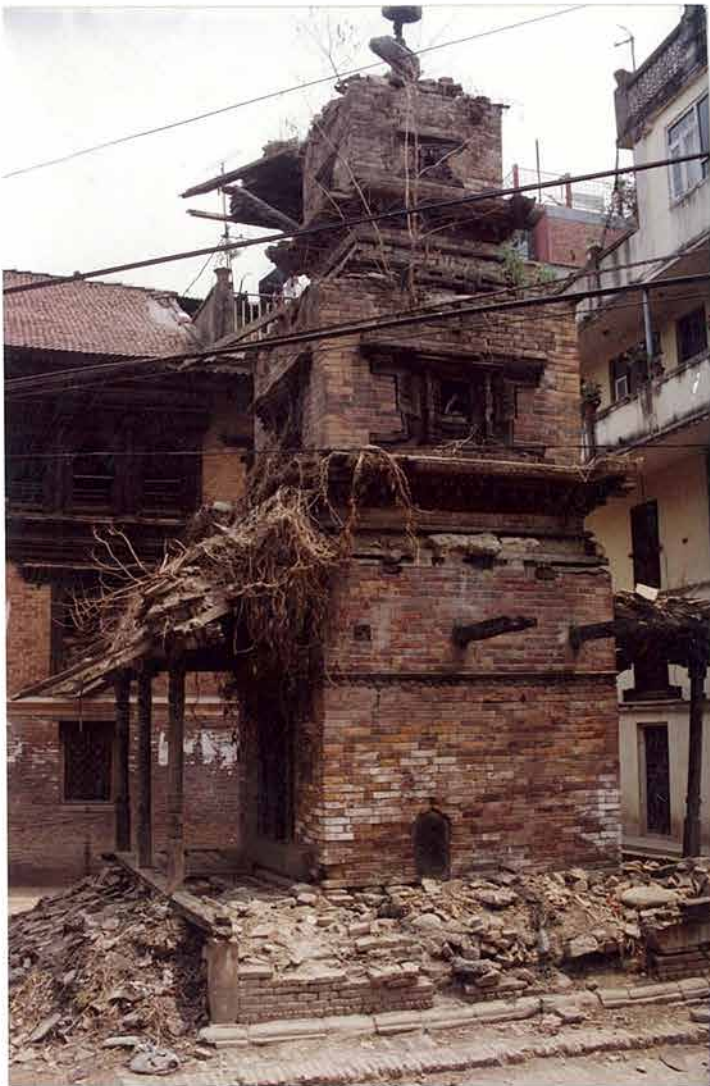
South facade: September 1997

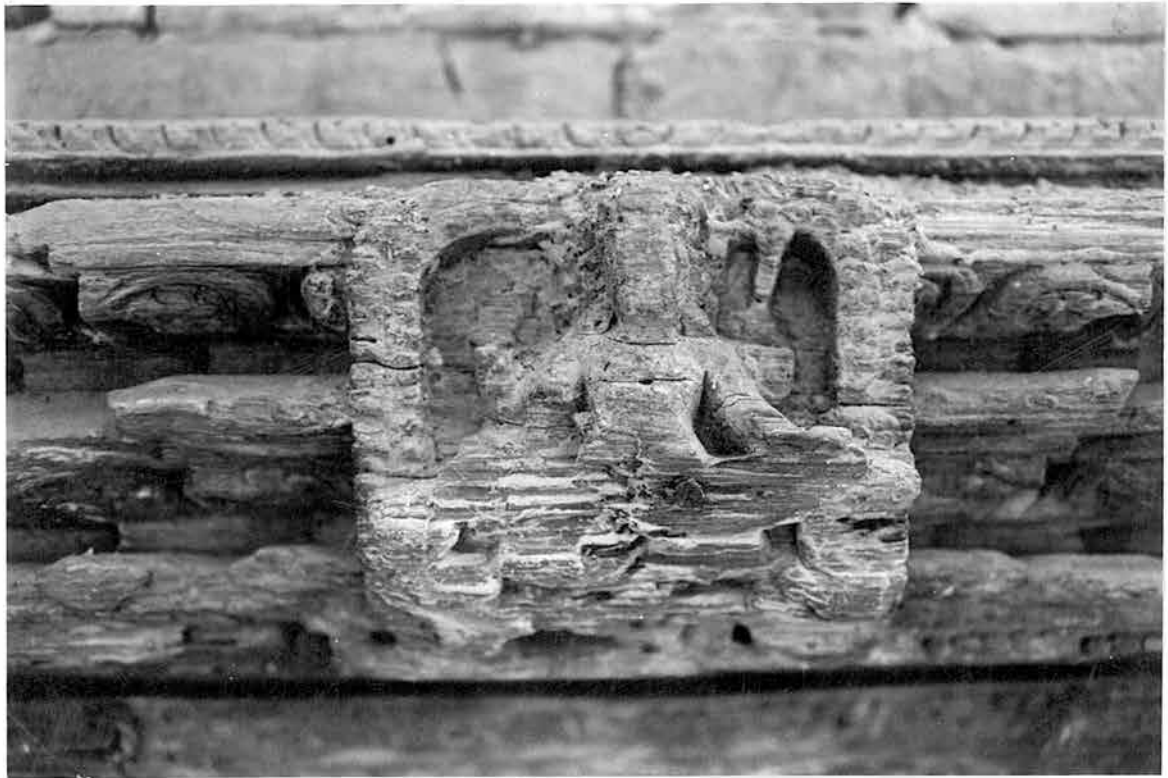
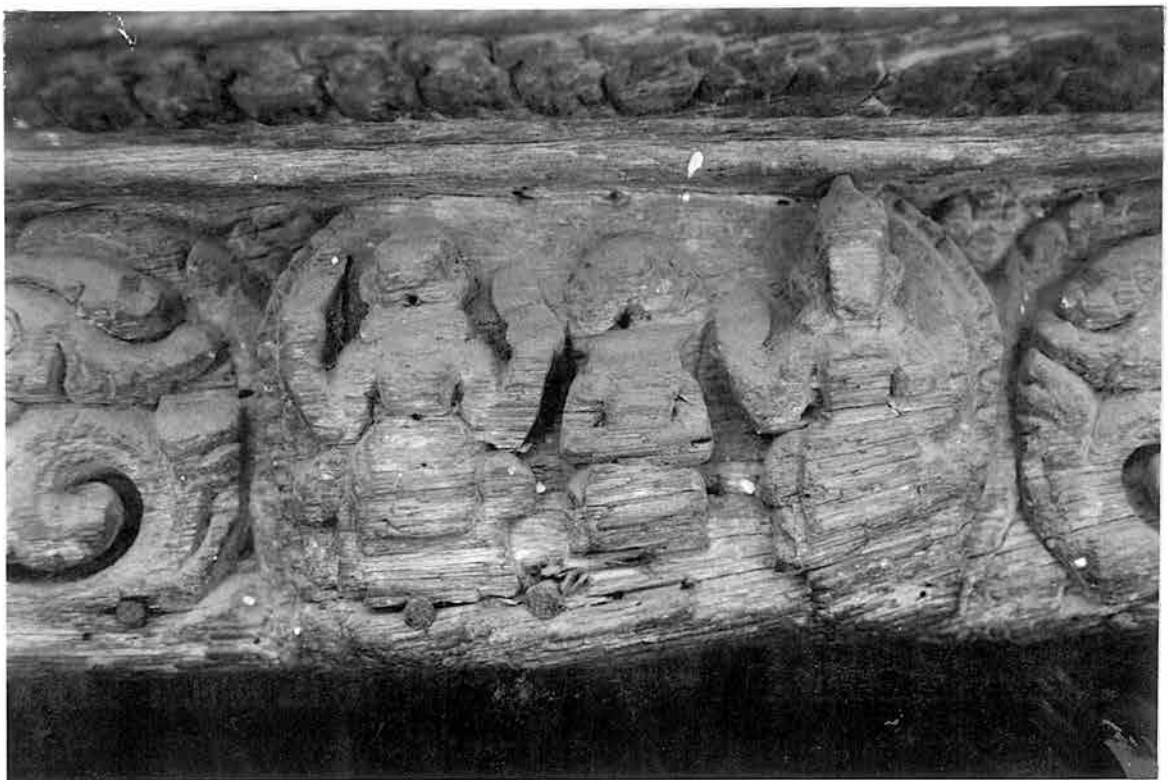
Above: Narayan image on the uppermost part of door lintel. Lower half of the figure is broken.

Below: Three unidentified deities on the lower part of the door lintel. Because of its location in the most touchable area, there is heavy wear. Also the presence of several nails has contributed to the weakening and breaking of the wood.

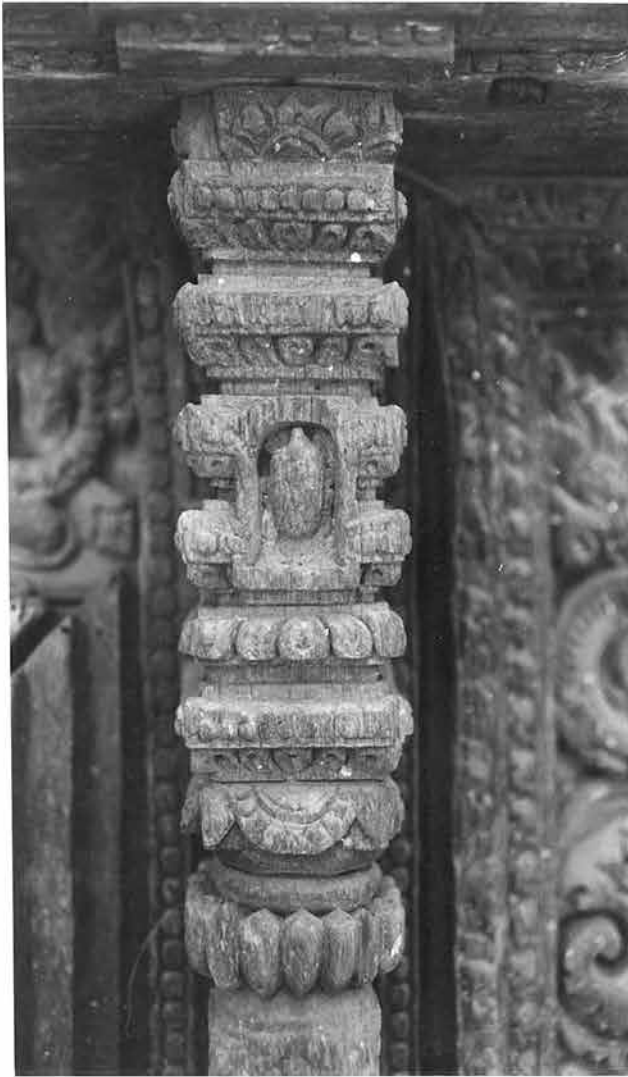
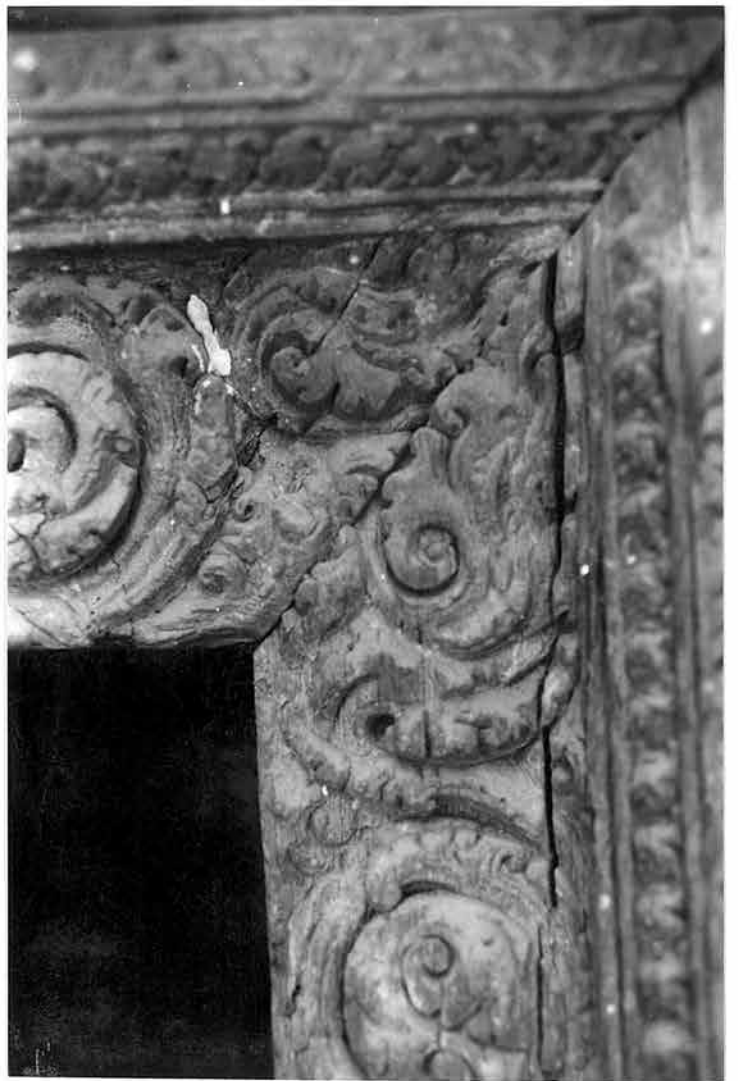
Left: extended timber column on main entrance doorway. Face of the small deity is worn due to weathering

Right: upper right corner of main door frame. Vertical member has a crack on right side, but structurally is still sound.

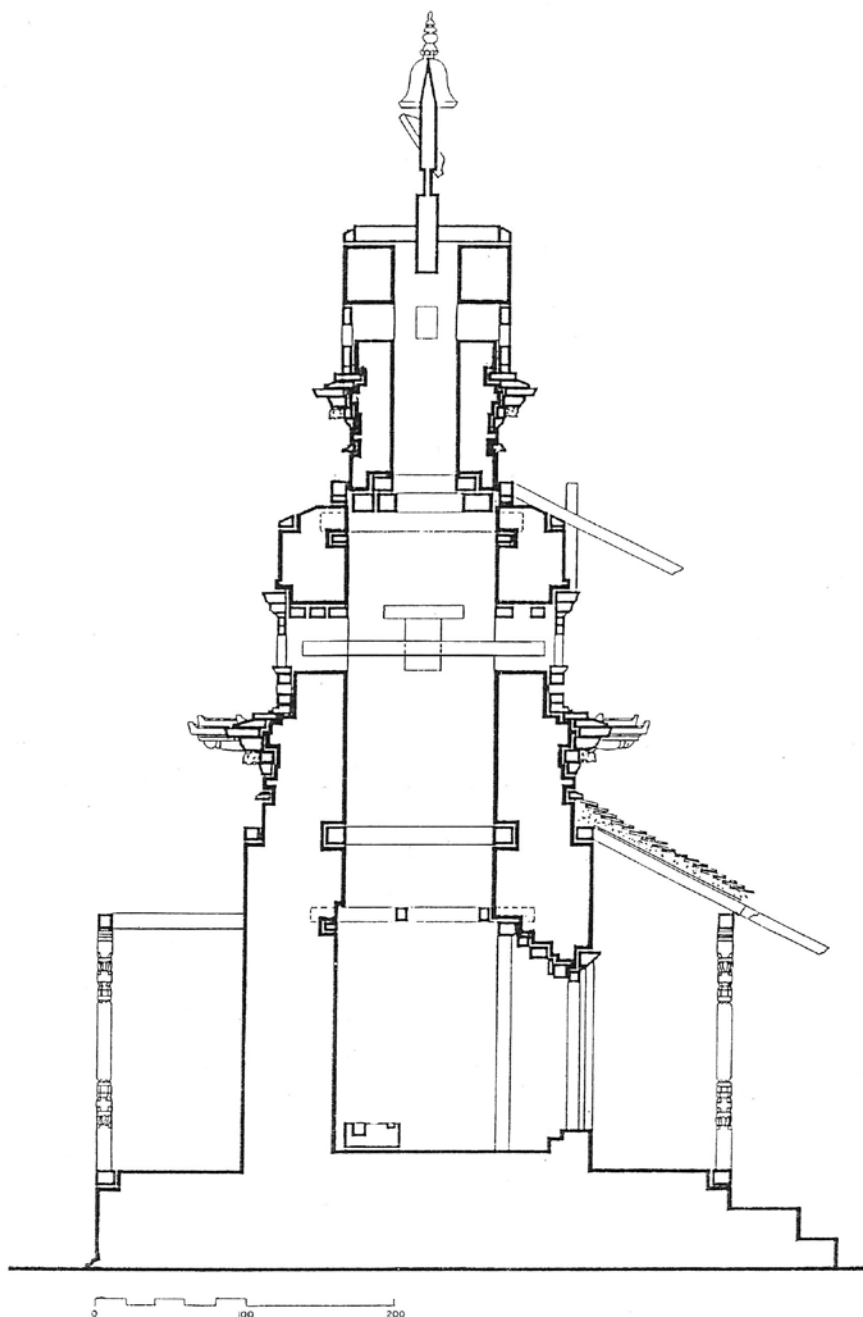
SECTION EAST-WEST: EXISTING CONDITIONS

*Galsi* (pinnacle king post) completely damaged

Pinnacle terracotta base completely damaged

Upper roof: wall plates, rafters, purlins, and eaves board severely damaged by wet rot or lost

Masonry wall damage in the upper 12 layers of brick

Timber cornice: 20% damaged by wet rot

Middle roof timber members – rafters, purlin, eaves board were completely damaged or lost

Wall plate: inner-damaged 20%,

Wall plate: outer-100% damaged by wet rot

Upper layers of brick damaged by vegetal growth

*Lah-kah* (extended terracotta cornice): 20% damaged

Lower roof: 50% damaged on two sides by wet rot and other two sides collapsed

Wall plate: outer damaged completely

Timber bracket completely damaged

*Laka-si* (timber plinth beam) completely damaged

Plinth wall 60% of bricks are replaced with mismatched common brick or random rubble

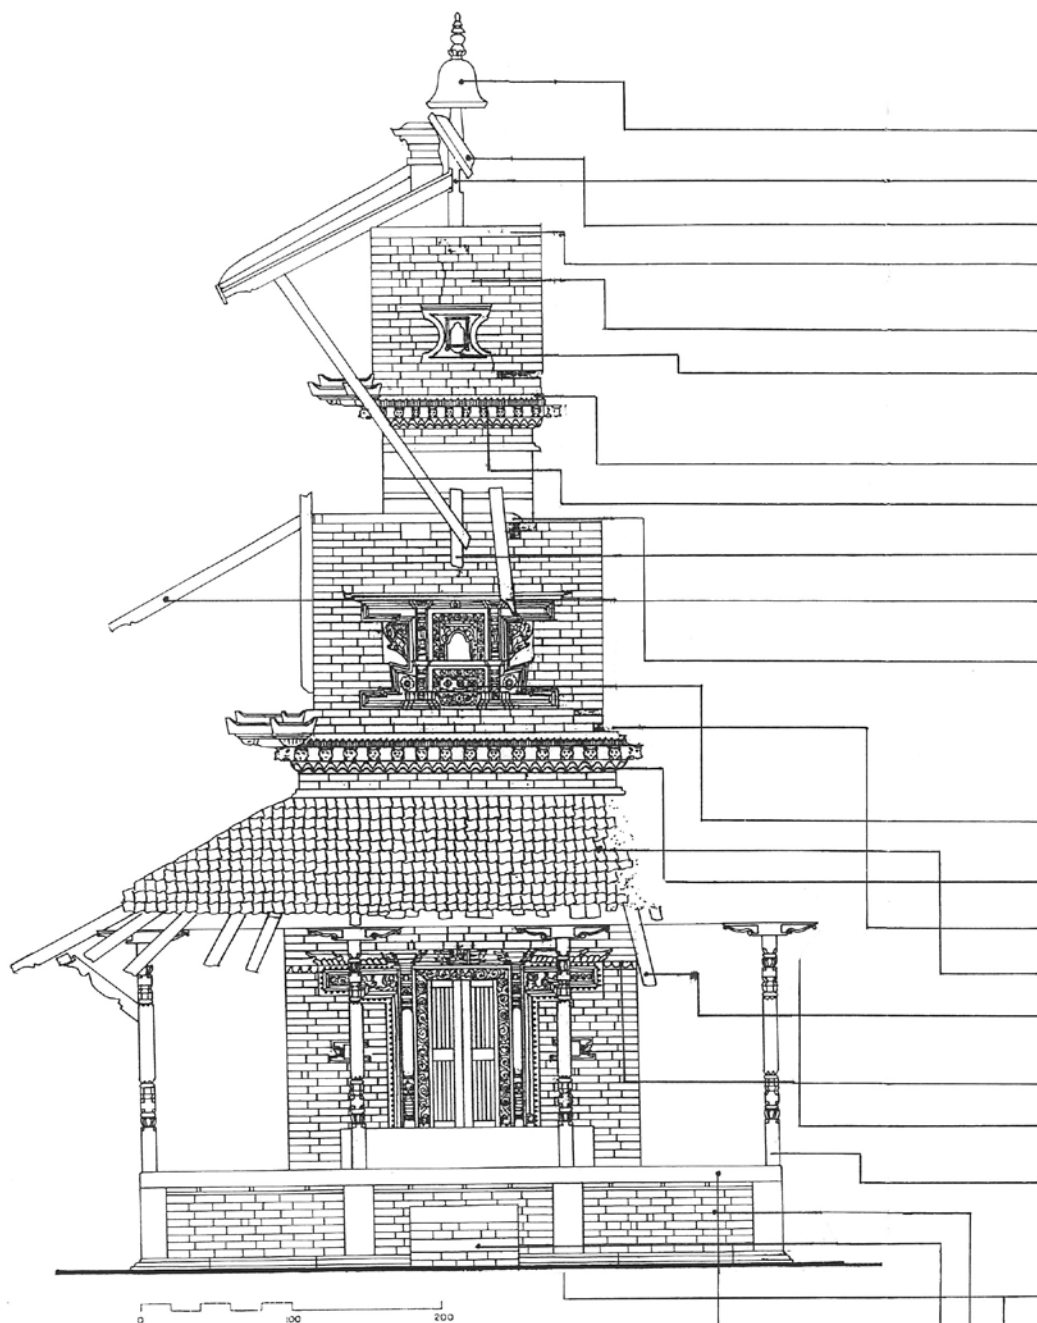
### PRINCIPAL WEST FACADE: EXISTING CONDITIONS

- Gajura* (terracotta pinnacle) lost two months back
- Galsi* (pinnacle king post) completely damaged
- Pinnacle terracotta base completely damaged
- Upper roof: wall plates, rafters, purlins, and eaves board severely damaged by wet rot or lost

- Masonry wall damage in the upper 12 layers of brick
- Small window: good condition
- Roof struts: 1 middle strut salvaged
- Lah-kah* (extended terracotta cornice): lost

- Timber cornice: 20% damaged by wet rot
- Gajura* (terracotta pinnacle) at middle roof salvaged
- Middle roof timber members – rafters, purlin, eaves board were completely damaged or lost

- Wall plates: inner-damaged 20%, outer-100% damaged by wet rot
- Upper layers of brick damaged by vegetal growth
- Roof struts: 1 middle & 1 corner salvaged

- Ga'jhyah* (decorative carved wooden window): damaged middle fragment
- Wood cornice: good condition
- Lah-kah* (extended terracotta cornice): lost
- Jhingati* (terracotta roof tiles): 40% surviving

- Lower roof timber members – rafters, purlins, missing or completely damaged by wet rot
- Wooden cornice in good condition
- Timber bracket completely damaged

- Timber posts: 2 surviving in good condition & 2 damaged by wet rot
- Brick wall in good condition except at corners where a few bricks are damaged by moisture

- Stone threshold: good condition
- Laka-si* (timber plinth beam) completely damaged
- Plinth wall 60% of bricks are replaced with mismatched common brick or random rubble

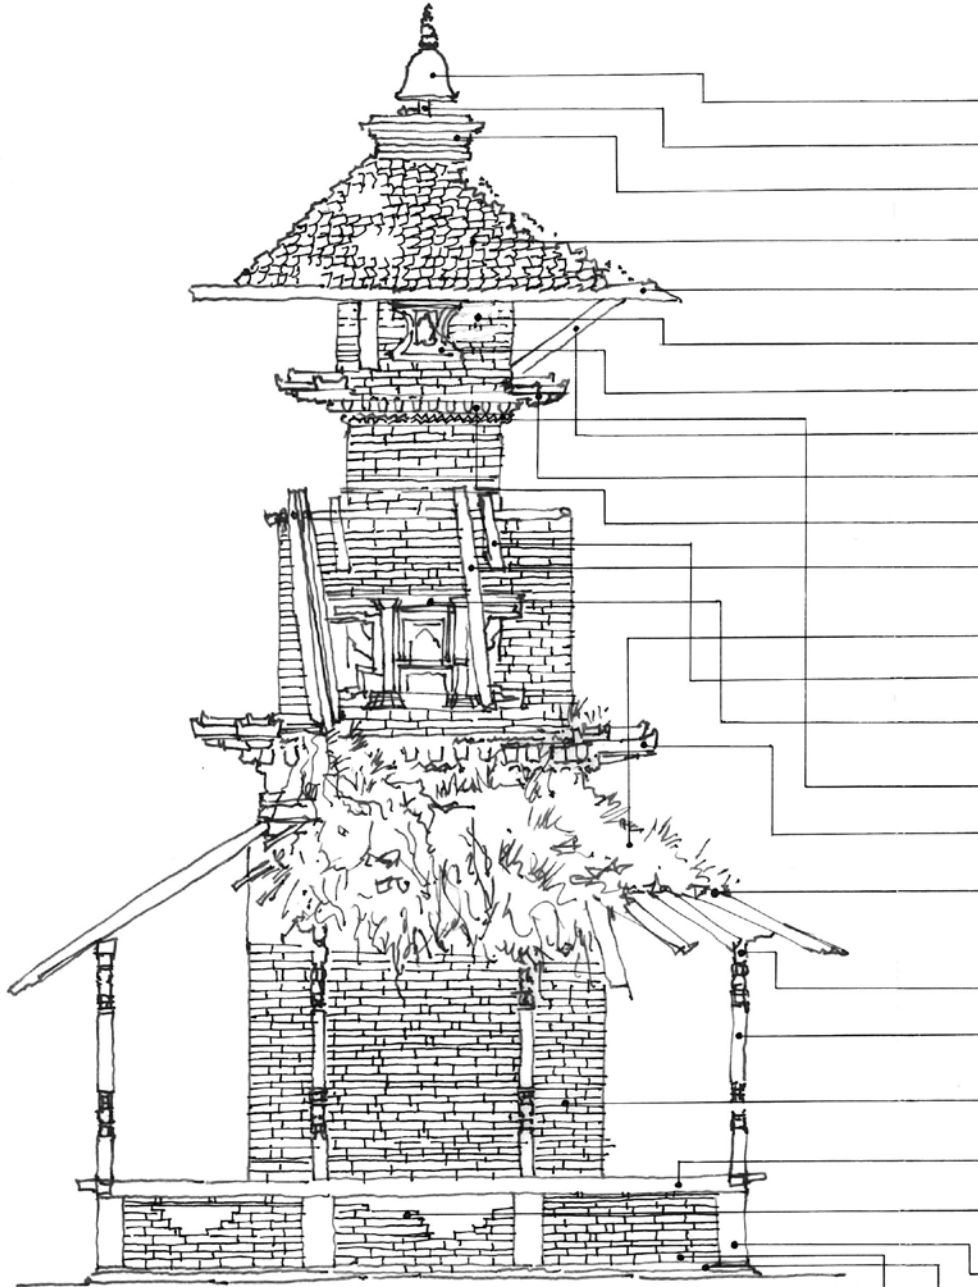
### NORTH FACADE: EXISTING CONDITIONS

- Gajura* (terracotta pinnacle) lost two months back
- Galsi* (pinnacle king post) completely damaged
- Pinnacle terracotta base completely damaged
- Jhingati* (terracotta roof tiles) 25% good condition

- Wall plates, rafters, purlins, and eaves board severely damaged by wet rot
- Masonry wall damage in the upper 10 layers of brick
- Small window: good condition

- Roof struts: 1 corner strut salvaged
- Lah-kah* (extended terracotta cornice) in good condition
- Timber cornice: good condition
- Middle roof timber members – rafters, wall plates, purlin, eaves board were completely damaged or lost

- Upper 10 layers of brick damaged by water infiltration
- Roof struts: all lost
- Ga Jhyah* (decorative carved wooden window): lost upper fragment
- Wood cornice: good condition

- Lah-kah* (extended terracotta cornice) slightly chipped
- Lower roof timber members – rafters, purlins, missing or completely damaged by wet rot
- Wooden cornice in good condition

- Timber bracket completely damaged
- Timber posts: 2 surviving in good condition & 2 damaged by wet rot
- Brick wall in good condition except at corners where a few bricks are damaged by moisture

- Laka-si* (timber plinth beam) completely damaged
- Plinth wall 40% of bricks are sloppily repaired with mismatched common brick or random rubble
- I-loh* (base stone for timber post): good condition

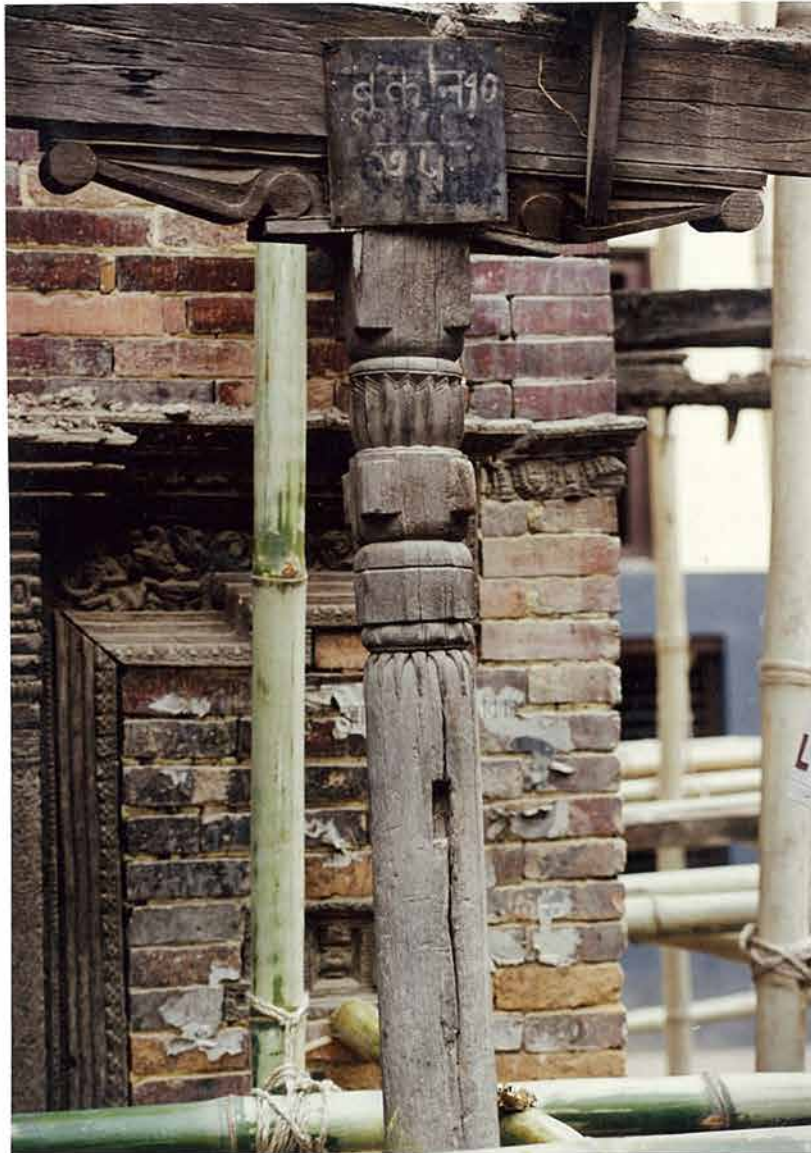
Original column and capital assembly, west elevation, fall, 1998. The notch accepts lost roof strut.

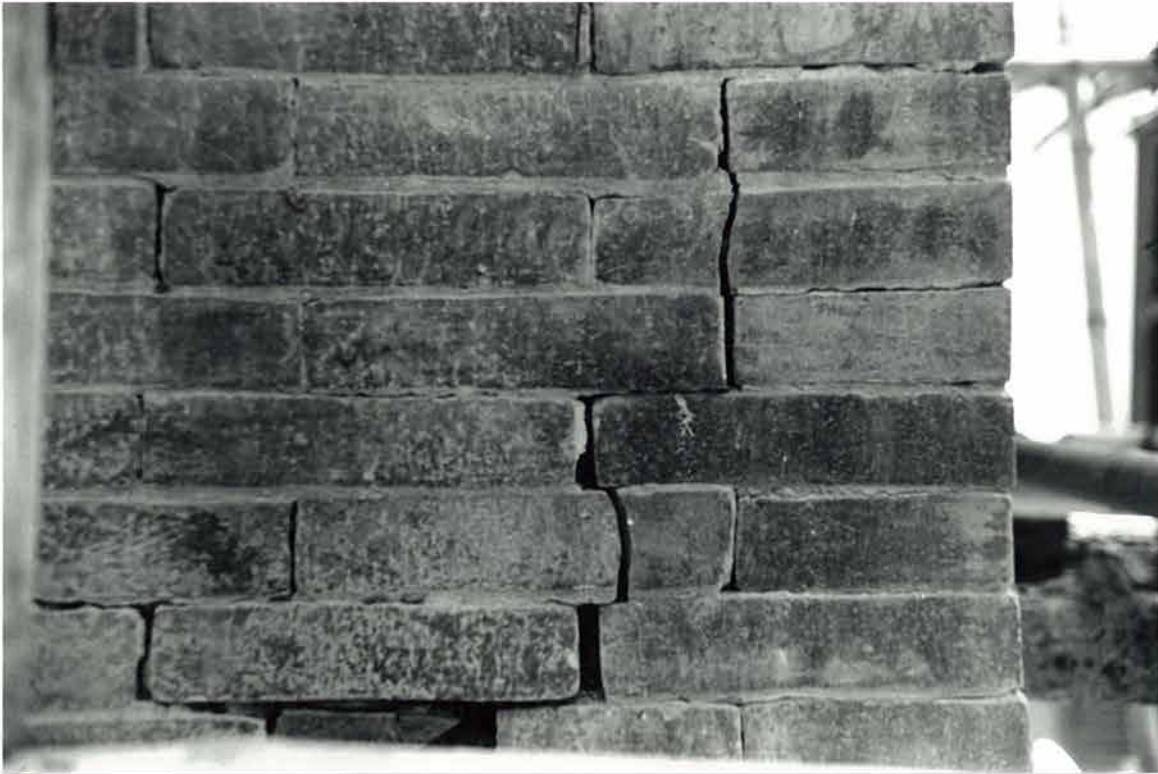
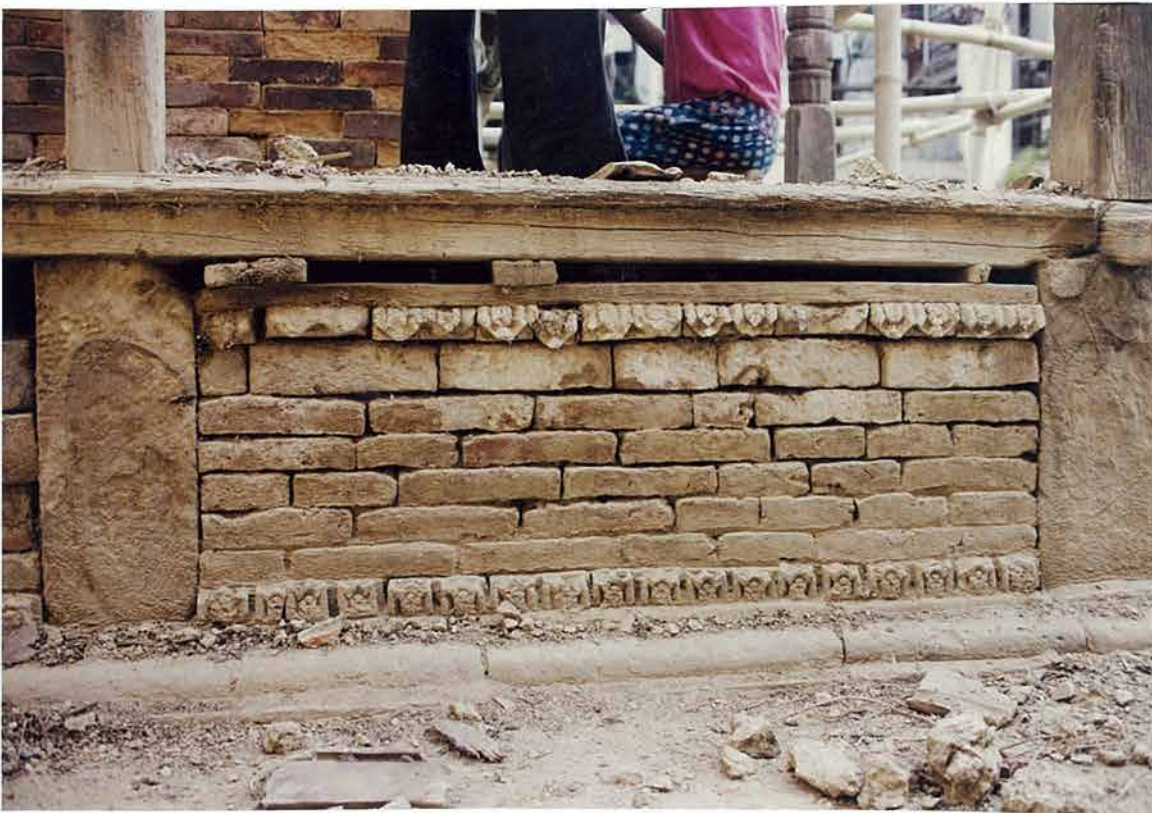
The plinth wall was in poor condition with mismatched bricks and rubble laid with no mud mortar. Evidence of sloppy repairs circa 1974 substituted common brick in mismatched sizes for the original veneer brick (Newari: *daci-apa*). Such well meaning attempts by locals to repair the damage did little to remedy the situation.

Above: A crack on ground floor wall on right side above extended timber doorway lintel.

Below: Plinth, south elevation, fall 1998. Rebuilt in common brick of mixed sizes, circa 1974.

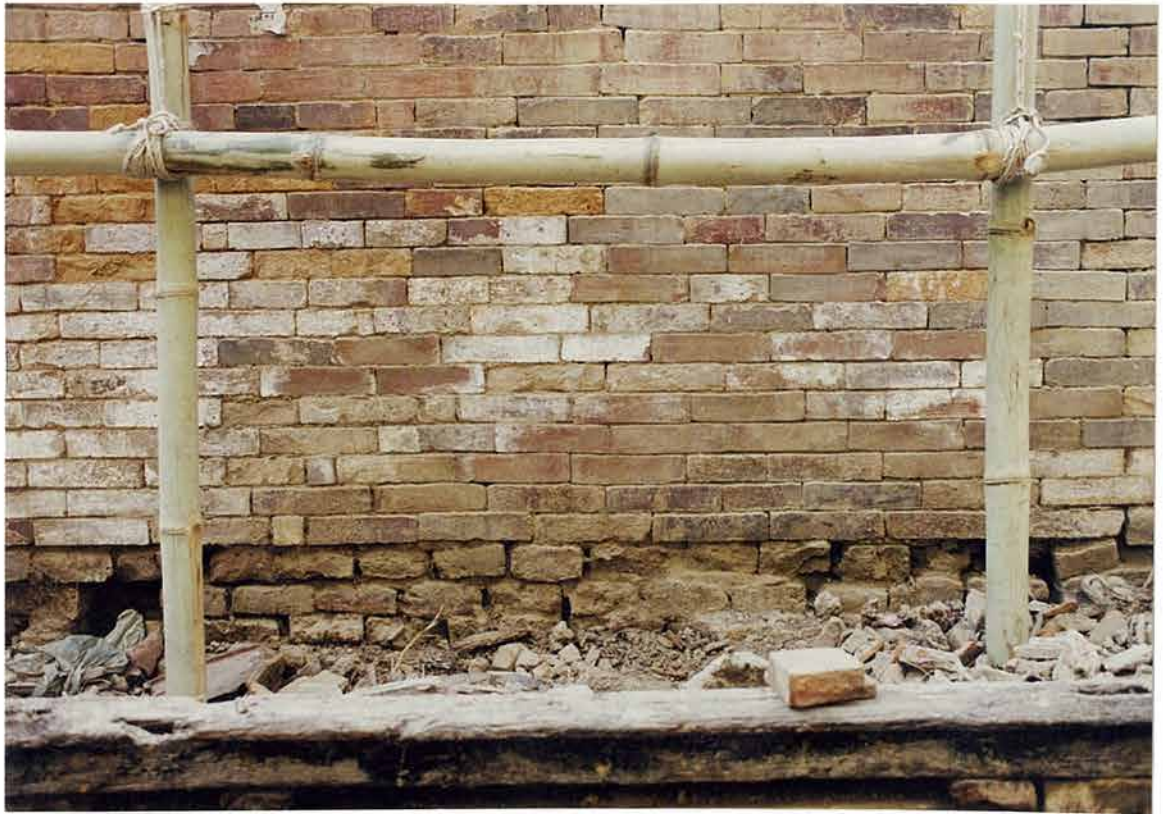
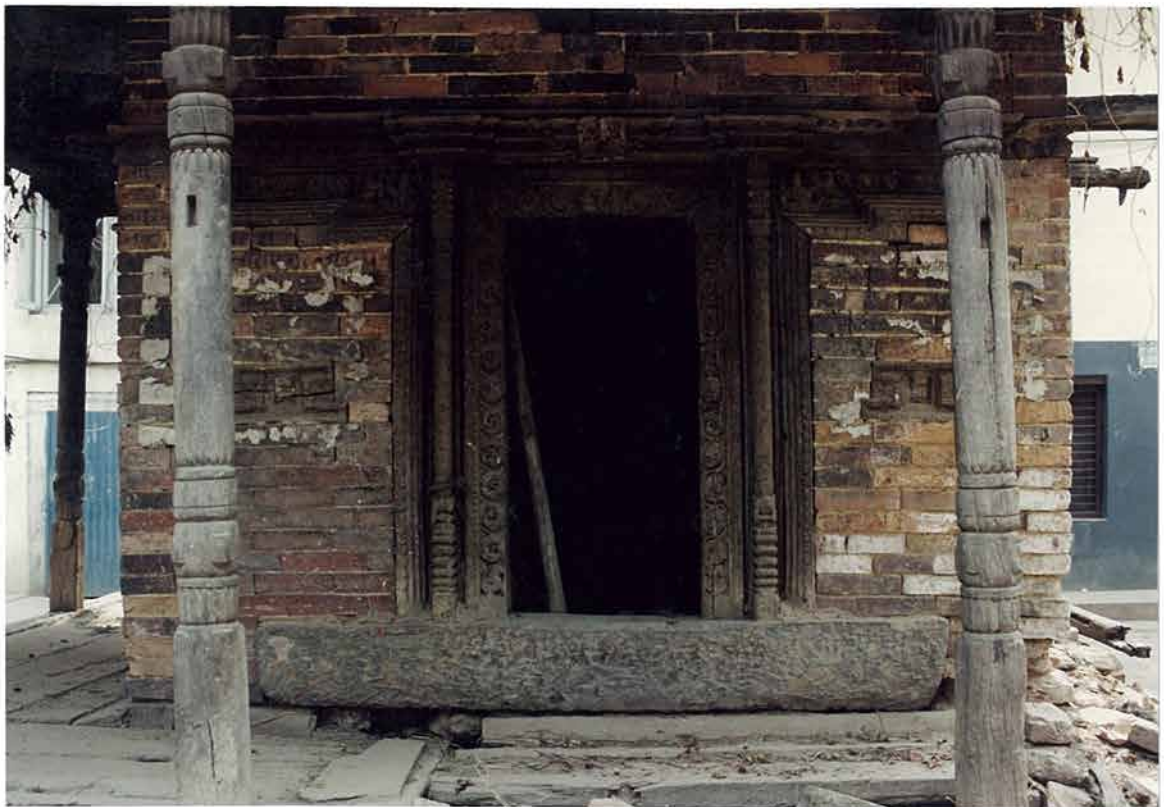
Above: North facade of ground floor wall was damaged due to the efflorescence of the salt. Brick courses below plinth planking was reconstructed in common brick.

Below: The main doorway on the west facade in good condition. The stone threshold protected the carved doorway from rising dampness.

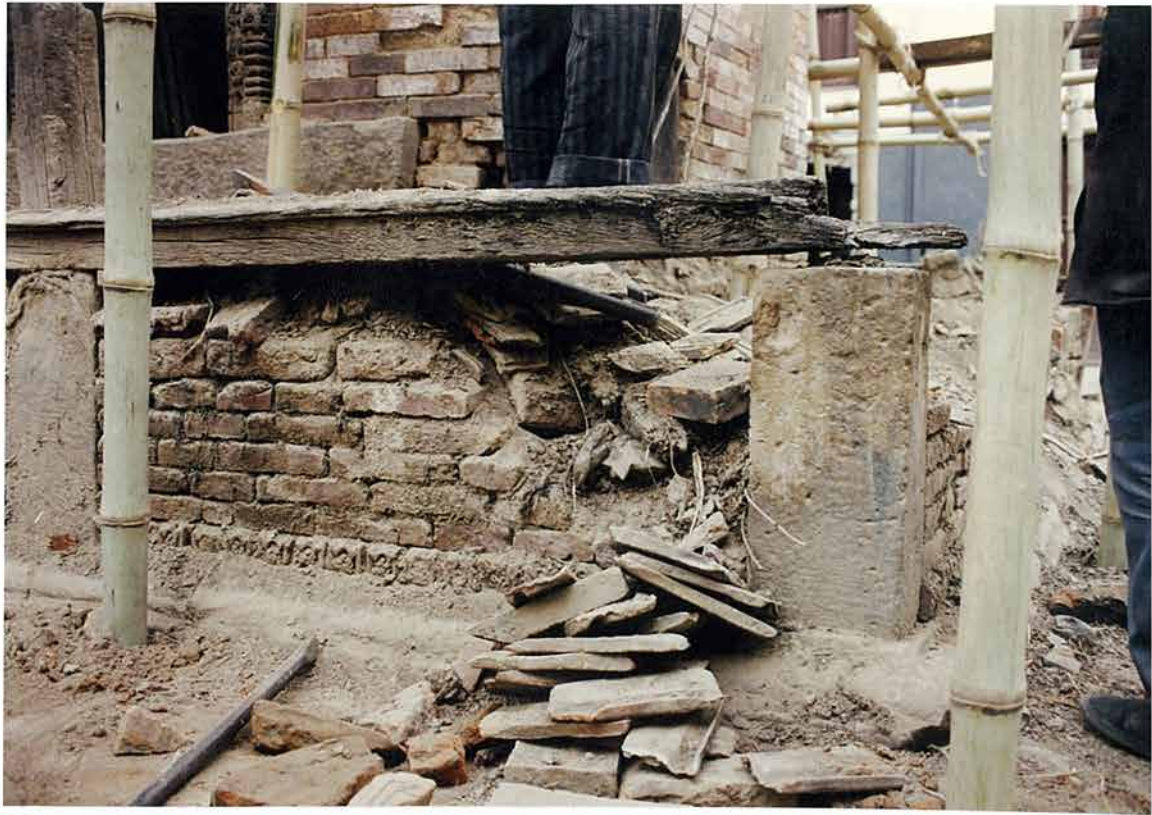
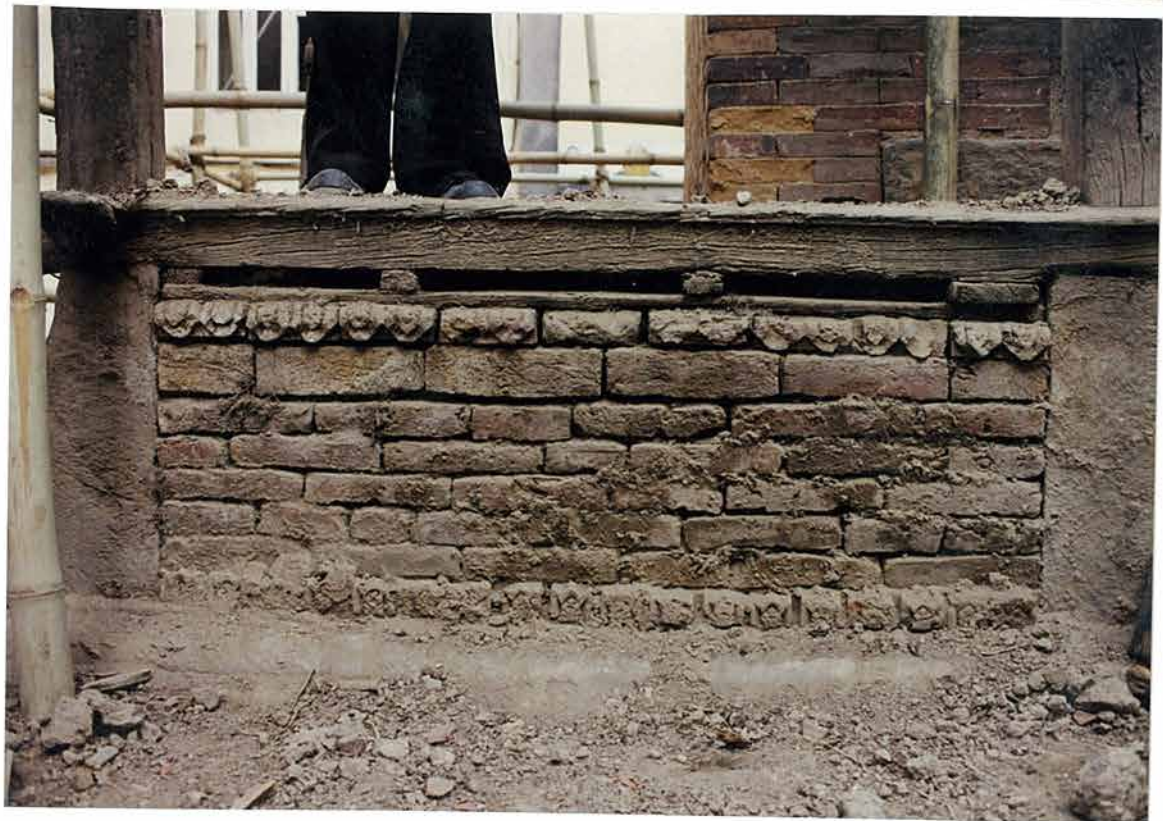
Plinth, west elevation and right corner, fall 1998.  
Rebuilt in decorative and common brick of mixed sizes, ca. 1974.

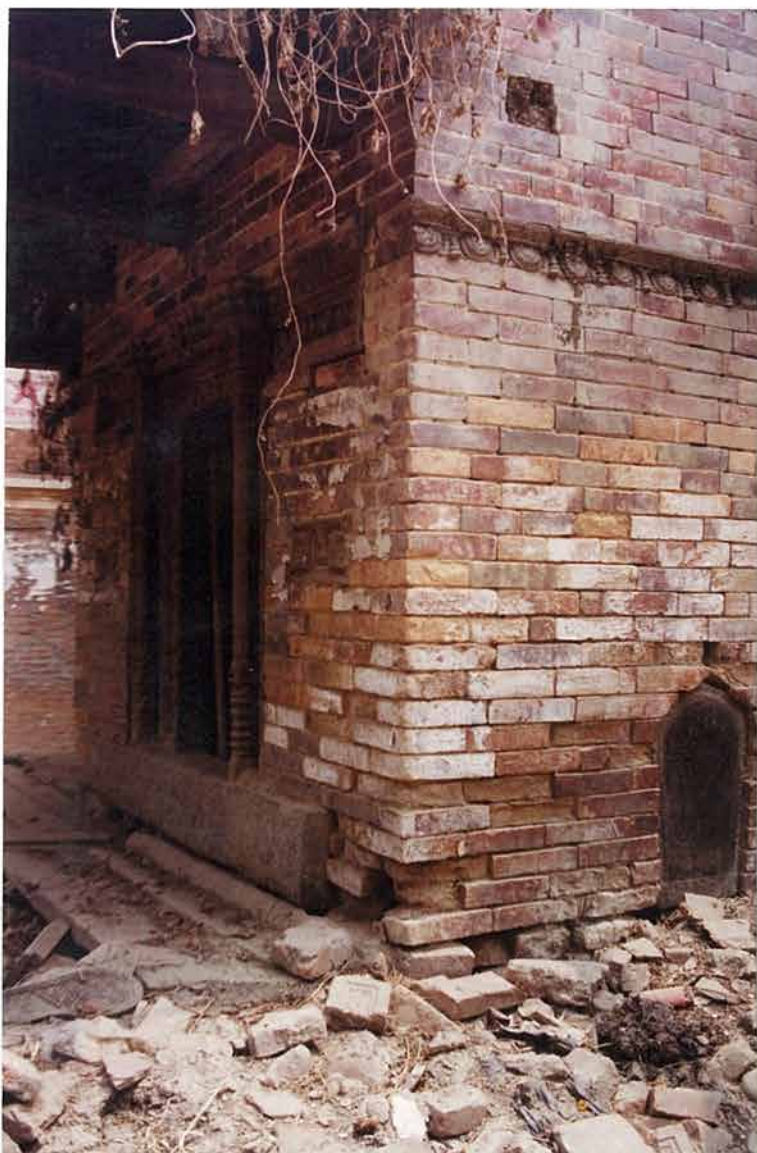
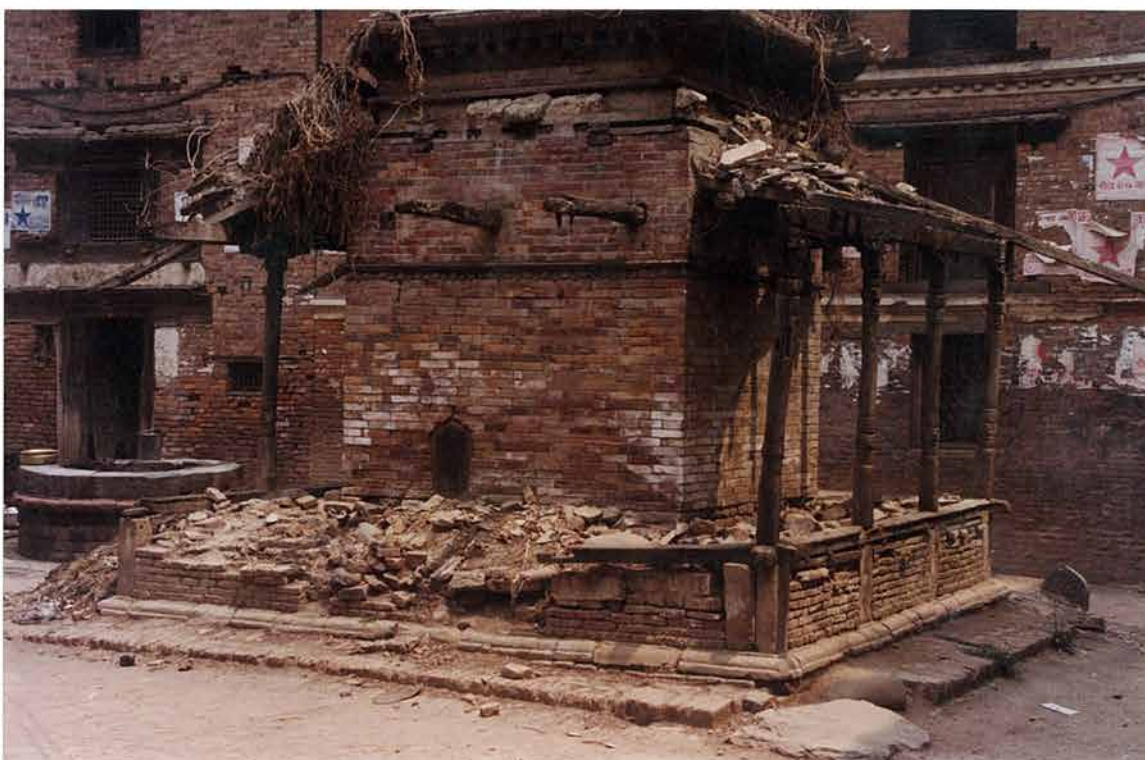
Left: west-south corner at the ground level. The lowermost bricks are damaged due to rising ground dampness particularly at the corner. The main doorway is intact.

Below: most of the plinth planking is lost. On the south elevation base stones for the two middle timber posts were also lost. Photo December 1997.

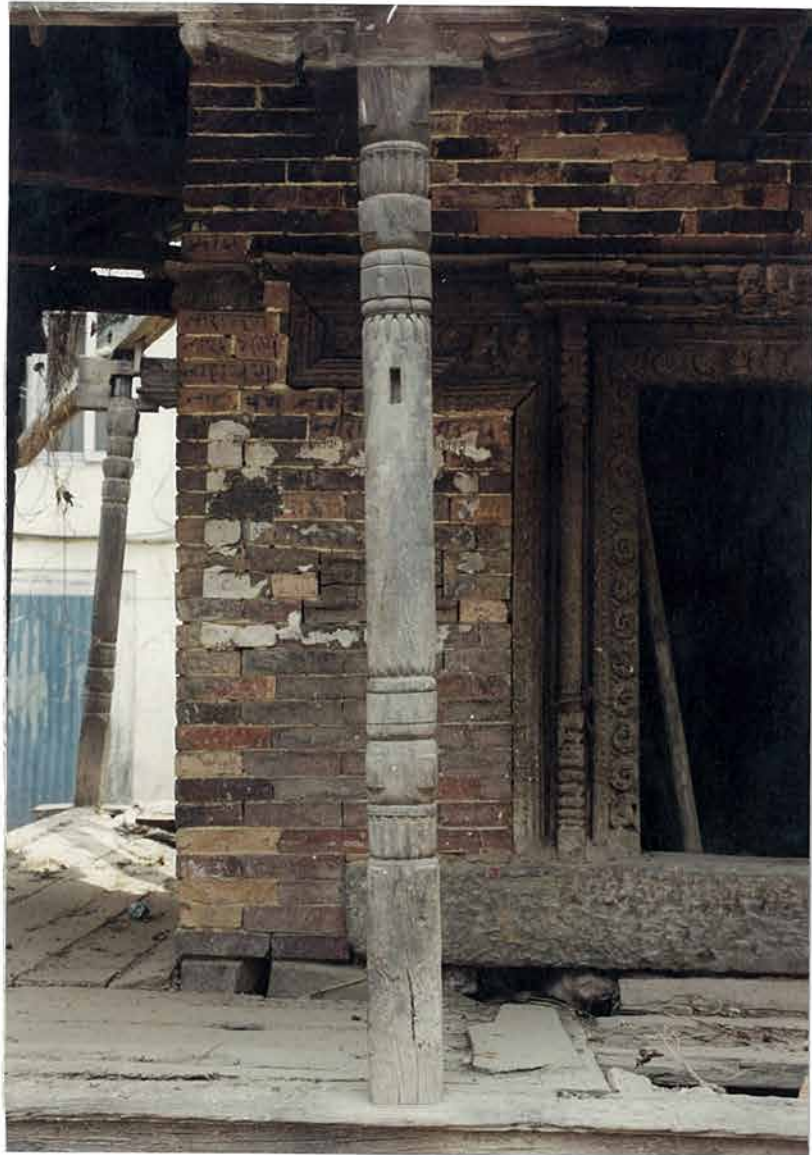
Some of the floor planking and many timber posts were still there until December 1997, when this photo was taken.

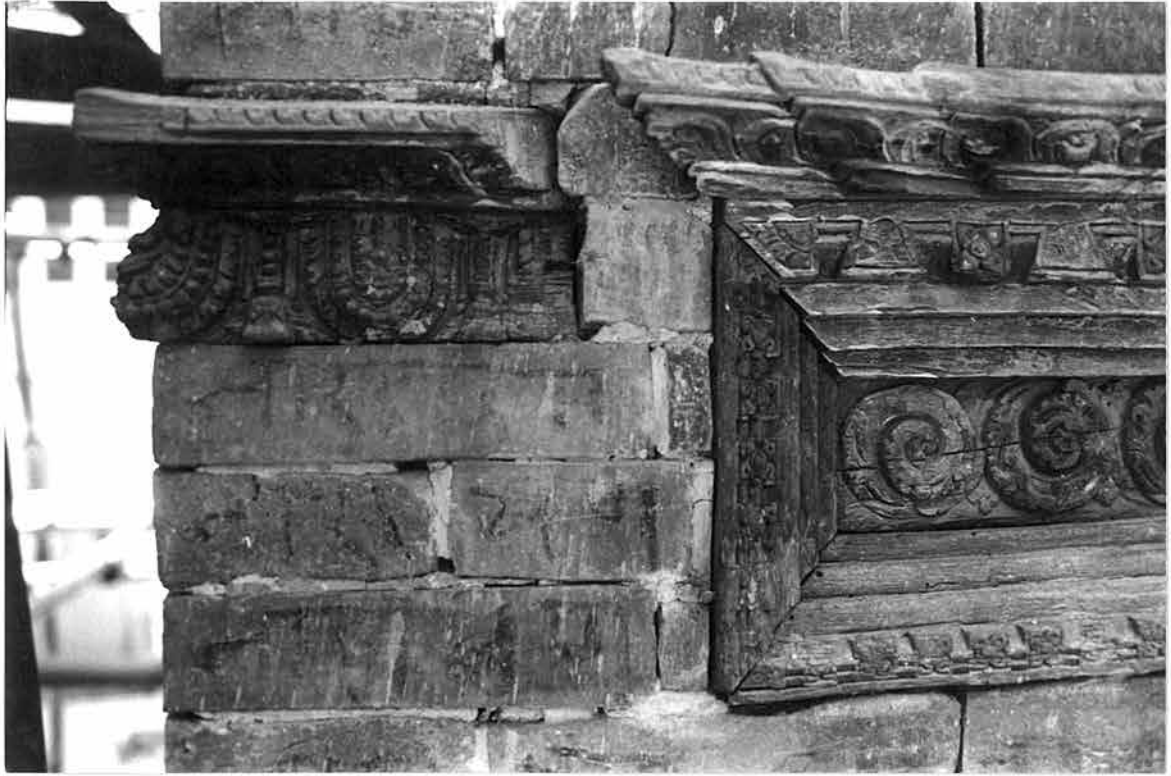
The decorative carved *sal* wood cornice that wraps around the structure is in good condition, however the cornice adjacent to the main doorway entrance of west facade is not symmetrical on both sides. The left side of the masonry wall is 2" longer than the right resulting in gap between the extended door lintel and the timber cornice. The gap was filled by a piece of brick probably installed by a previous renovation.

Existing lintel of the door frame on the ground floor level. The edge of the masonry wall is 2" longer on the left side leaving a space between the extended door lintel and timber cornice that is filled by a piece of brick.
