# TUM BAHA NARAYAN TEMPLE

## HISTORIC STRUCTURE REPORT

PATAN DARBAR WORLD HERITAGE SITE  
KATHMANDU VALLEY PRESERVATION TRUST

SUMMER, 2000

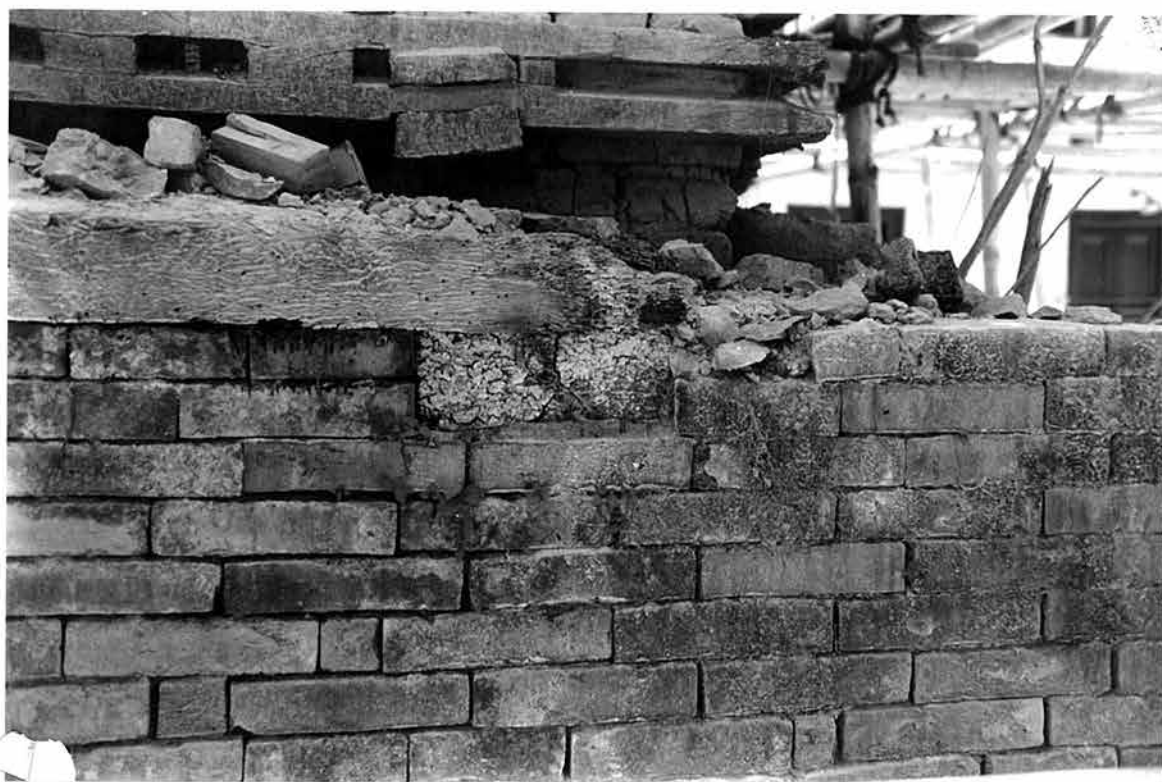
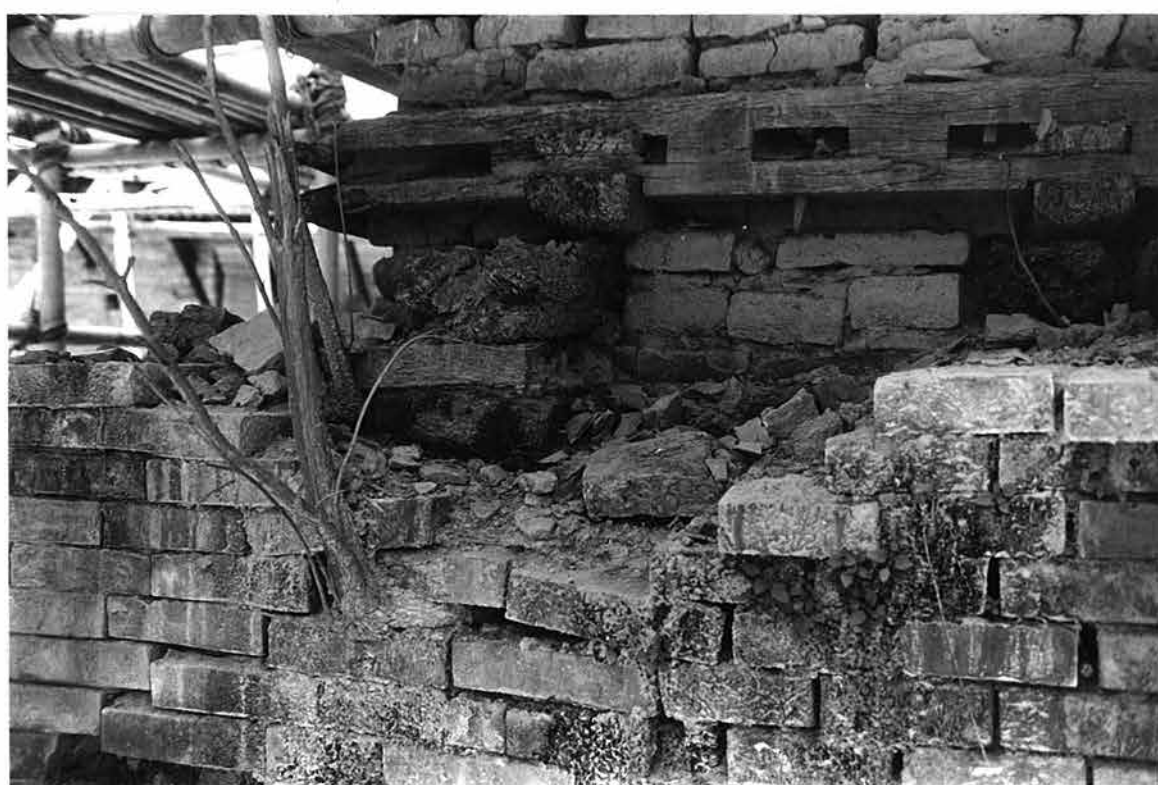
There is significant damage due to exposure to the elements from the missing middle roof. Vegetal growth is entrenched in the upper layers of brick. On the south facade a *pipal* tree has taken root resulting in water infiltration, moisture damage, and displacement to the upper 13 courses of brick. The remaining three facades have similar damage to the upper 10 courses of brick where the mud mortar is washed out leaving the face veneer bricks unstable. Vegetal growth has also taken root in the exposed areas.

Above: water damage at middle level showing outer wall plate and washed out mud mortar at upper layers of brick.

Below: south facade at missing middle roof level showing brick wall damaged by vegetal growth and washed out mud mortar.

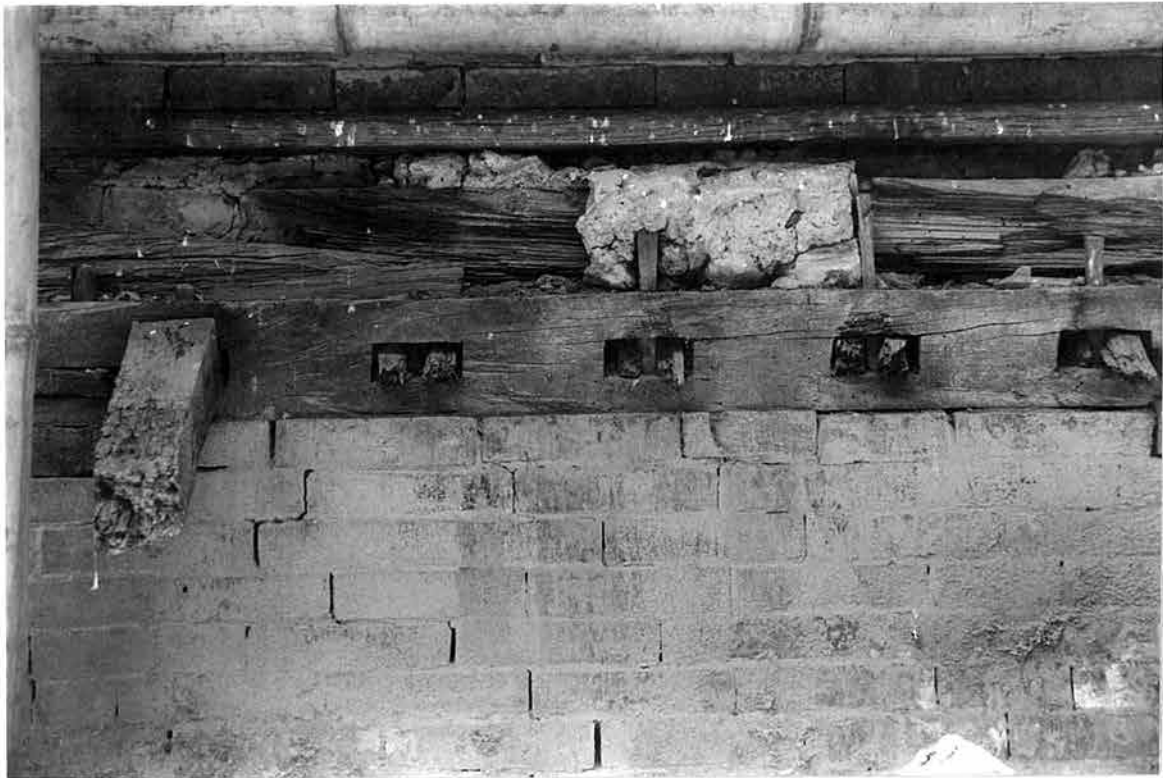
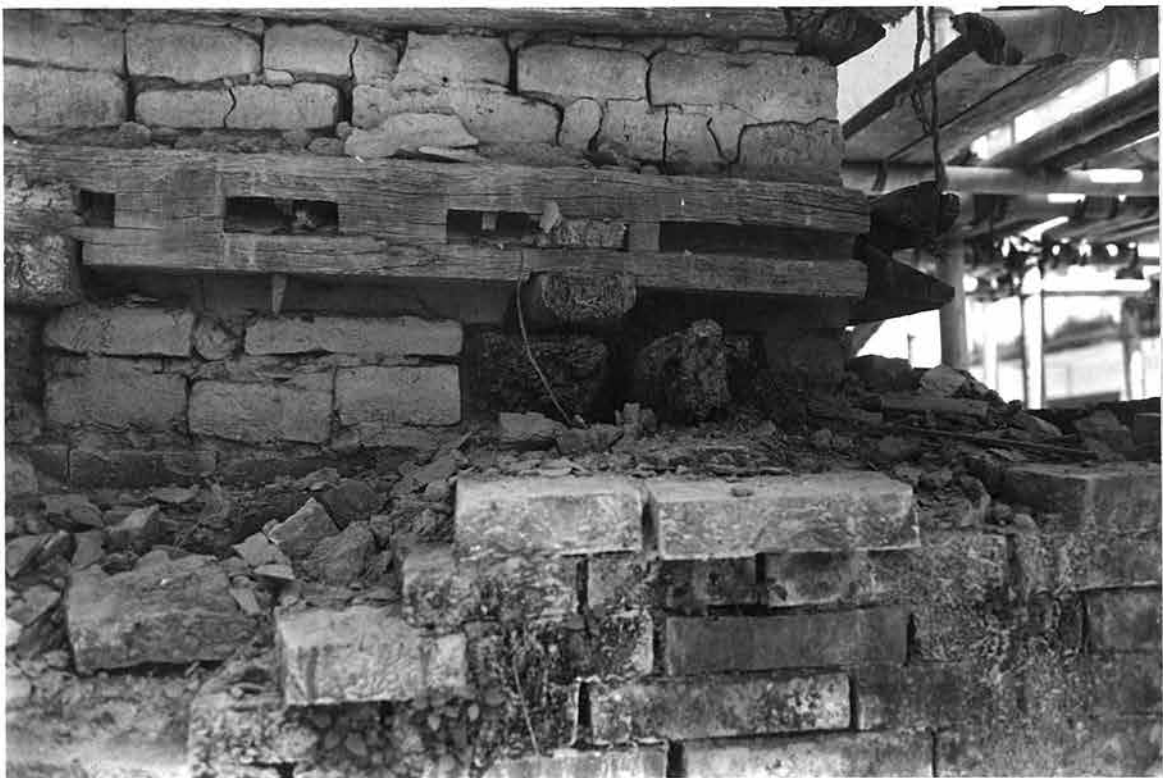
All the rafters are damaged due to several years of monsoon rain exposure but upper wall plate stil intact, except on the corners.

Above: upper wall plate on lower roof.

Below: upper wall plate on middle roof.

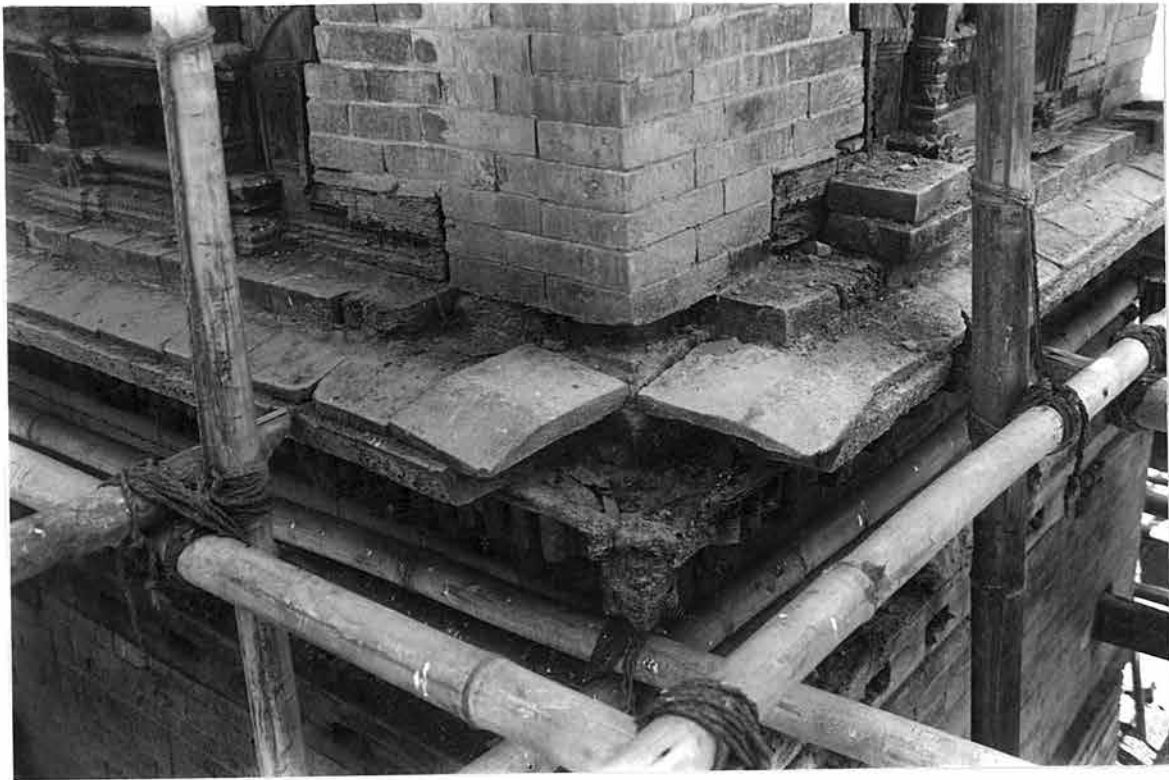
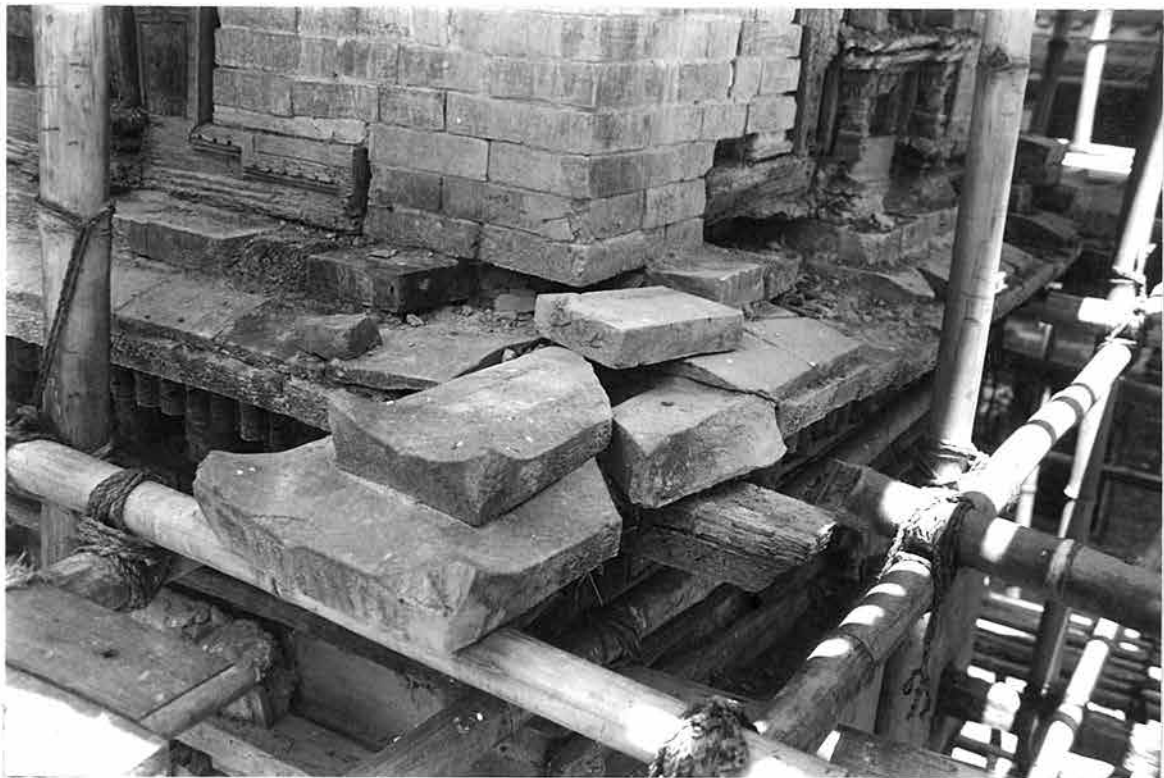
Top: completely missing *lah kah* and *lah phvah* at south-west corner.

Bottom: missing *lah kah* at north-west corner.

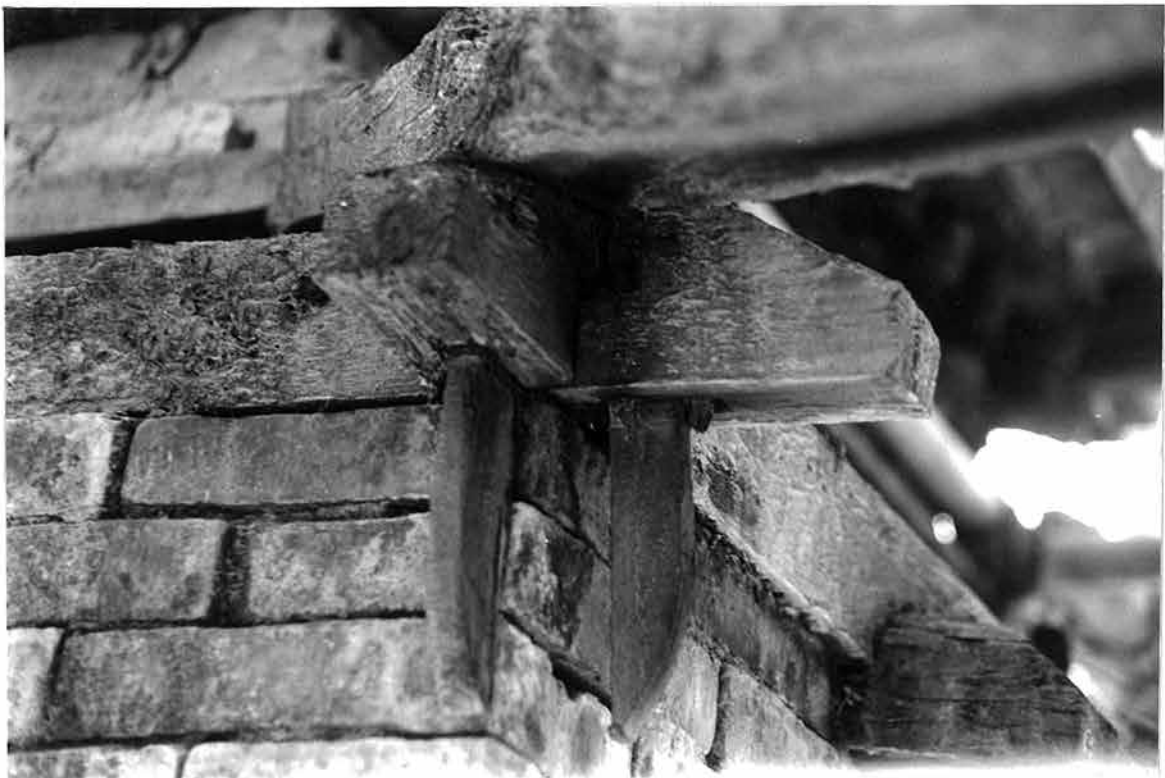
Corner lap joint of outer wall plate on middle level damaged by exposure to weather.

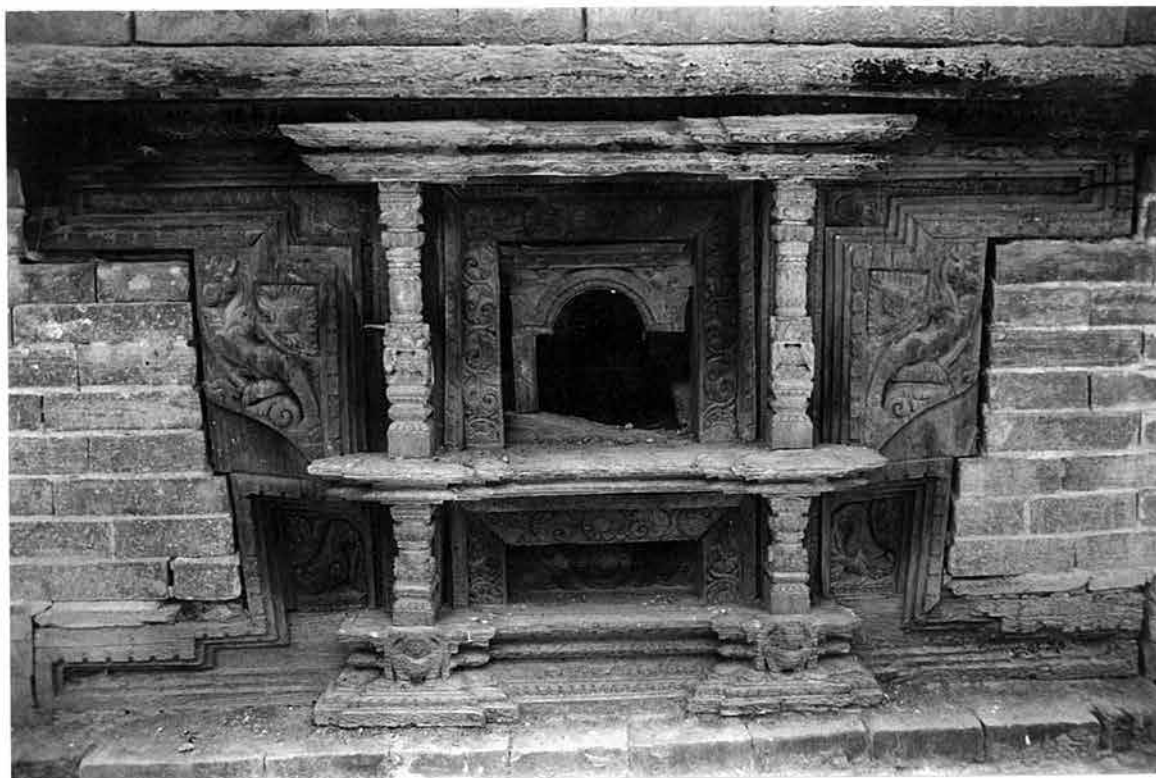
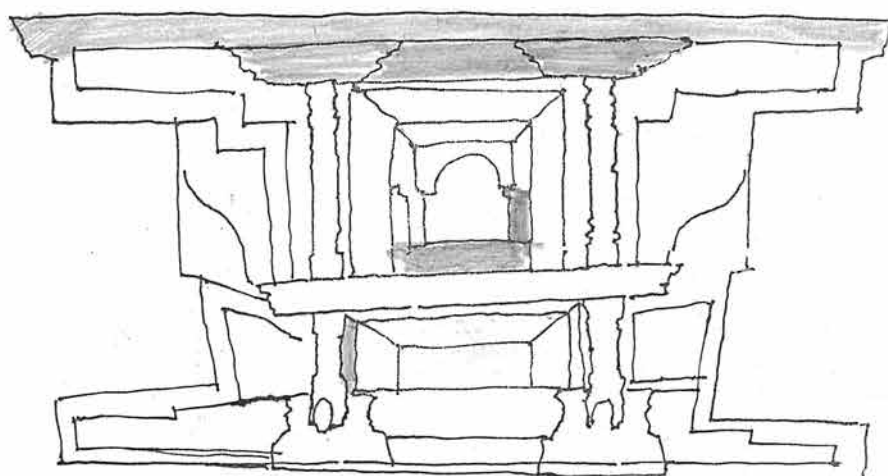
**Existing Condition of Decorative Carved Window (*Gh jhyah*)**  
**PHOTO OF *GH JHYAH* AT WEST FACADE**

**MISSING OR DAMAGED ELEMENTS OF WEST WINDOW**

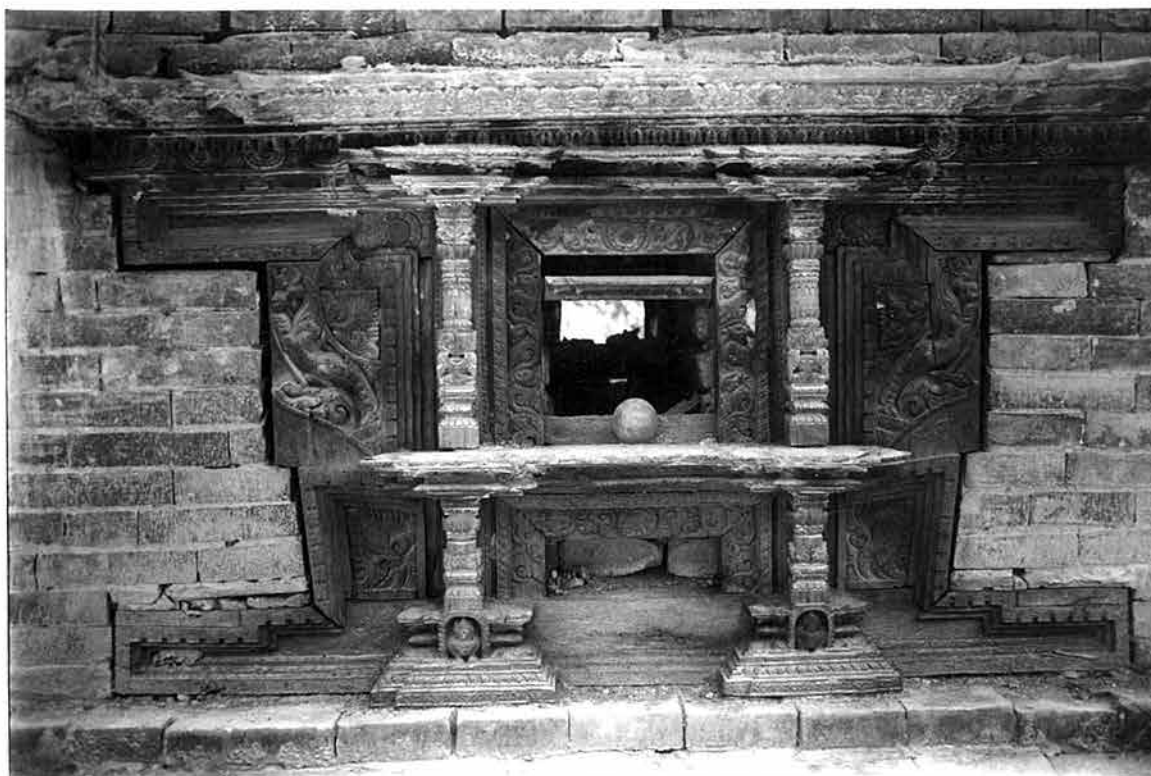
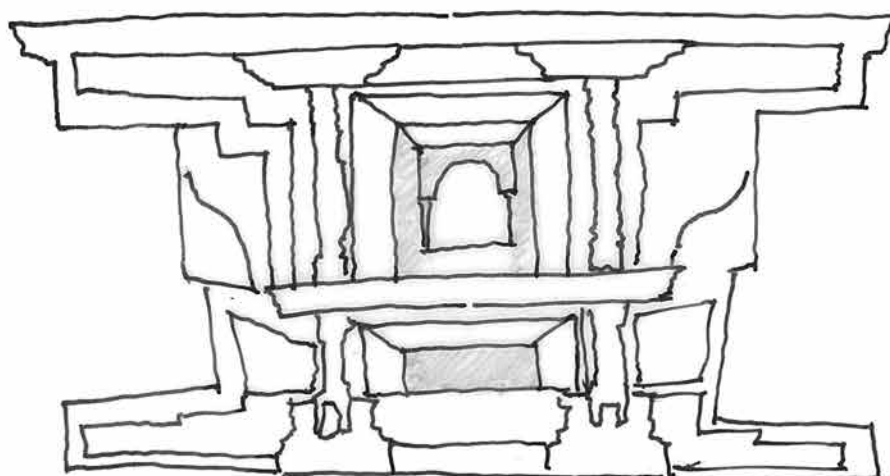
**Existing Condition of Decorative Carved Window (*Gh jhyah*)**  
**PHOTO OF *GH JHYAH* AT NORTH FACADE**

**MISSING OR DAMAGED ELEMENTS OF NORTH WINDOW**

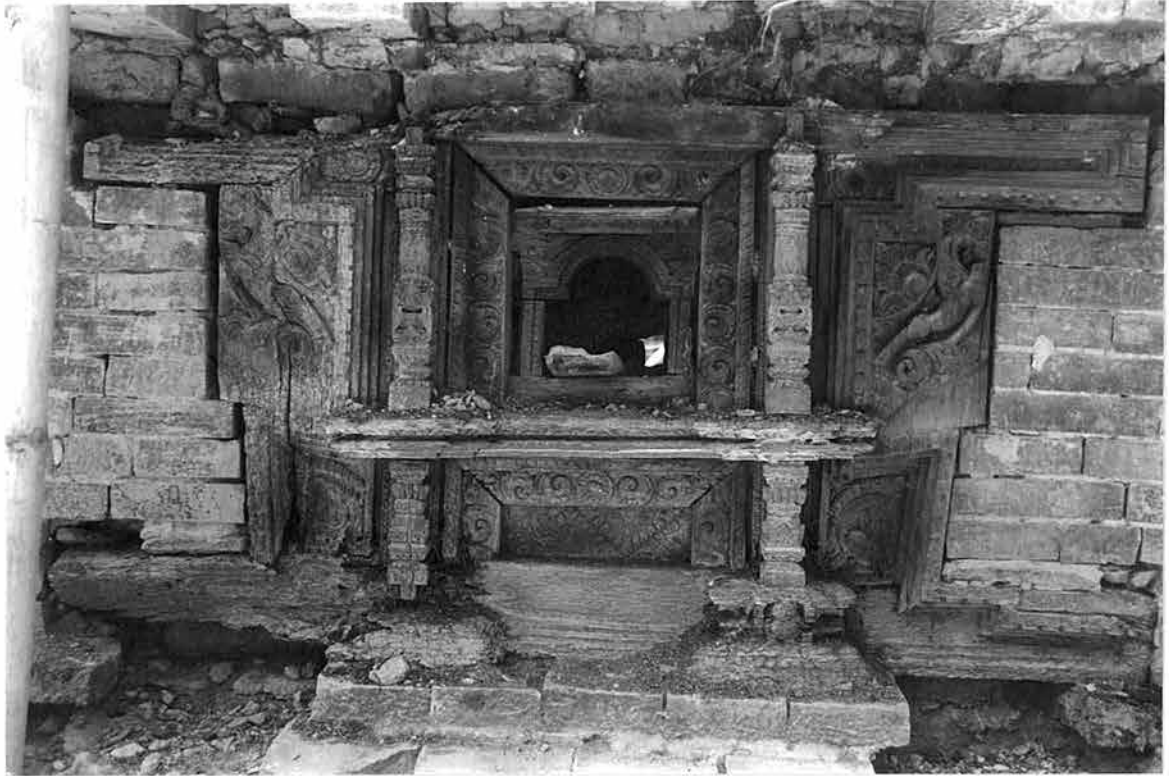
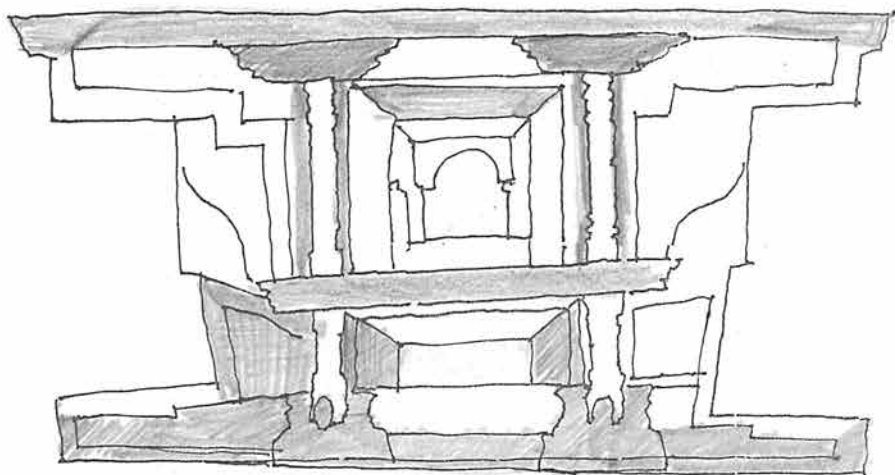
**Existing Condition of Decorative Carved Window (*Gh jhyah*)**  
 PHOTO OF *GH JHYAH* AT EAST FACADE

**MISSING OR DAMAGED ELEMENTS OF EAST WINDOW**

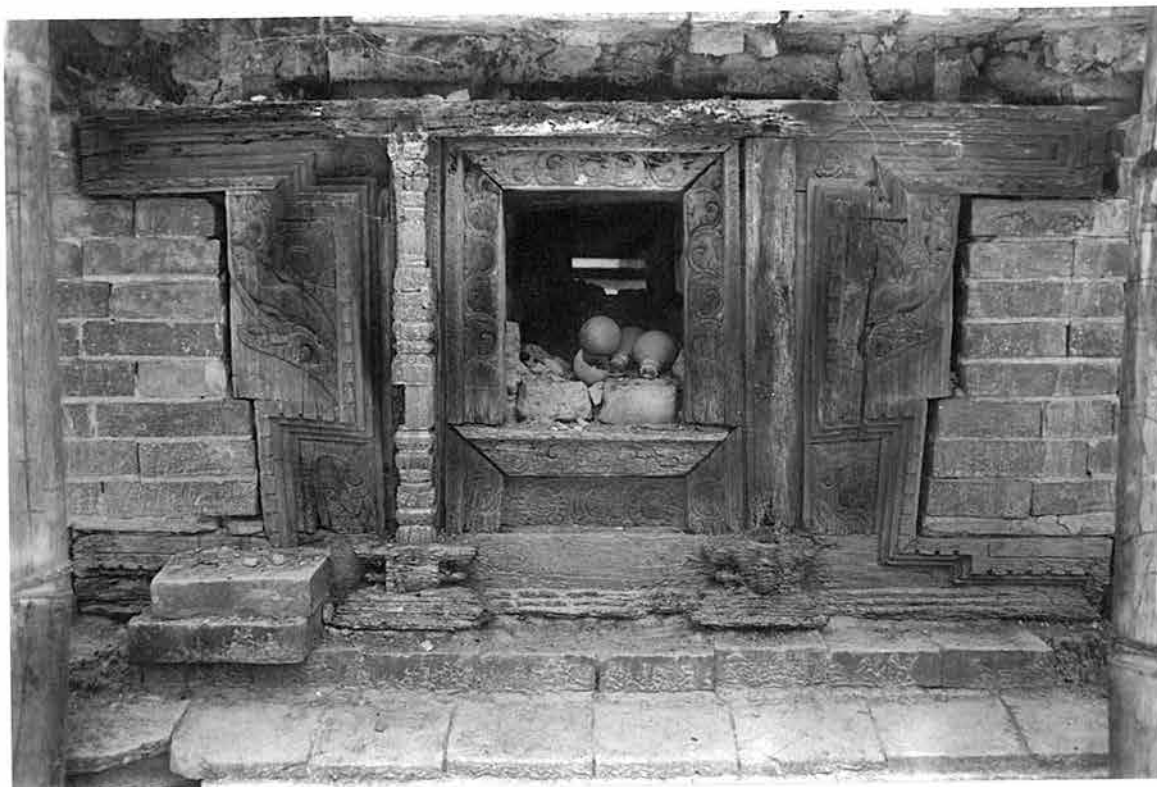
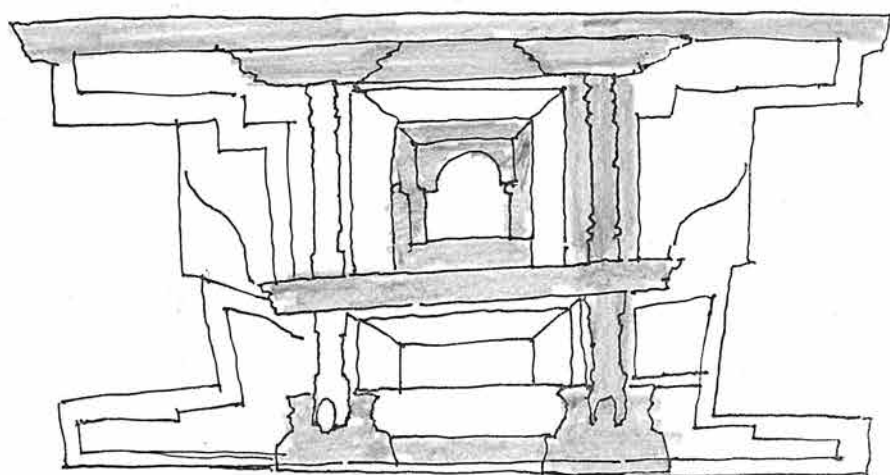
**Existing Condition of Decorative Carved Window (*Gh jhyah*)**  
**PHOTO OF *GH JHYAH* AT SOUTH FACADE**

**MISSING OR DAMAGED ELEMENTS OF SOUTH WINDOW**

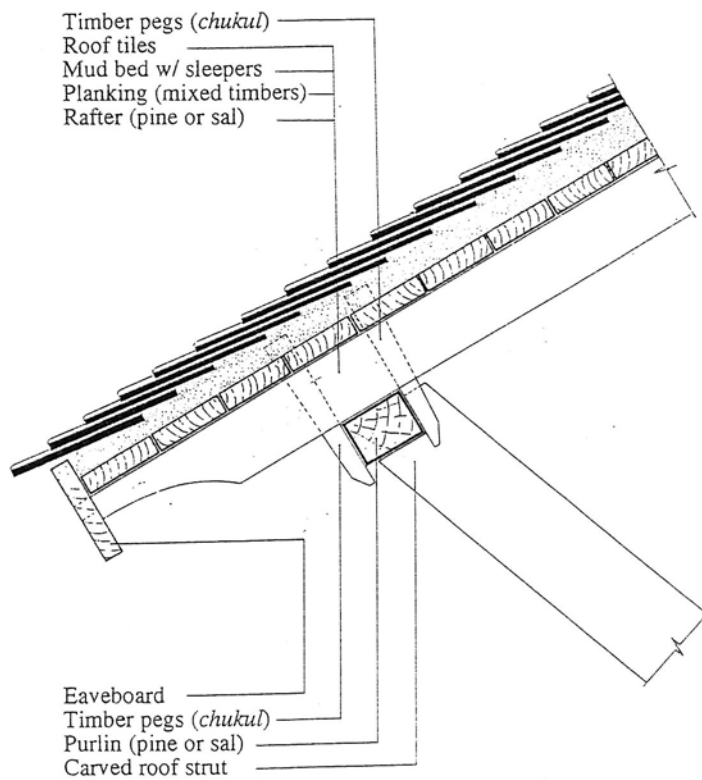
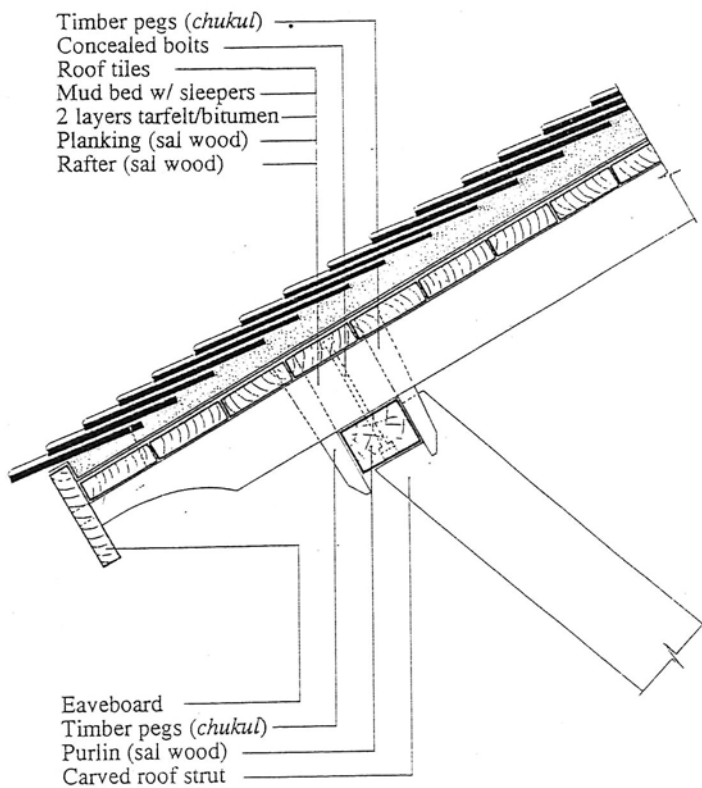
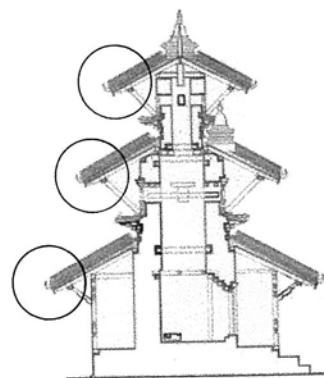
**The KEY Problem.**

Section at roof overhang: traditional and improved detail.
