ICOMOS INTERNATIONAL WOOD COMMITTEE (IIWC)  
8th INTERNATIONAL SYMPOSIUM

Symposium Proceedings edited by Knut Einar Larsen and Nils Marstein

# TIMBER CONSERVATION PROBLEMS OF THE NEPALESE PAGODA TEMPLE

*Erich Theophile and Rohit Ranjitkar*

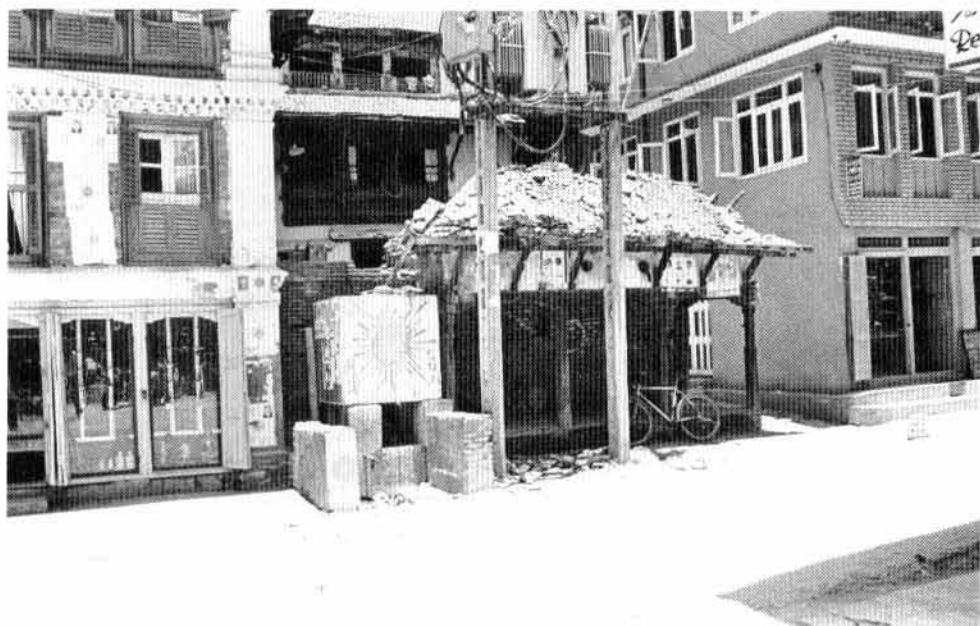
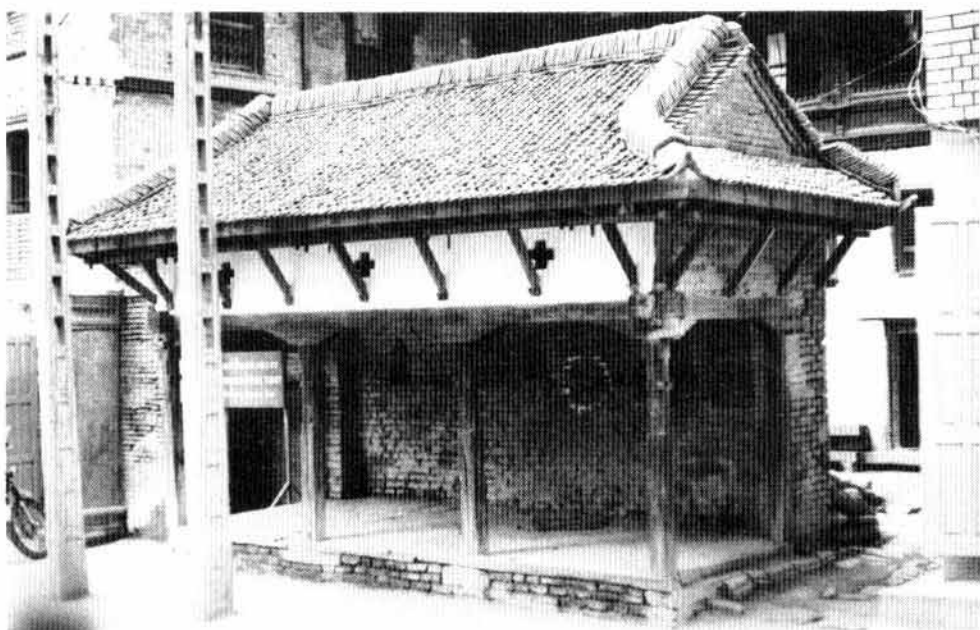
*Emergency roof repairs, Patan Darbar World Heritage Site*

Above: the small octagonal Mani Gufa Temple before and after emergency roof repairs, 1992. Repairs included patching of tar felt, relaying of mud bed and roof tiles, and insertion of concealed iron rods to hold the traditional stacking ridge tiles from slipping. Timely repairs prevented deterioration of the timber rafters beneath. Next page: 19th century *Pati* (resthouse) at Kwalkhu Tol. Repairs included rebuilding of the damaged roof *in situ* with the introduction of a tarfelt-bitumen waterproof membrane beneath the mud bed.

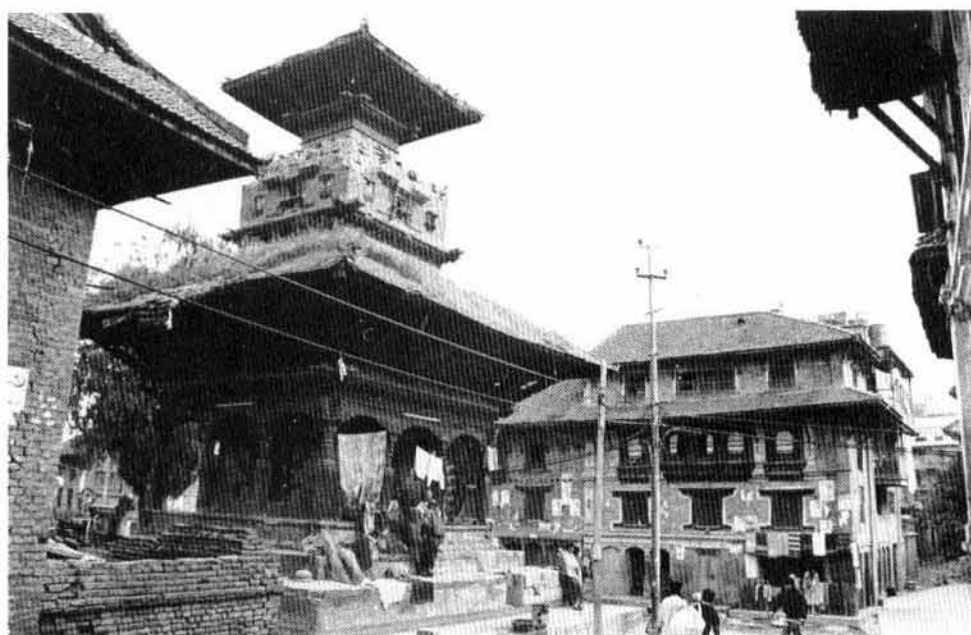
This page, left: the restored principal elevation. Below: view of the temple in January, 1992 showing intact 19th century houses which define the square, an auxiliary space to the main Dar-bar Square.

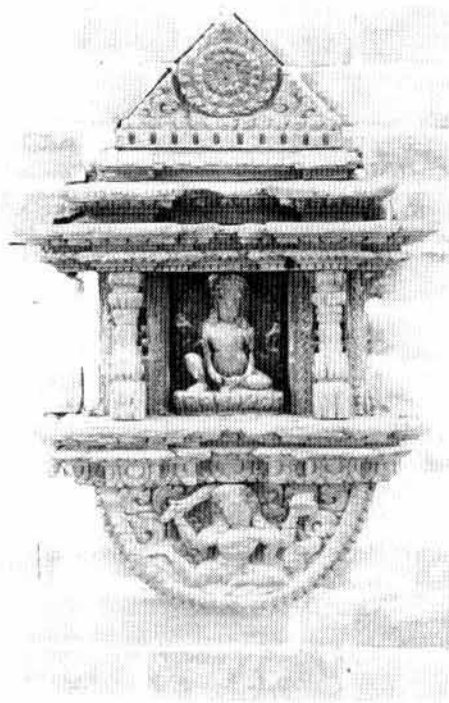
*Replacement of lost niche*

The pair to the original 1802 niche left of the door was stolen some 12 years ago. The repetitive imagery of the niche (as reported by the temple priest) allowed a new niche to be carved.

The facade with new niche in place (-right of door), August, 1992.

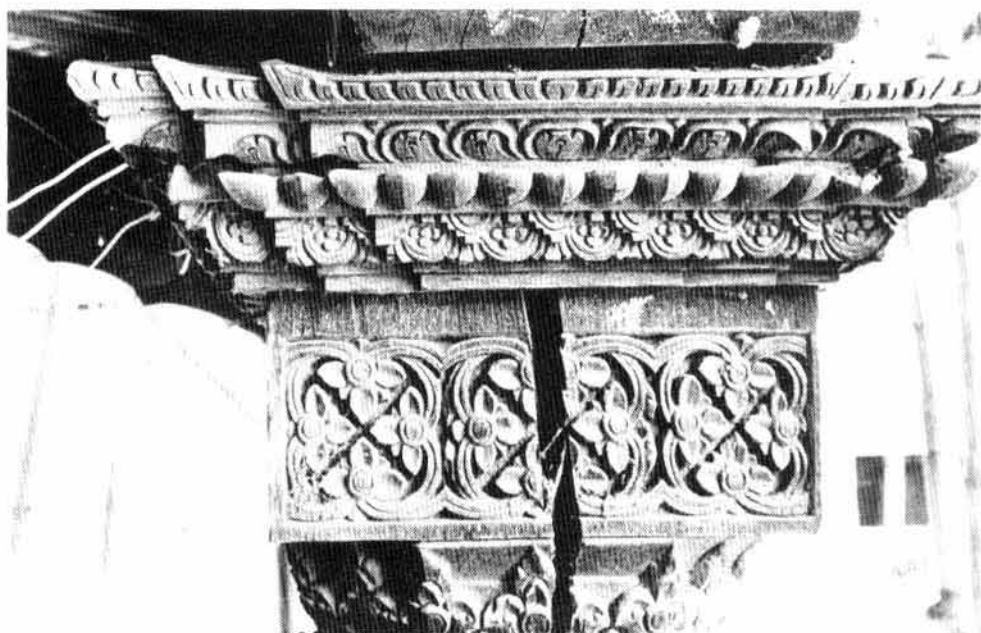
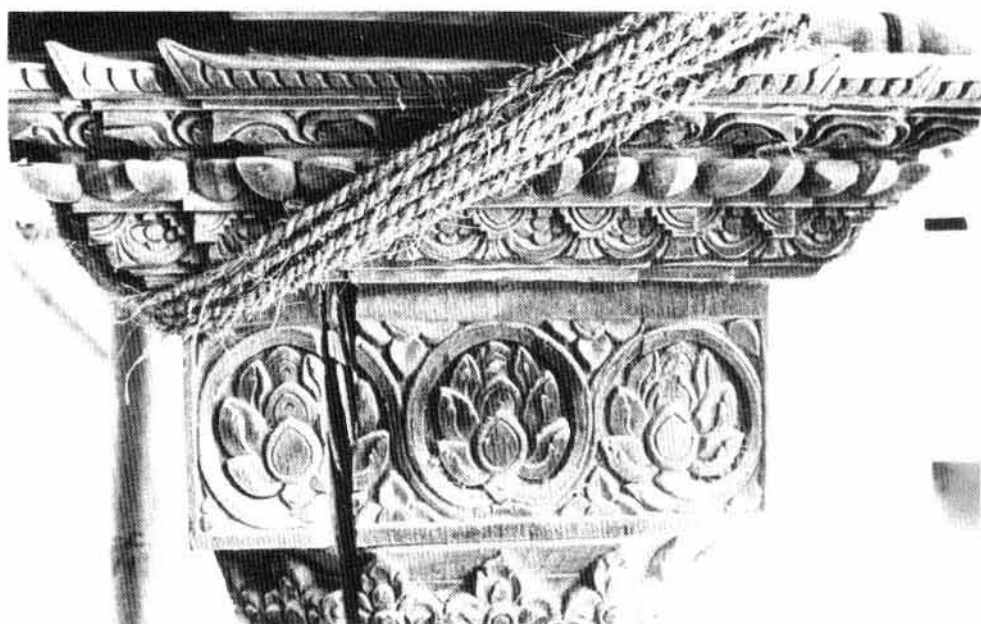
Varying carved floral motifs just below the capitals of arcade-level pillars, two pillars on north elevation. The vertical cracks are typical of historical timbers in Nepal which are never seasoned before carving and installation.

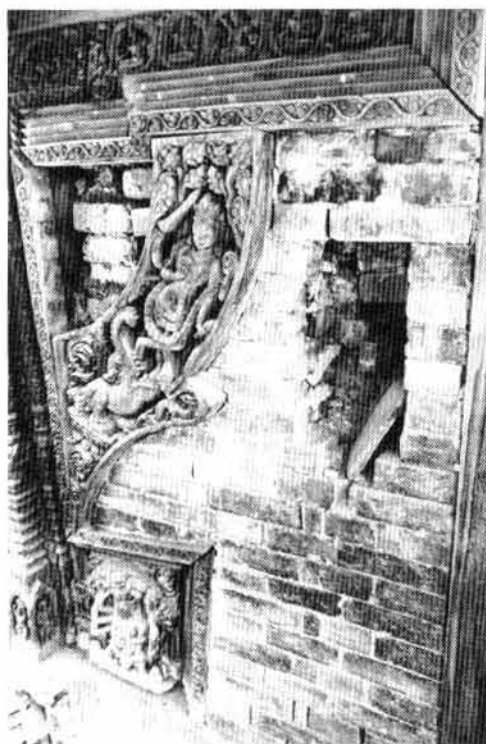
Above: identification of elements from N. Gutschow, *Newar Towns and Buildings*, 1987. Below left: the east elevation of Radha-Krsna showing lost *Astamatrika* panel and adjacent niche, January, 1992. Right: only on the right side of the south elevation were all iconographic features intact.

Although the authors maintain that either of these approaches could be successfully developed, certain existing conditions and design characteristics of the temple itself as well as local conservation trends helped the project team to decide *not* to fabricate any new figurative carvings in these locations. The fortunate presence of rich but repetitive frames around many of the carved deities, frames whose reproduction without a central image allowed a large part of the historical effect of the facade to be regained, solved the problem for *torana* and niche locations. At the lost carving locations around the doors, however, such repetitive frames were not present.
