**AYUGUTHI SATTAL**  
PATAN DARBAR SQUARE, WARD 11

**HISTORIC STRUCTURE REPORT**  
**JANUARY, 1996**

**KATHMANDU VALLEY PRESERVATION TRUST**  
**IN COOPERATION WITH**  
**HMG DEPARTMENT OF ARCHAEOLOGY**

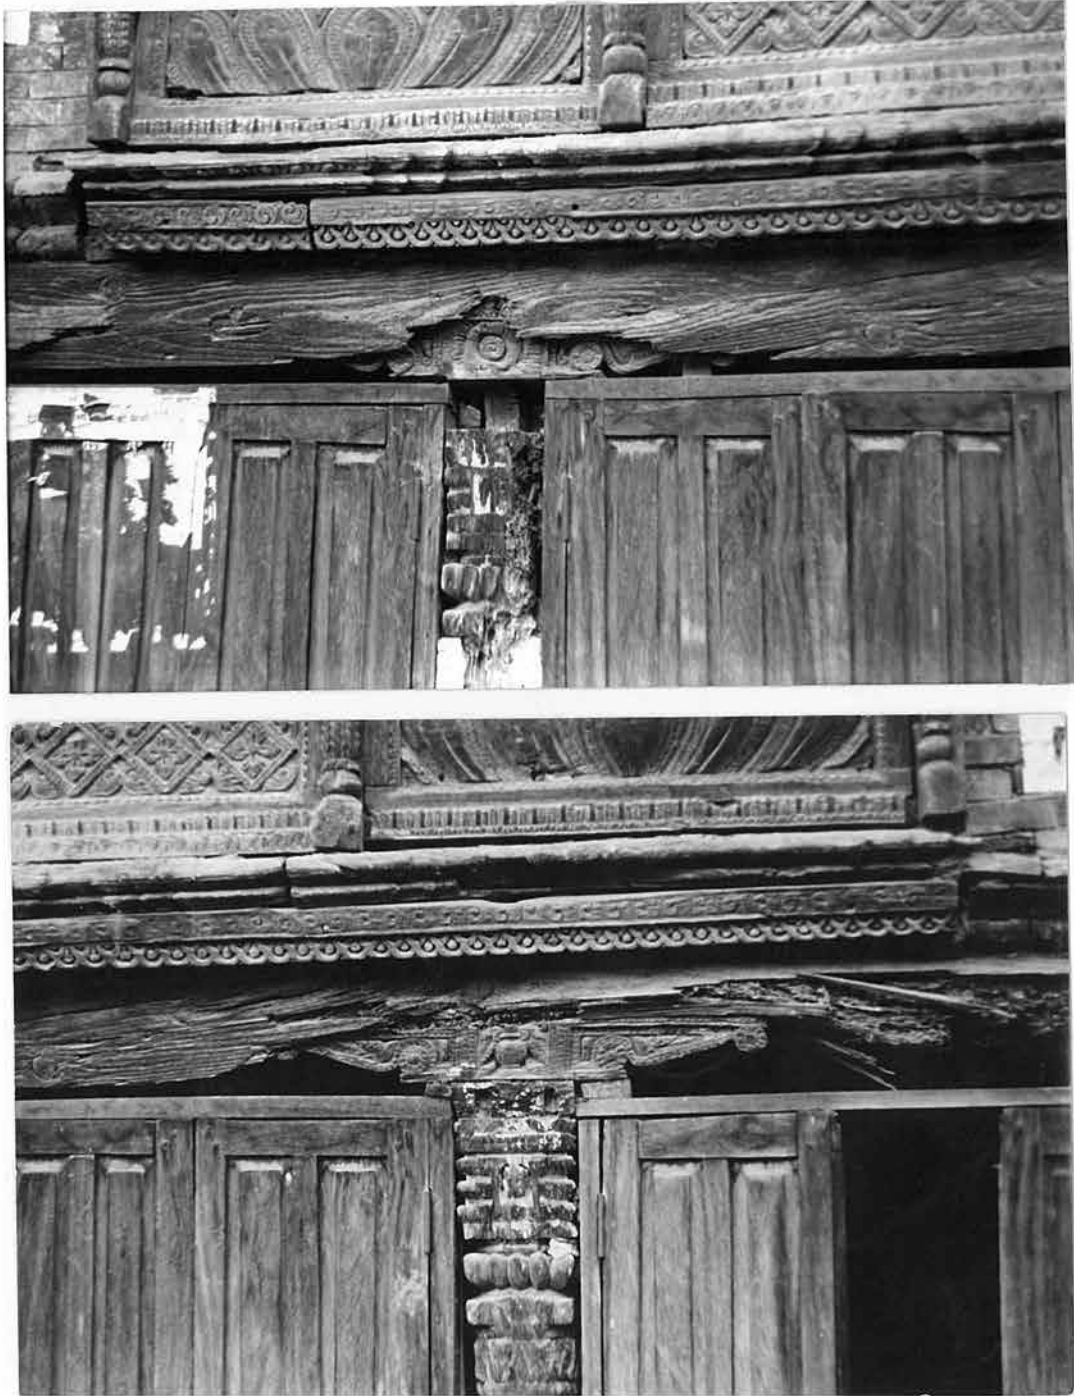
Column capitals ( left central above; right central below ). The details in the middle carved panel of each capital (Newari: *metli*) varies: above lotus flower, below water vessel or *kalash*. Opposite: end columns are more heavily damaged and decorative details are indeterminable.

All four historical oversized and carved timber posts in sal wood are completely structurally denatured by drywood termite infestation. This infestation was diagnosed by visiting expert Sir Bernard Feilden (based on the pest's visible mud tracks). The column capitals (Newari: *meth*) are damaged to varying degrees by the termite infestation as well, the outer of four capitals severely denatured, the central two capitals appear to have only superficial damage.

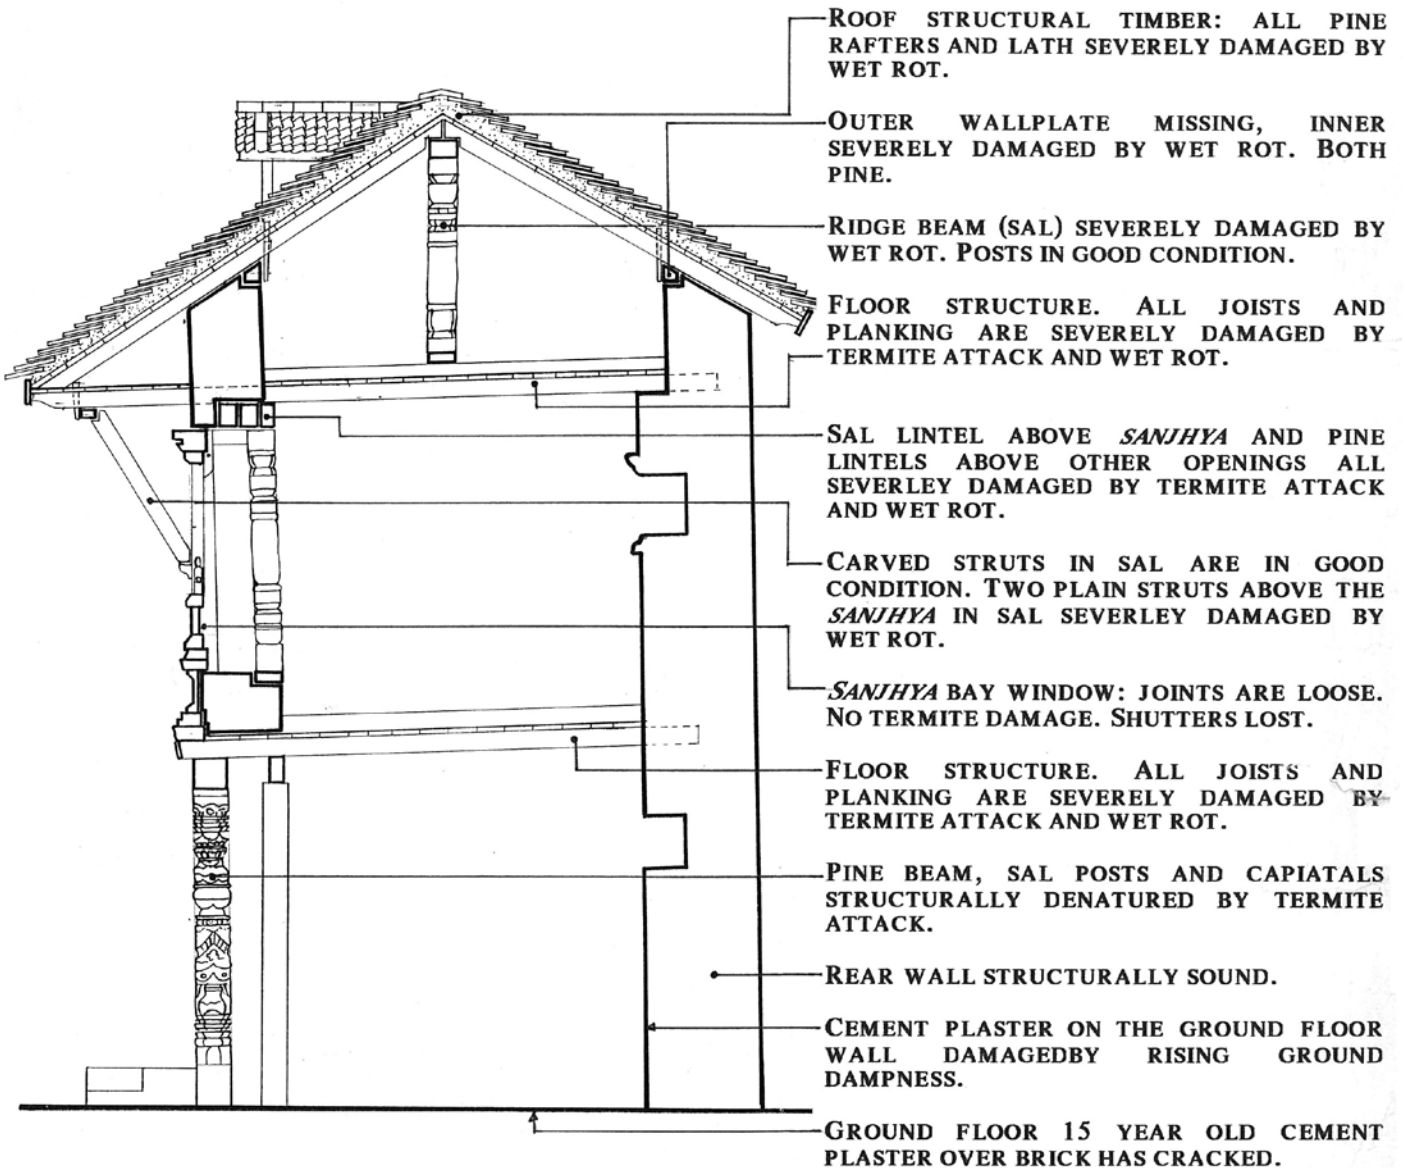
SOUTH-NORTH SECTION: EXISTING CONDITION

Rear and side facades retain common brick, *ma apa*, in fair condition laid in yellow mud from the 1974 renovations and shortening of the building.

Interior cement plaster on interior ground floor by current occupant 5-10 years old has cracked due to rising ground dampness.

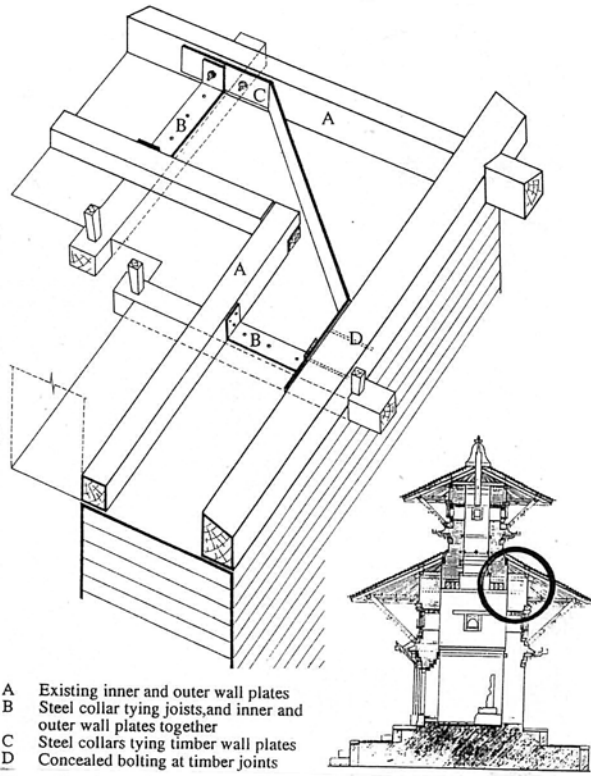
- A Existing inner and outer wall plates
- B Steel collar tying joists, and inner and outer wall plates together
- C Steel collars tying timber wall plates
- D Concealed bolting at timber joints

**Detail of timber ring beam and pagoda section.** 1992 reinforcement of Uma Maheswar Temple included development of the existing timber wall plates as a ring beam, as well as other reinforcements of the timber structure including concealed bolting of rafters to wall plates.

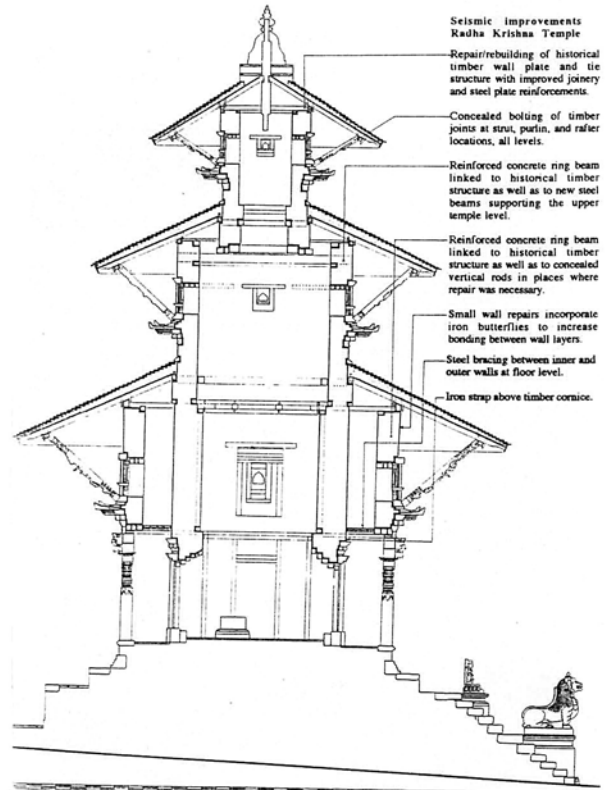
- Seismic improvements Radha Krishna Temple
- Repair/rebuilding of historical timber wall plate and tie structure with improved joinery and steel plate reinforcements.
- Concealed bolting of timber joints at strut, putin, and rafter locations, all levels.
- Reinforced concrete ring beam linked to historical timber structure as well as to new steel beams supporting the upper temple level.
- Reinforced concrete ring beam linked to historical timber structure as well as to concealed vertical rods in places where repair was necessary.
- Small wall repairs incorporate iron butterflies to increase bonding between wall layers.
- Steel bracing between inner and outer walls at floor level.
- Iron strap above timber cornice.

**Section through pagoda.** 1992-93 reinforcement of Radha Krishna Temple by KVPT included reinforced concrete ring beams at two levels and minor reinforcements of the timber structure.

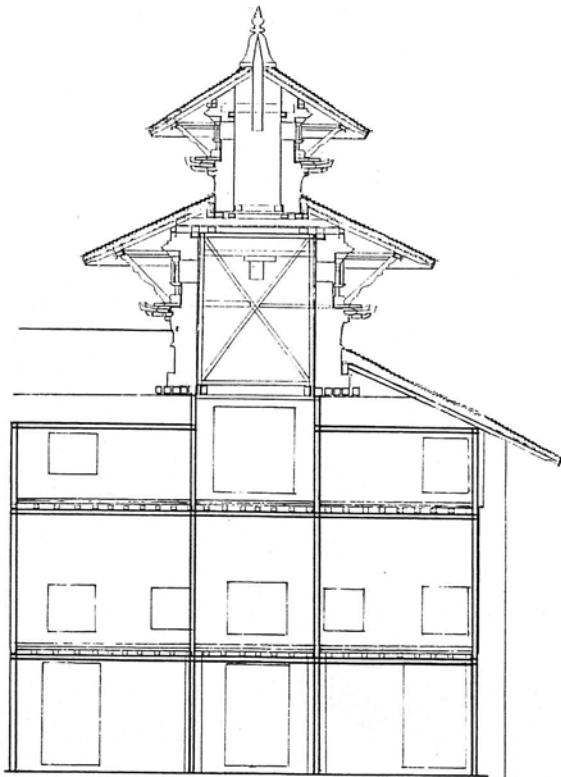
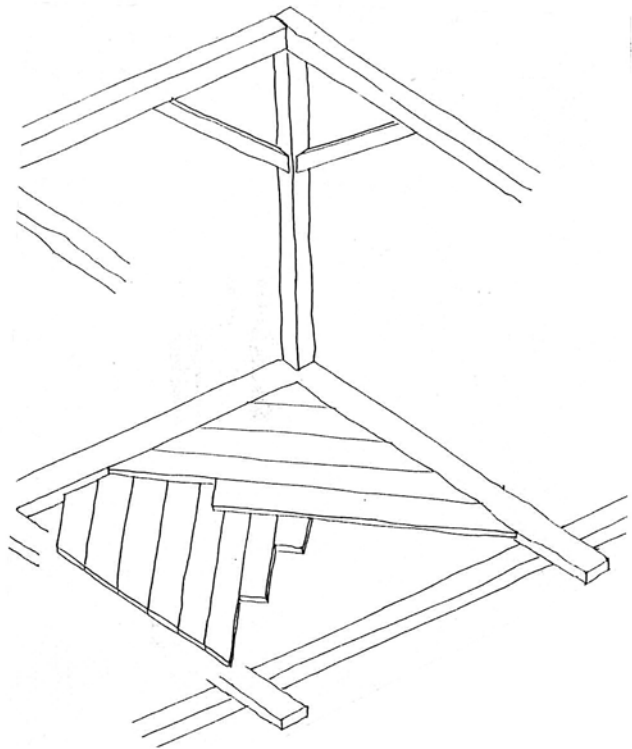
**Longitudinal section and axon detail of framework/planking.** 1994 reinforcement of the Patukva Agam include the insertion of a back-up interior timber frame which will carry loads if walls are damaged in an earthquake. Stiffening of the building is achieved by this timber back-up frame in combination with double layered angled planking floor system.
