# NARAYANA TEMPLE

KULIMA, PATAN

HISTORIC STRUCTURE REPORT

KATHMANDU VALLEY PRESERVATION TRUST  
MARCH, 1998

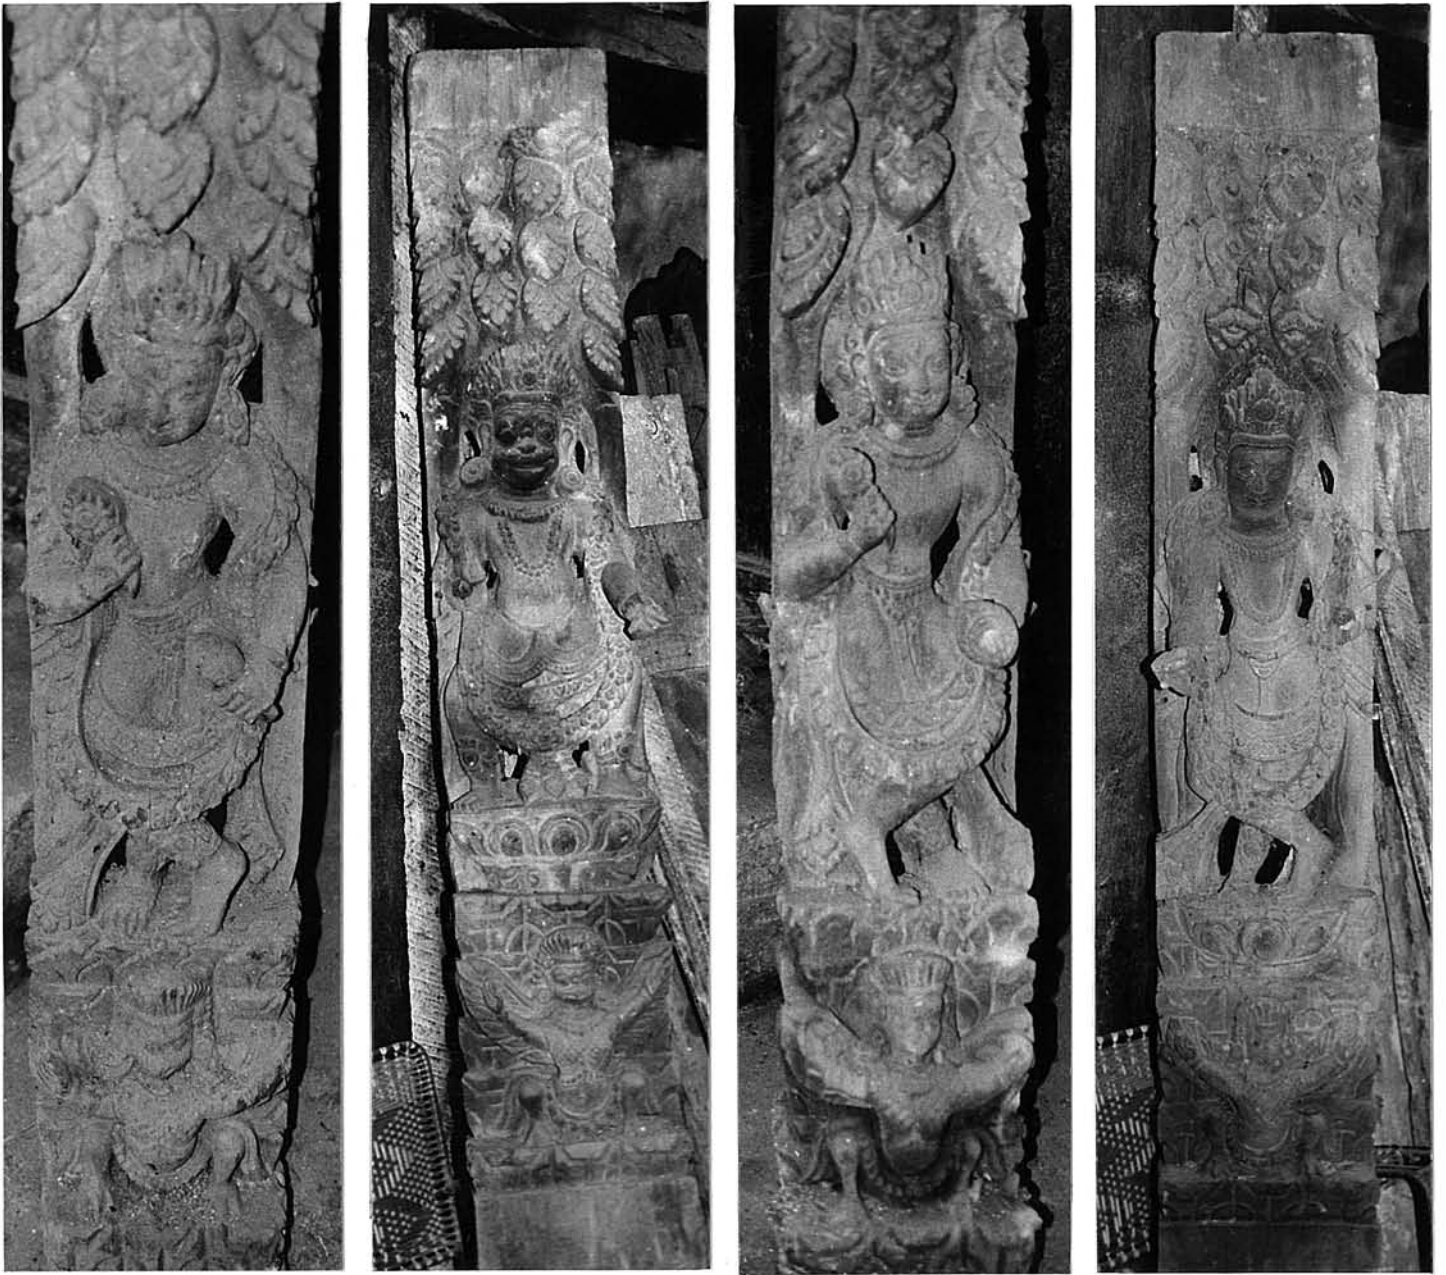
**Four of the remaining roof struts.**

Documentation of four of the total 13 struts in possession by the local *guthi*. Five struts (Newari: *bilampau*) from the upper roof and four from the lower roof survive in sound condition. Another four are structurally damaged by wet rot. These pictured above are from middle locations, i.e. not at the corners where formulaic animal forms are found (Newari: *kusala* or corner horses). These above belong to a well known iconographic convention, the Dasavatar or 10 emanations of Lord Visnu, a common theme for struts on Vishnu temples. Here he is seen with his characteristic Garuda mount in the lower register and with foliage above, the mount and foliage are typical conventions of roof struts in Nepal 12th-20th centuries.

The four missing corner struts (*kunsuru*) will be replaced as exact copies of those that survive. This process counts on the abilities of carvers like Radhe Shyam Silpakar, master carver. Lost corner horse struts can be easily recarved based on the surviving examples as these members are largely formulaic. One of the upper corner struts is in a critical condition and will require further study to determine the necessity for reinforcement.

The other missing struts (Newari:*bilampau* ) will be replaced by plain members as no precise historical evidence survives. These plain members will, however, be sized to allow future votive offering of carving.

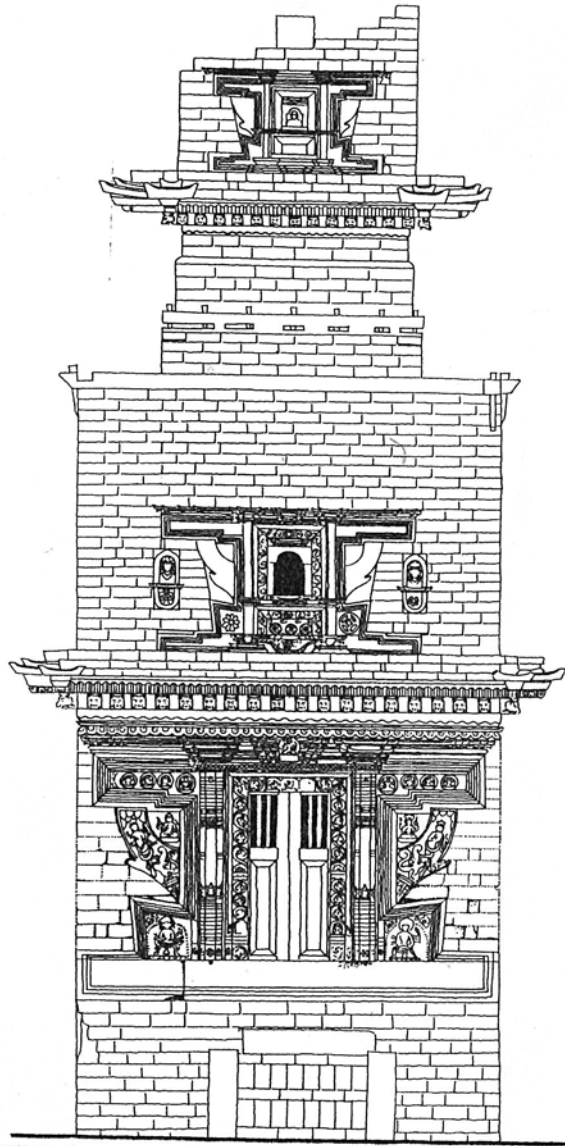
**PRINCIPAL EAST ELEVATION : EXISTING CONDITION**  
KATHMANDU VALLEY PRESERVATION TRUST - NOVEMBER 1998

During renovation in 1958 this level was reconstructed using mixed *dachi apa* (veneer brick) and *ma apa* (common brick). The top level has suffered considerable damage. The top three courses of brick masonry have collapsed as a result of water penetration. The southern face was repaired using *ma apa* in the 1958 restoration. The water has penetrated the mud mortar between the structural and veneer wall layers ( inner and outer leaf layers, respectively) and has caused the wall to pull apart brick by brick. Water penetration has also caused the northern and eastern wall to bulge by 3" and the southern and western walls by 2".

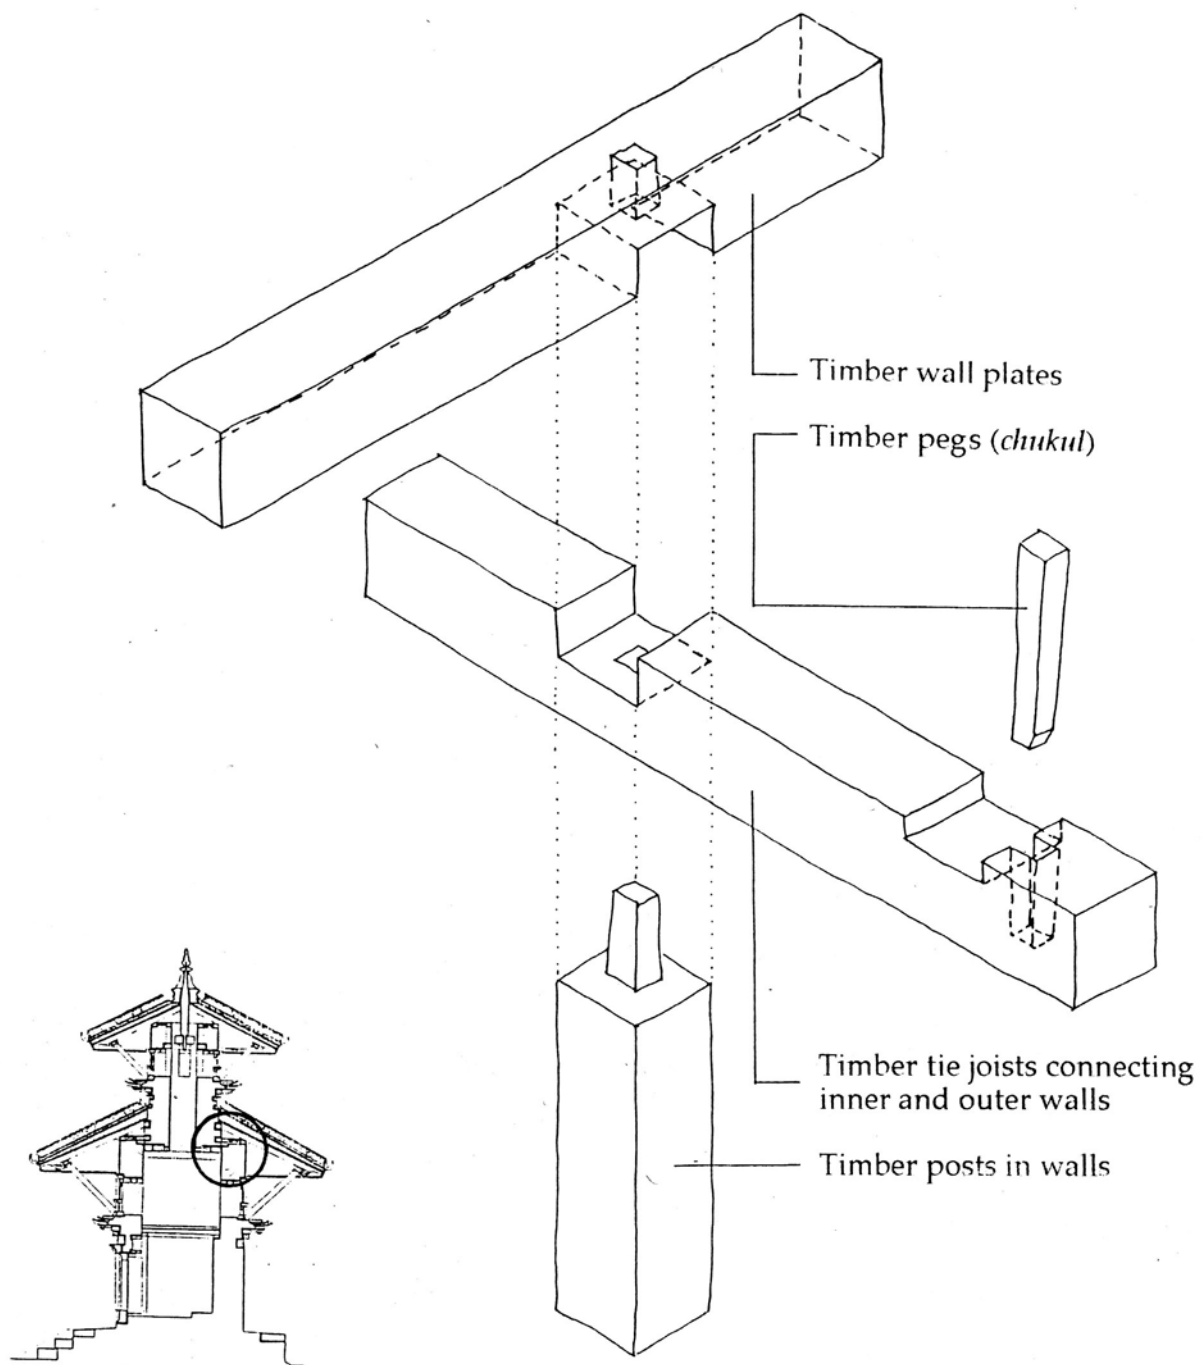
**TYPICAL TRADITIONAL JOINERY**  
**( CONNECTION BETWEEN TIMBER POST AND INNER WALL PLATE )**  
KATHMANDU VALLEY PRESERVATION TRUST - NOVEMBER 1998

*Connection between inner wall post and wall plate.* This is a difficult joint to achieve if rebuilding is not necessary. In this case the wall is in a fair condition and does not need rebuilding. The existing tenon at the top of the post has decayed and is rotten due to water penetration but the rest of the post is in good condition. It is therefore proposed to drill a hole in the post to insert new timber to make a joint between the vertical and horizontal members.
