PATUKVA AGACHE PATUKVA TOL, PATAN

HISTORIC STRUCTURE REPORT JUNE, 1994

ERICH G. THEOPHILE
ROHIT K. RANJITKAR
KATHMANDU VALLEY PRESERVATION TRUST
IN COLLABORATION WITH
HIS MAJESTY'S GOVERNMENT
DEPARTMENT OF ARCHAEOLOGY

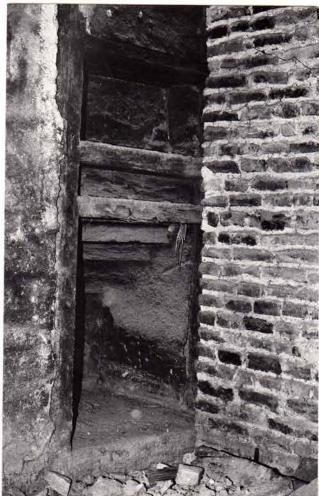
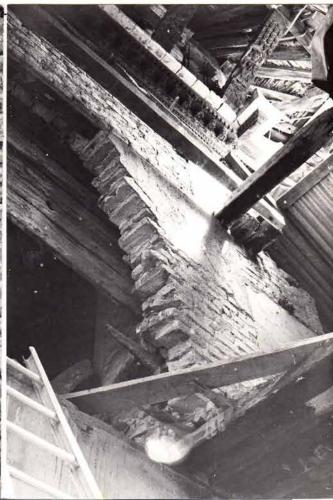
Above left: Partition on first floor (14" thick) wall was added in 1954 and partially blocks the window.

Above right: The masonry wall added in 1954 which led to collapse of joists below and roof above Seen from below, summer 1993.

only a layer of timber planks closing the niche-like opening at the rear facade. The addition of this improperly supported masonry wall has led in fact to the structural collapse of the rear portion of the building (discussed in detail under 5.0). At the same time, the Guthi repaired portions of the western and northern roofs, replacing the mud bed and traditional *jhingati* tiles with larger tiles. These tiles rest on timber battens instead of the *jhingati*'s mud bed.

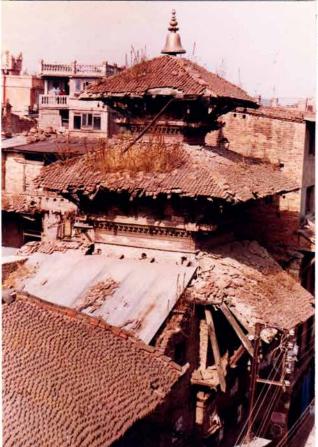
Below: Zinc sheet on lower roof south, installed 1977.

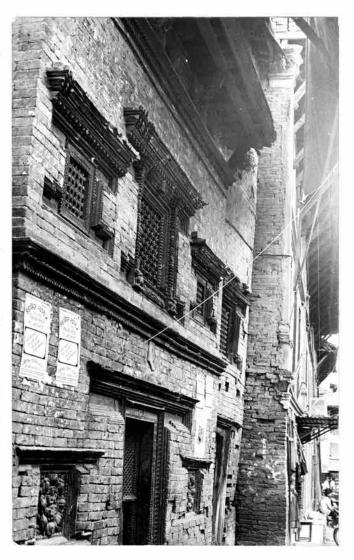
One brick projection of central bay of the principal facade.

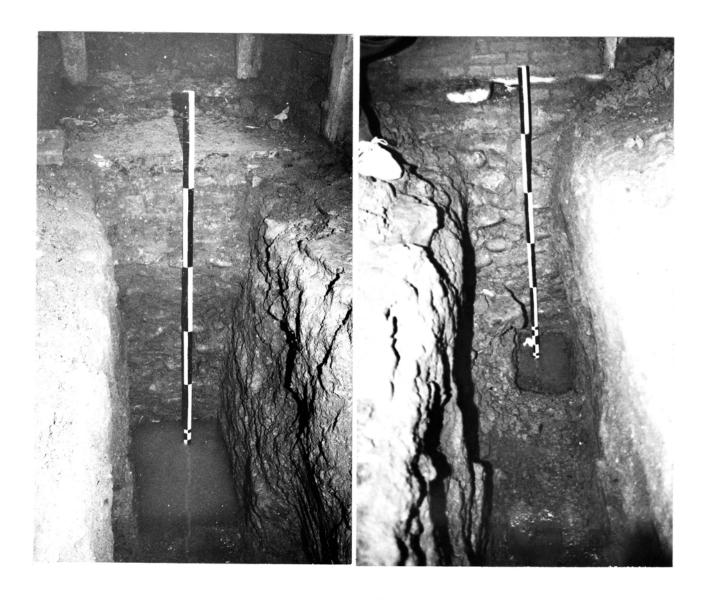
The foundation of the building appears to be in excellent condition, consisting of river stones laid in mud mortar total height 5'-1" to ground level. Excavation summer 1993.It is unclear why significant settlement of up to 6"has taken place in the tower area of the N-S wall facing back courtyard (called middle wall in text).

Settlement of the middle masonry wall has occurred only under the tower section of the building. Settlement varies from 7" maximum in the middle to 5" under the tower's north and south walls. No settlement is found at the end of this wall (outside central tower area). Settlement has been determined by comprative study of the wall plate levels.

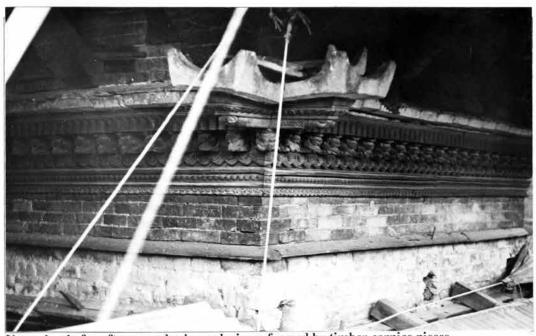
Upper level of rooftop pagoda shows daci apa framed by timber cornice pieces. Below commonm fired brick with visible mud mortar joints. All in excellent condition.

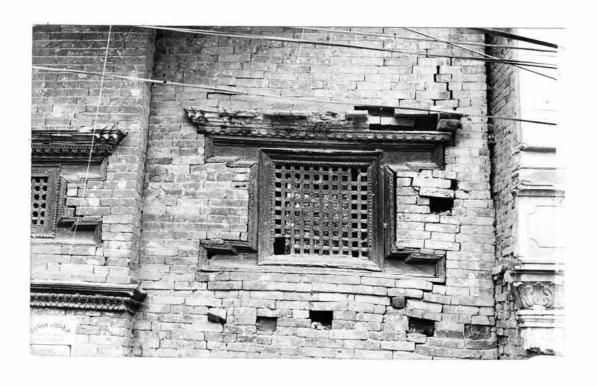
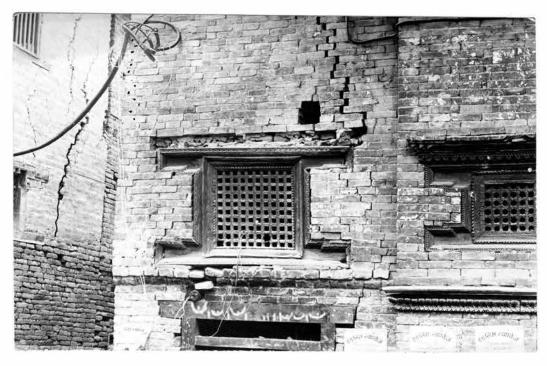
On the first floor, openings are in good condition except for missing brick cornice discussed under 5.02. Lattice work in the central and northern windows is damaged, approximately 6"x4" and 4"x4", respectively.

This page: First floorwindows north and south ends. Opposite page: central window first floor. above with north and south flanking units below, respectively.

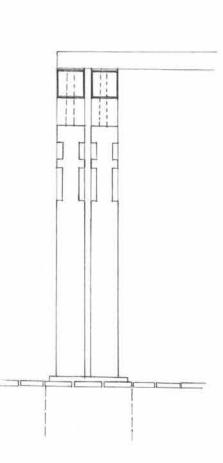
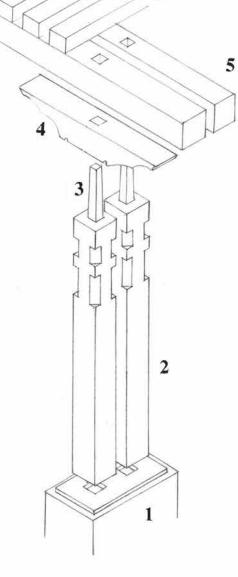
At the back elevation upper two floors (first and second floor) collapsed some five years back after several years of water penetration. Now only seven of the ground floor timber posts remain.

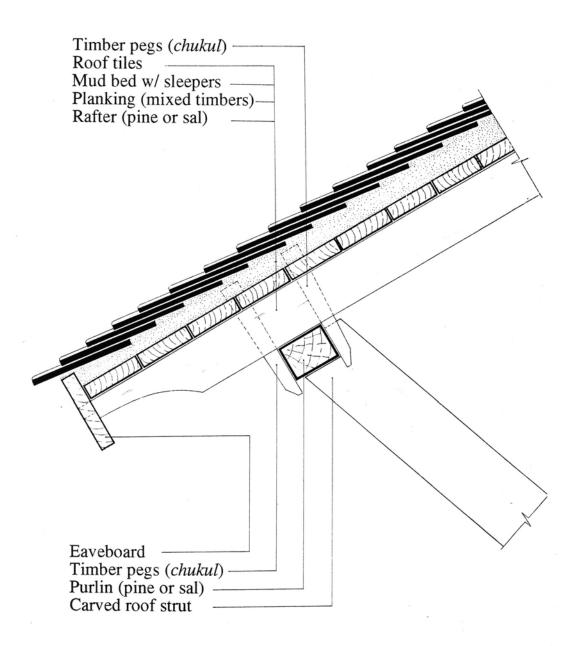
Section at roof overhang: as traditionally detailed

An important conclusion after detailed study of the extant roof structure is that the traditional wooden peg (Newari: *cuku*, Nepali: *chukul*) inserted as a key at wall plate and purlin is a principal entry point for water into the structural timbers. The traditional detail uses the peg as a key into the mud layer above. Thus any damage to or movement of the rather loose roof tile (Newari: *Jhingati*) allows water to reach the mud and then penetrate into the cross grain of the rafter through this wooden peg. Moreover when the small timber peg deteriorates, there is nothing to prevent the heavy rafters from sliding off the masonry core structure--this is especially critical at purlin locations.

At almost all (approximately 90%) of these peg locations, structural deterioration and in particular enlarged holes of these pegs to as much as 3" square (300%) has led to structural failure of the joints. This failure pattern is exacerbated by general dampness transmitted by the timber lath beneath the mud bed. This scenario describes the loss of rafters above the bay window here as well as the majority of roof failures in Newar buildings, and in particular at our other recent projects, Radha Krishna and Uma Maheswar Temples.

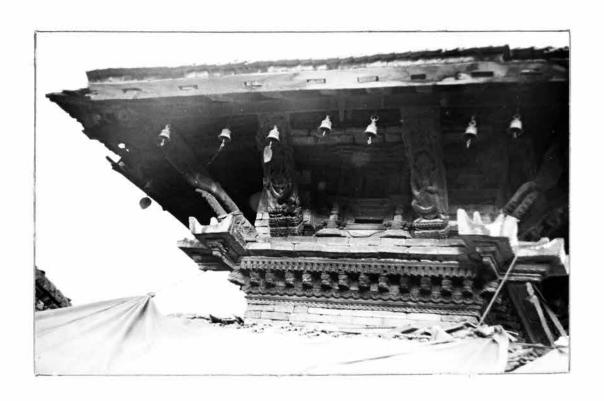
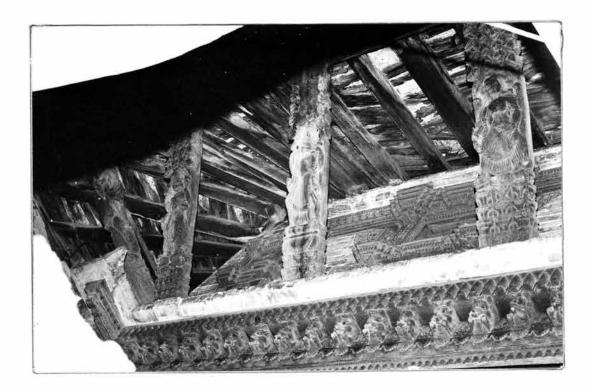
Above: Uppermost pagoda roof from west shows broken eaves on North-West corner.

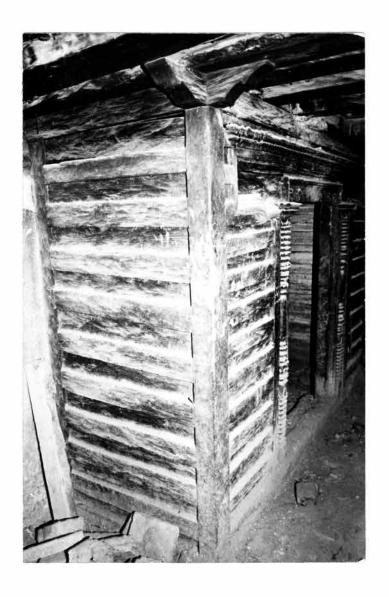
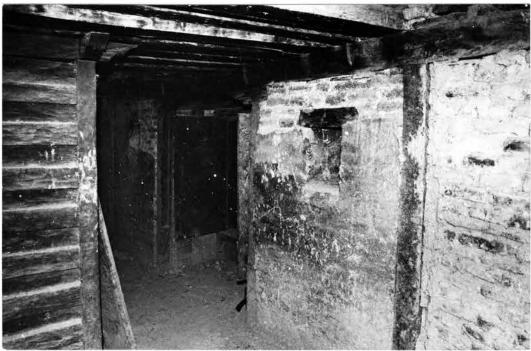
Above: Partition of esoteric shrine, second floor. Below: view towards san jhya with esoteric shrine left. August 1993.

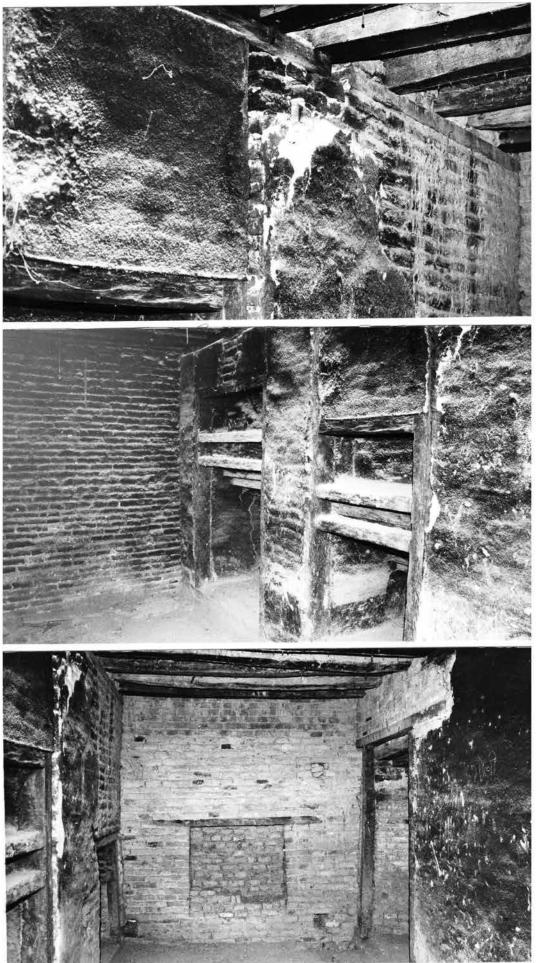
Above: Detail above south window first floor showing intact mud plaster and common brick beneath. Middle: First floor south face of 1954 partition left, central and south windows of principle facade right. Bottom: First floor looking south to blocked window.
