# TUM BAHA NARAYAN TEMPLE

## HISTORIC STRUCTURE REPORT

PATAN DARBAR WORLD HERITAGE SITE  
KATHMANDU VALLEY PRESERVATION TRUST

SUMMER, 2000

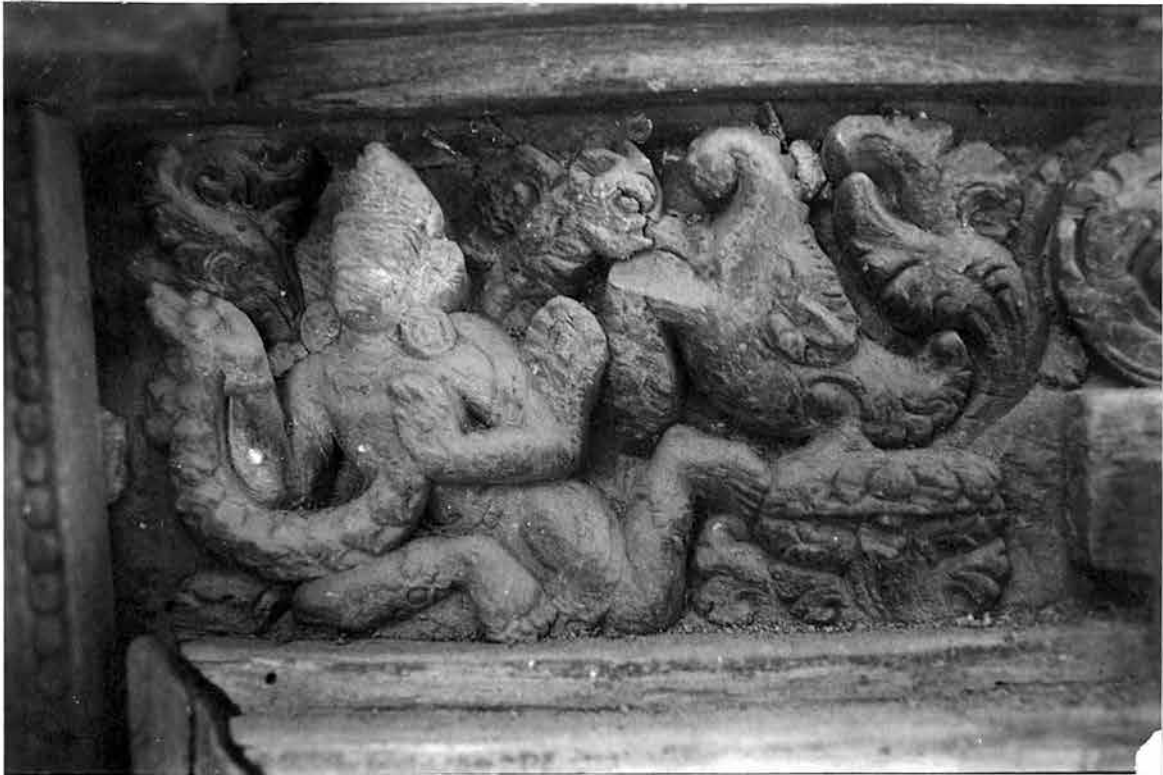
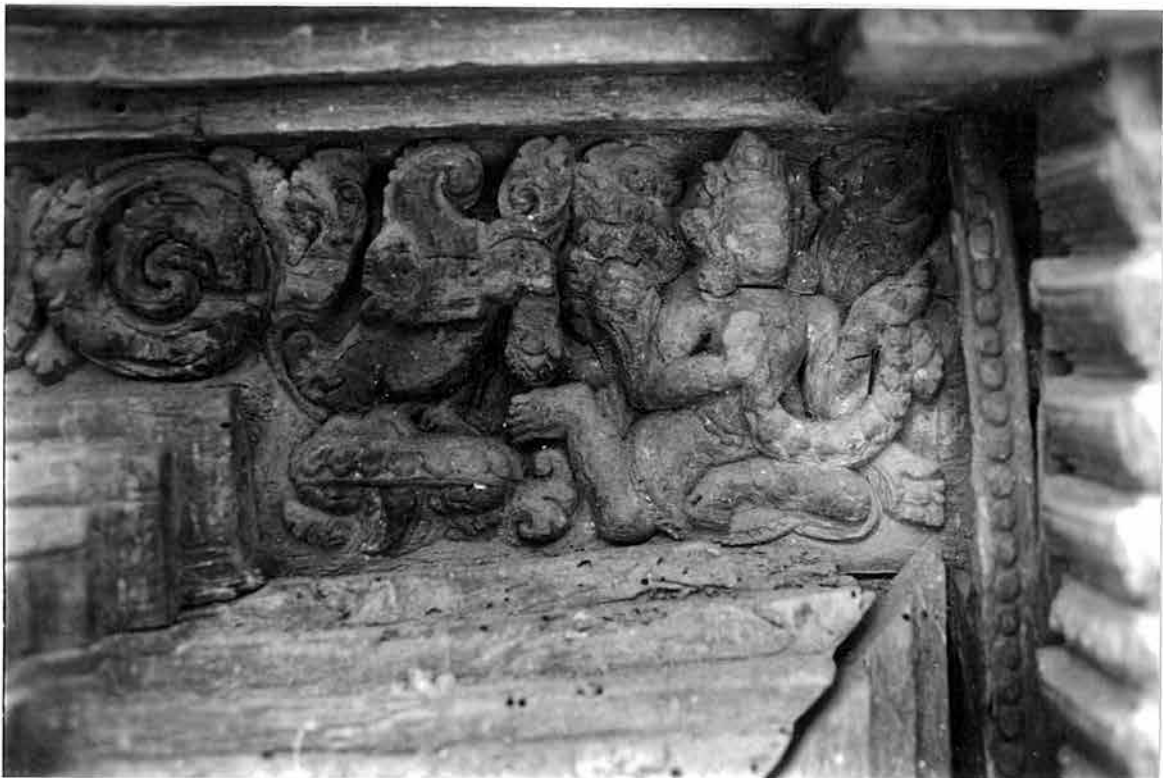
Detail of extended lintel on both sides of the extended door lintel. Each side shows *gandhara* with garland on front and at the back *makara* offering water.

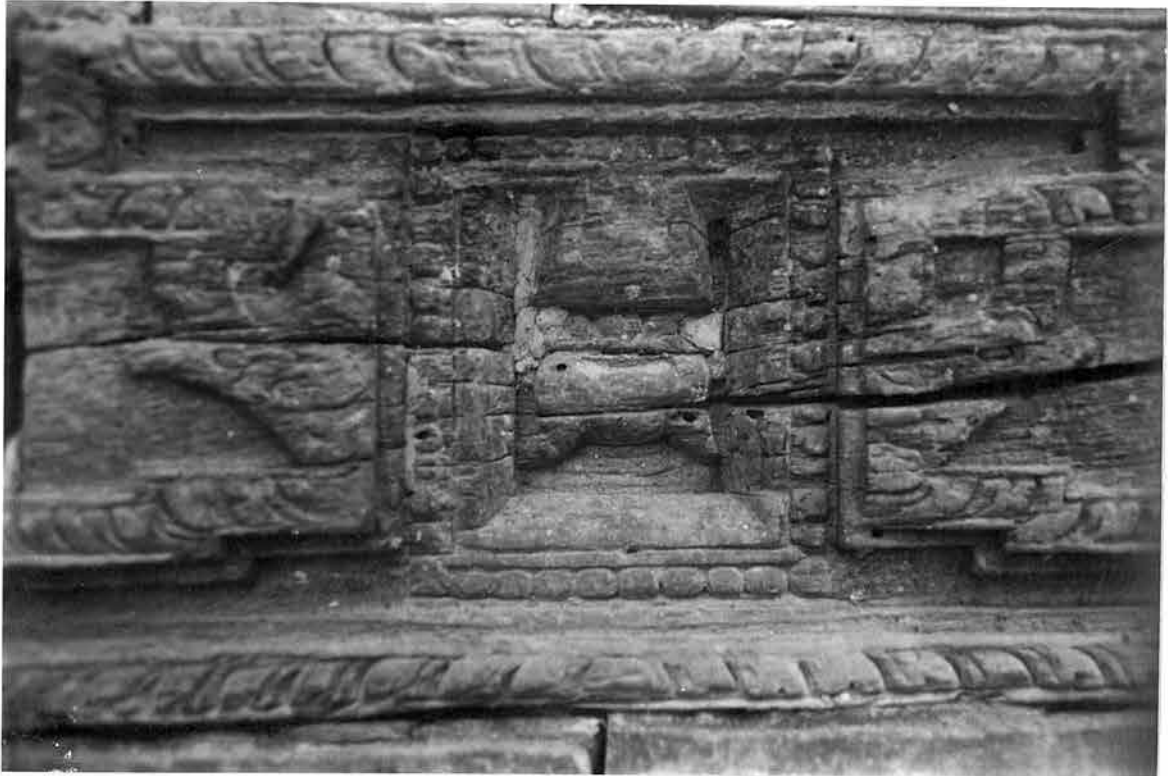
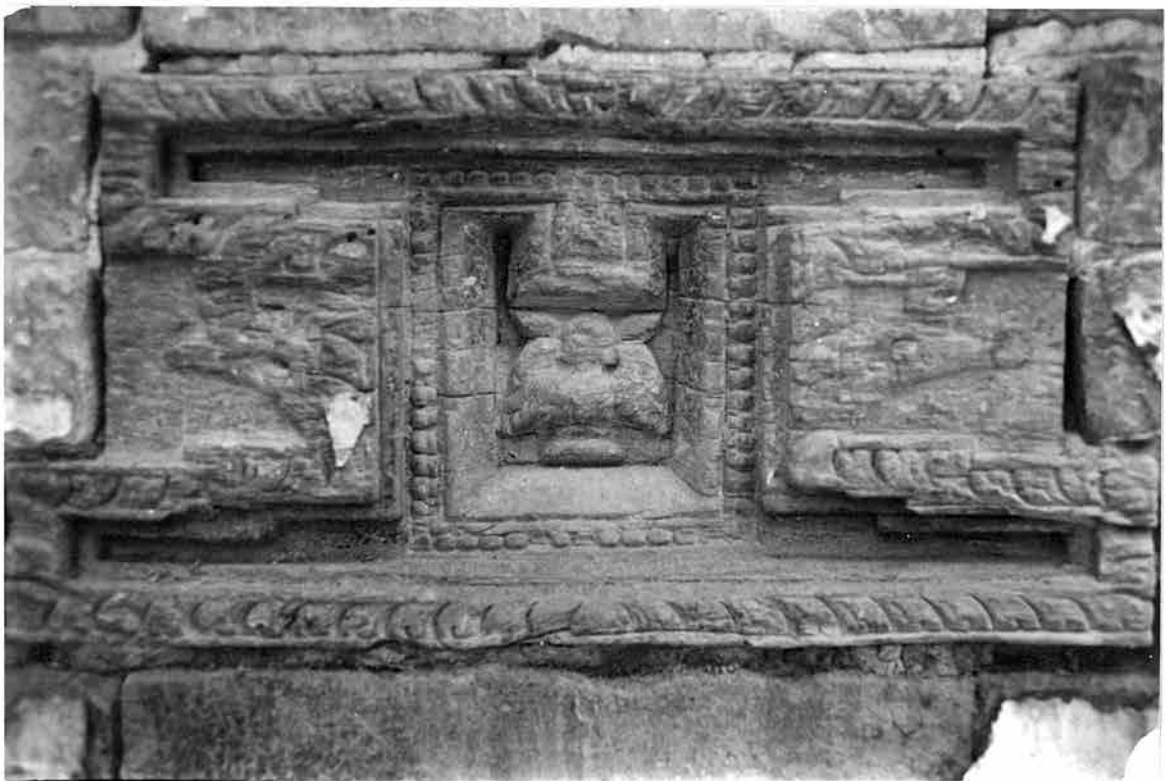
Blind window at the ground level beside main sanctuary room of the temple. Main figure on the middle of the blind window is "*Kalas*".

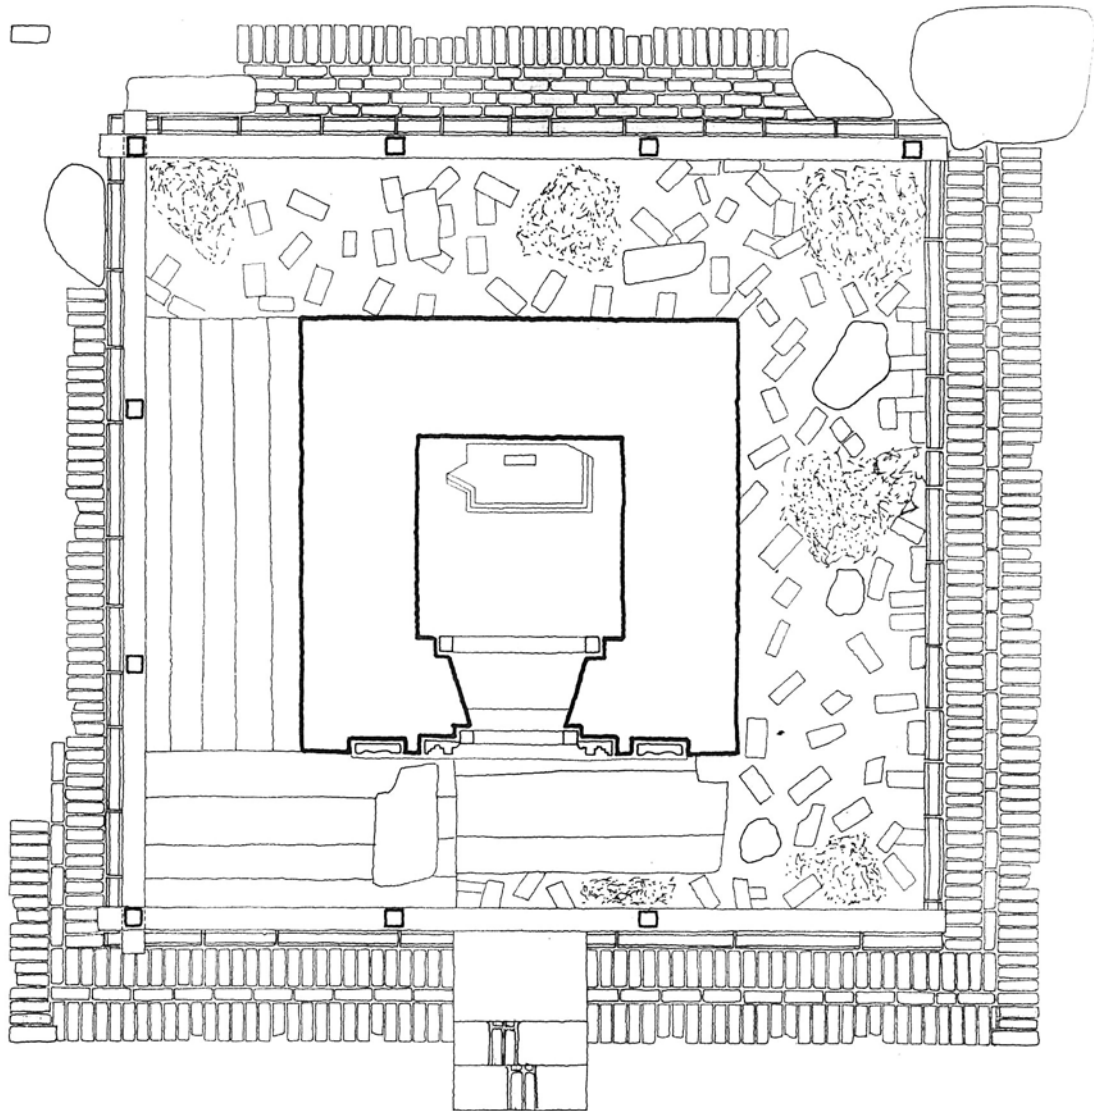
EXISTING PLAN

Severe structural problems are evident in the ground floor timber colonnade. Due to exposure to the elements and roof collapse, much of the timber arcade, i.e. post and beam structural elements are damaged or lost. Of the 12 carved *sal* timber columns only 8 survive from the west and north elevations, four of these eight have extensive wet rot damage. The timber planking and timber plinth beam (Newari: *lak-si*) upon which the columns rest is completely damaged. The timber planking on the floor incorporates random salvaged and reused door frame components.

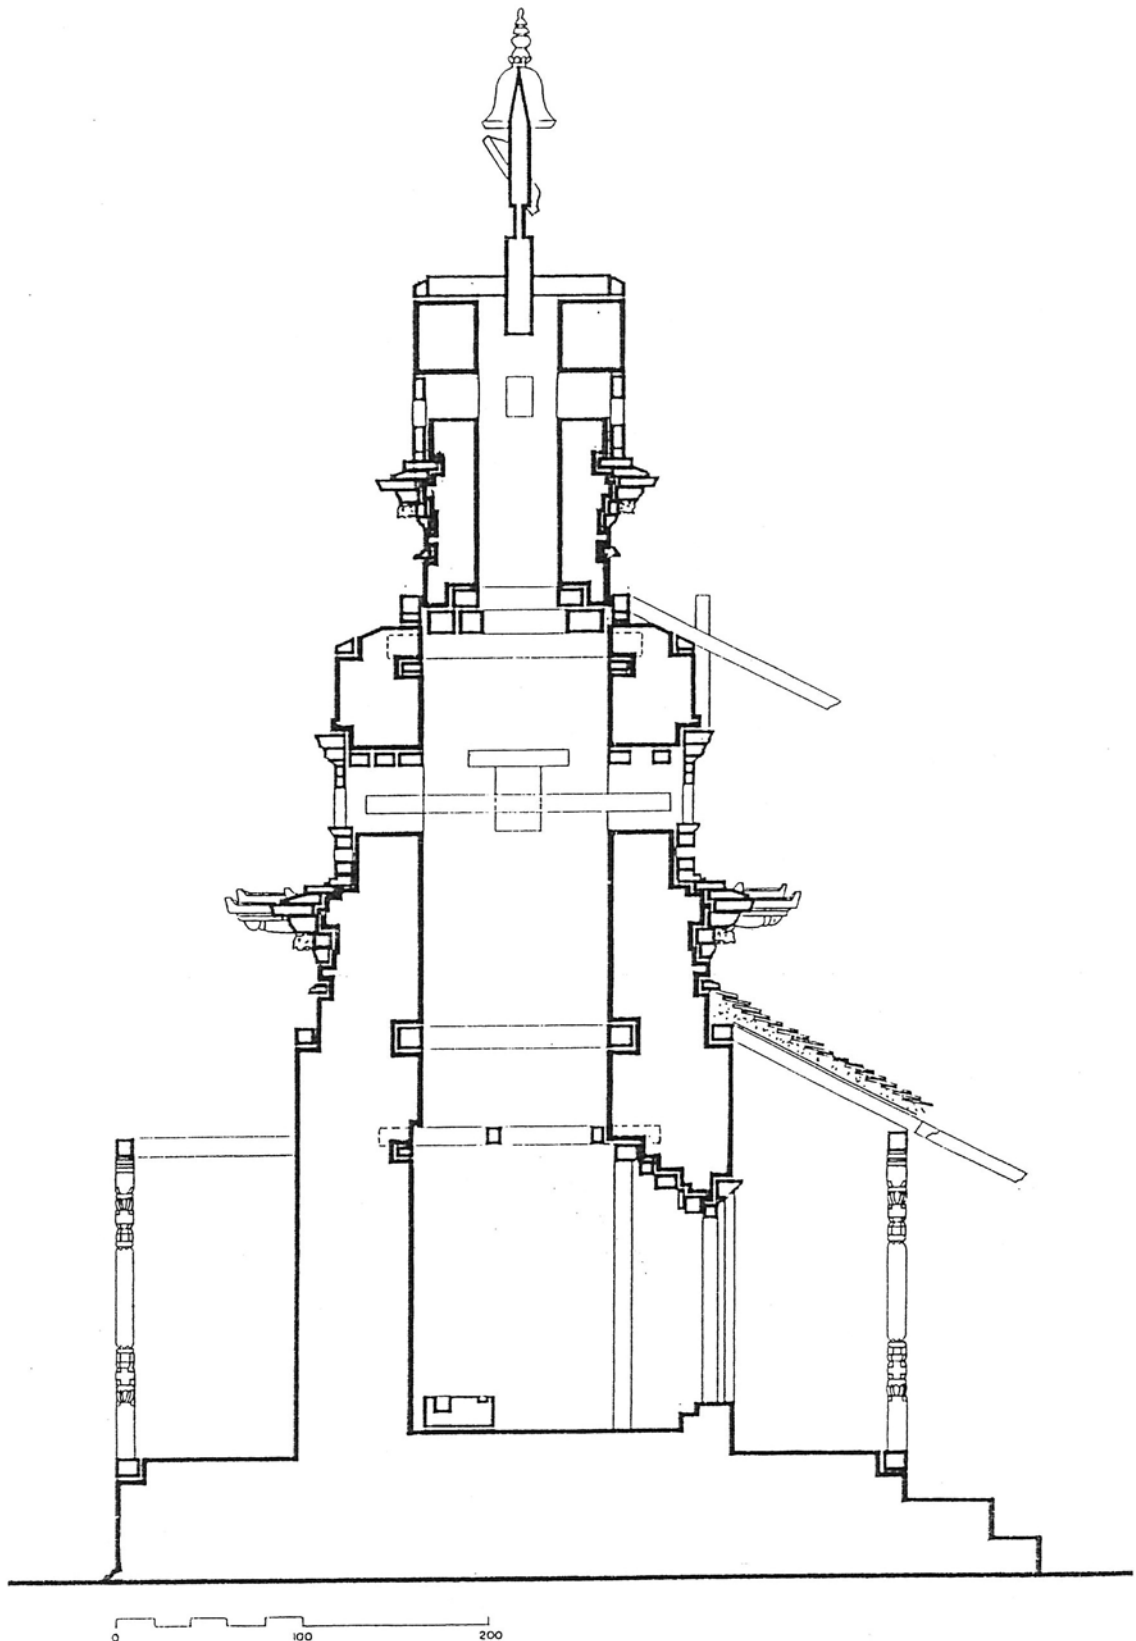
EXISTING CONDITION: SECTION AT EAST-WEST

Upper roof: wall plates, rafters, purlins, and eaves board severely damaged by wet rot or lost

Masonry wall damage in the upper 12 layers of brick

Timber cornice: 20% damaged by wet rot

Middle roof timber members – rafters, purlin, eaves board were completely damaged or lost

Wall plate: inner-damaged 20%,

Wall plate: outer-100% damaged by wet rot

Lower roof: 50% damaged on two sides by wet rot and other two sides collapsed

Wall plate: outer damaged completely

Timber bracket completely damaged

*Laka-si* (timber plinth beam) completely damaged

Plinth wall 60% of bricks are replaced with mismatched common brick or random rubble

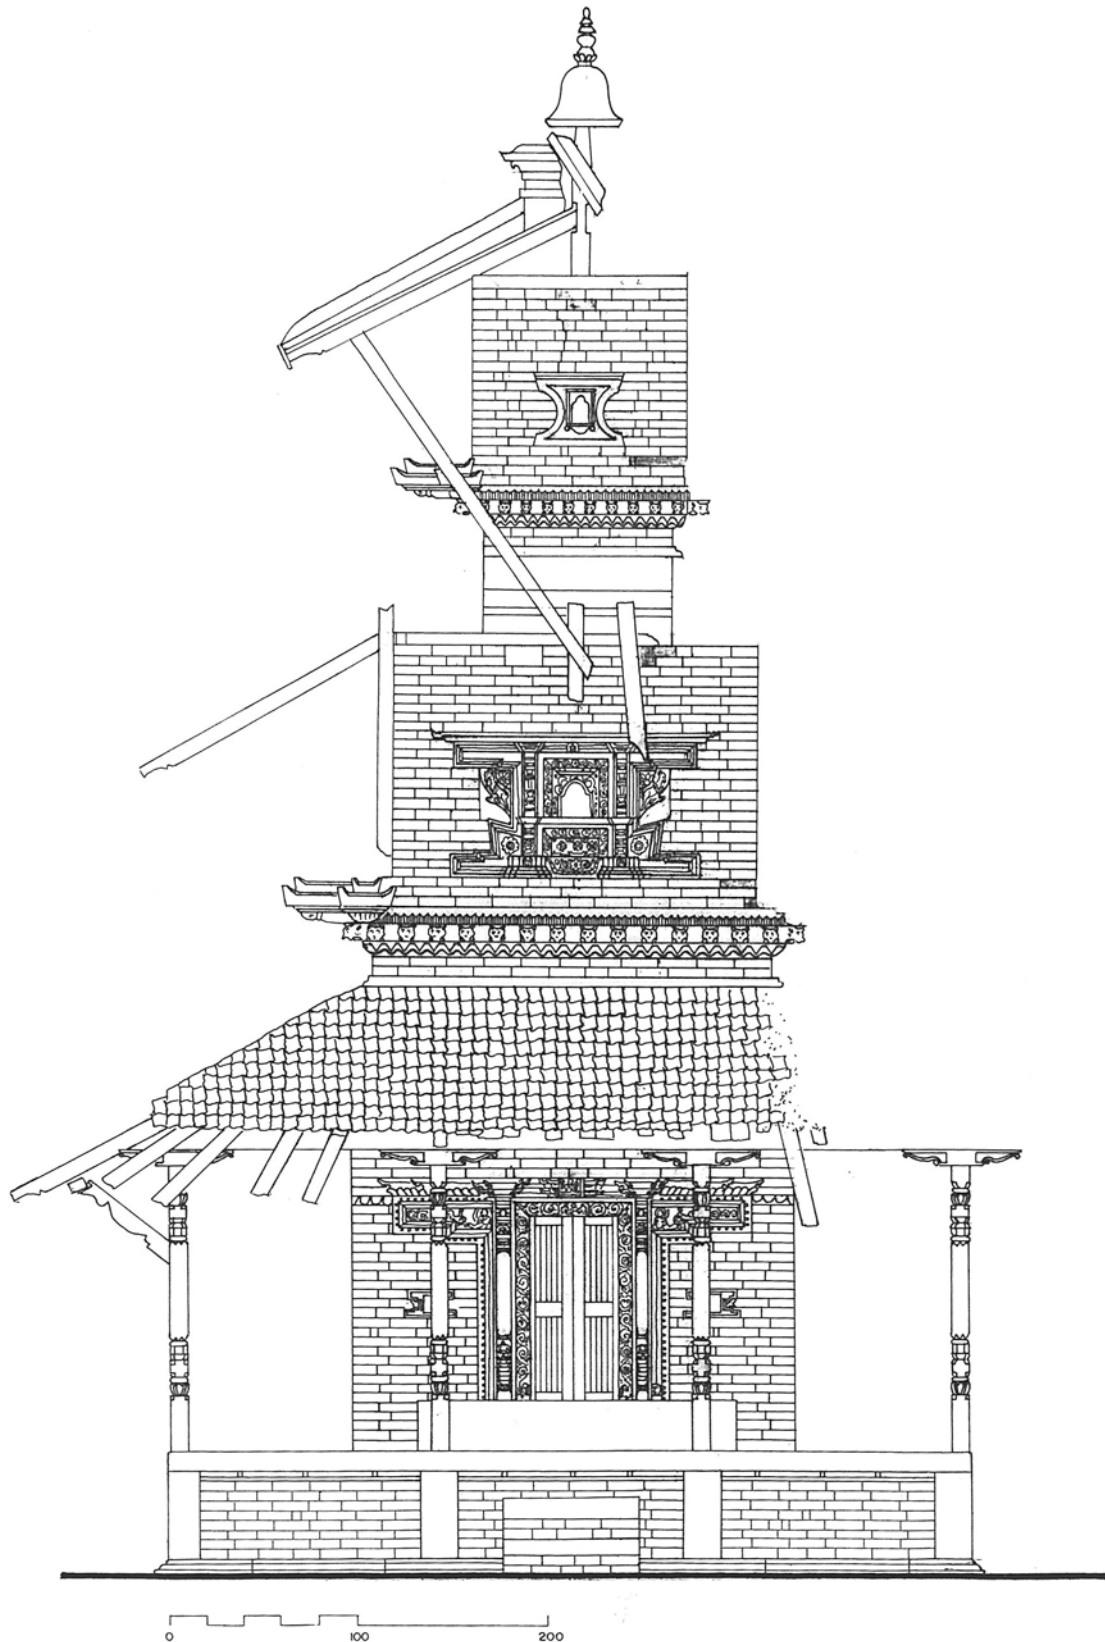
EXISTING CONDITION: PRINCIPAL ELEVATION

- Gajura* (terracotta pinnacle) lost two months back
- Galsi* (pinnacle king post) completely damaged
- Pinnacle terracotta base completely damaged
- Upper roof: wall plates, rafters, purlins, and eaves board severely damaged by wet rot or lost

- Masonry wall damage in the upper 12 layers of brick
- Small window: good condition
- Roof struts: 1 middle strut salvaged
- Lah-kah* (extended terracotta cornice): lost

- Timber cornice: 20% damaged by wet rot
- Gajura* (terracotta pinnacle) at middle roof salvaged
- Middle roof timber members – rafters, purlin, eaves board were completely damaged or lost

- Wall plates: inner-damaged 20%, outer-100% damaged by wet rot
- Upper layers of brick damaged by vegetal growth
- Roof struts: 1 middle & 1 corner salvaged

- Ga'jhyah* (decorative carved wooden window): damaged middle fragment
- Wood cornice: good condition
- Lah-kah* (extended terracotta cornice): lost
- Jhingati* (terracotta roof tiles): 40% surviving

- Lower roof timber members – rafters, purlins, missing or completely damaged by wet rot
- Wooden cornice in good condition
- Timber bracket completely damaged

- Timber posts: 2 surviving in good condition & 2 damaged by wet rot
- Brick wall in good condition except at corners where a few bricks are damaged by moisture

- Stone threshold: good condition
- Laka-si* (timber plinth beam) completely damaged
- Plinth wall 60% of bricks are replaced with mismatched common brick or random rubble

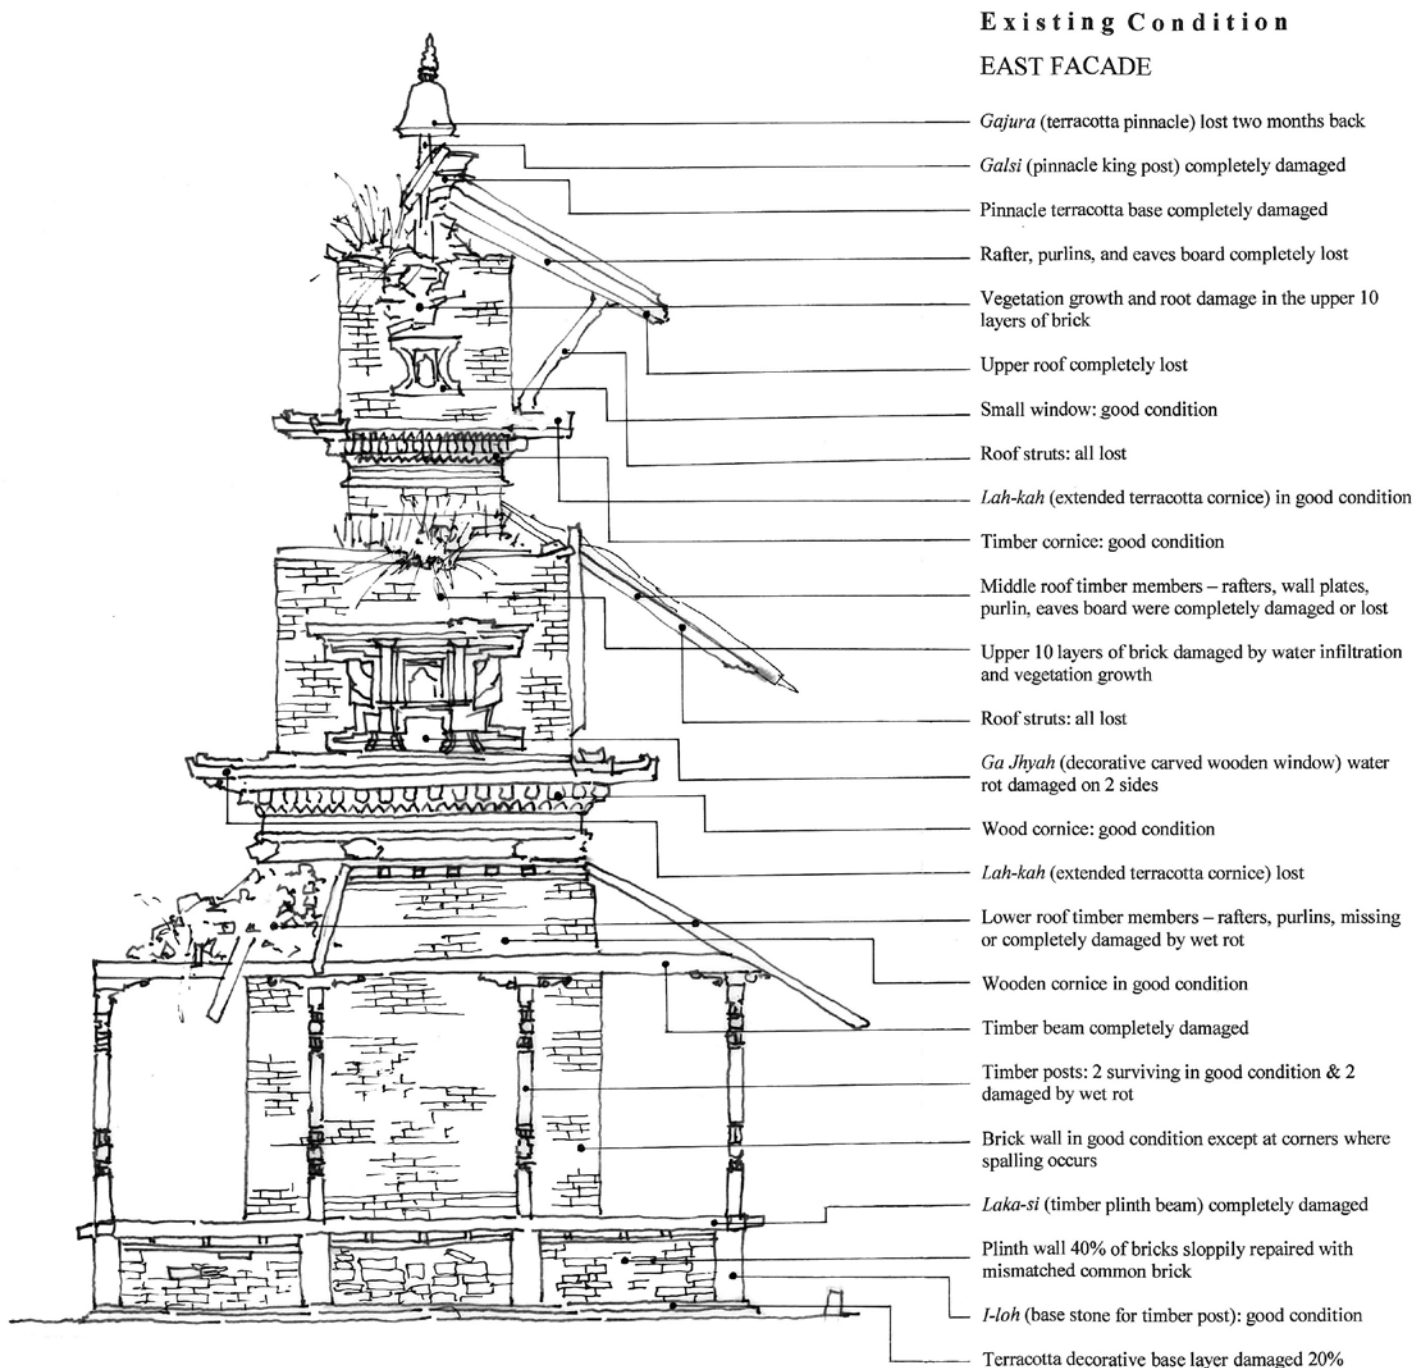
EAST FACADE: EXISTING CONDITIONS

- Gajura* (terracotta pinnacle) lost two months back
- Galsi* (pinnacle king post) completely damaged
- Pinnacle terracotta base completely damaged
- Jhingati* (terracotta roof tiles) 25% good condition

- Wall plates, rafters, purlins, and eaves board severely damaged by wet rot
- Masonry wall damage in the upper 10 layers of brick
- Small window: good condition

- Roof struts: 1 corner strut salvaged
- Lah-kah* (extended terracotta cornice) in good condition
- Timber cornice: good condition
- Middle roof timber members – rafters, wall plates, purlin, eaves board were completely damaged or lost

- Terracotta decorative base layer: good condition
- Base layer of brick: good condition

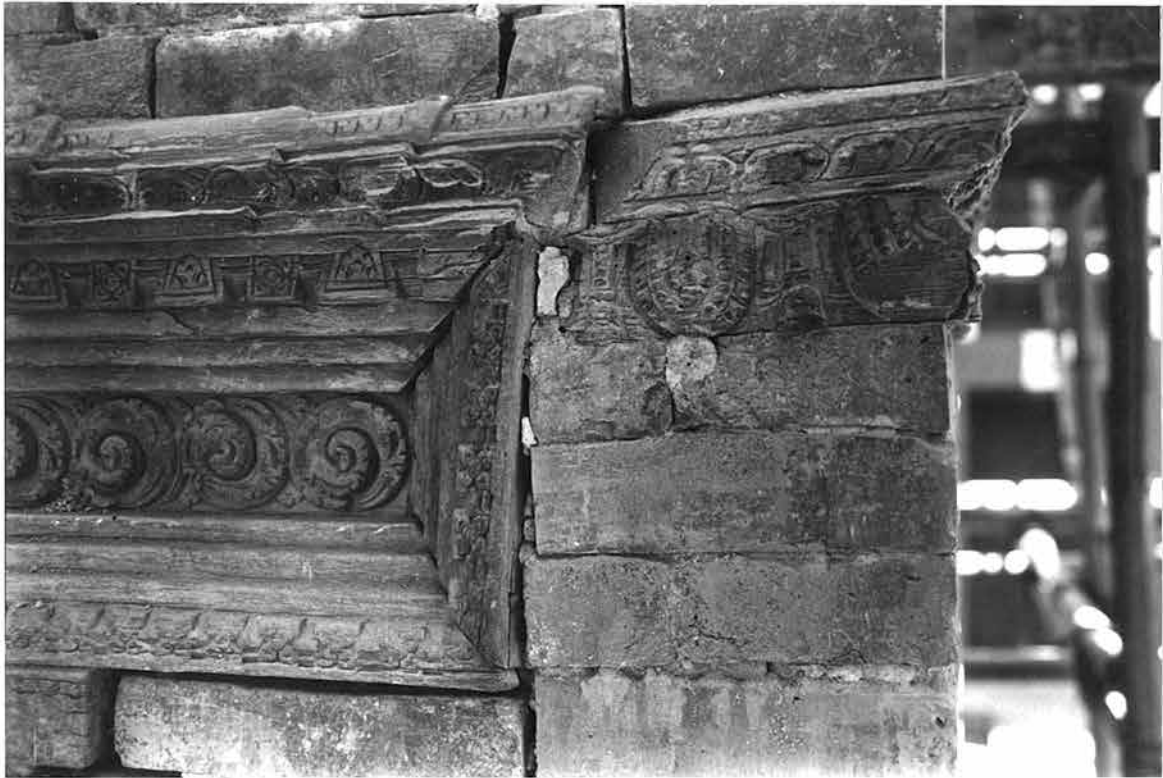
Existing lintel of the door frame on the ground floor level. The edge of the masonry wall is 2" longer on the left side leaving a space between the extended door lintel and timber cornice that is filled by a piece of brick.

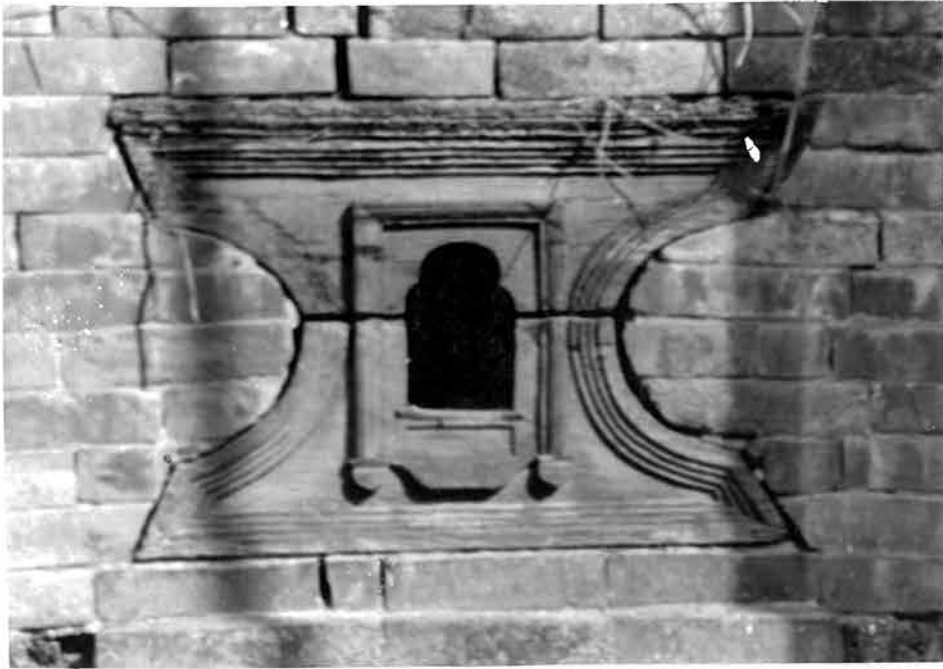
Middle window on the uppermost level. The carved details are much simpler compared to the lower levels .

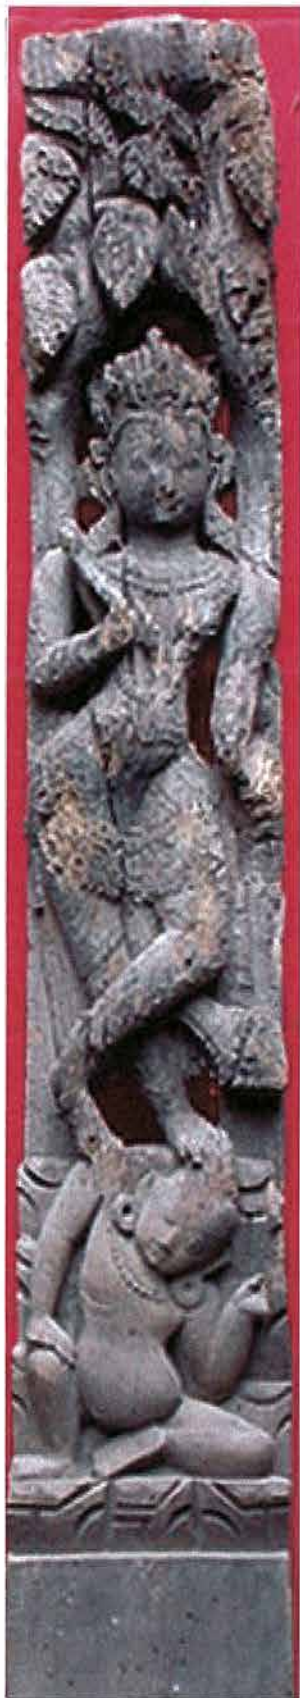
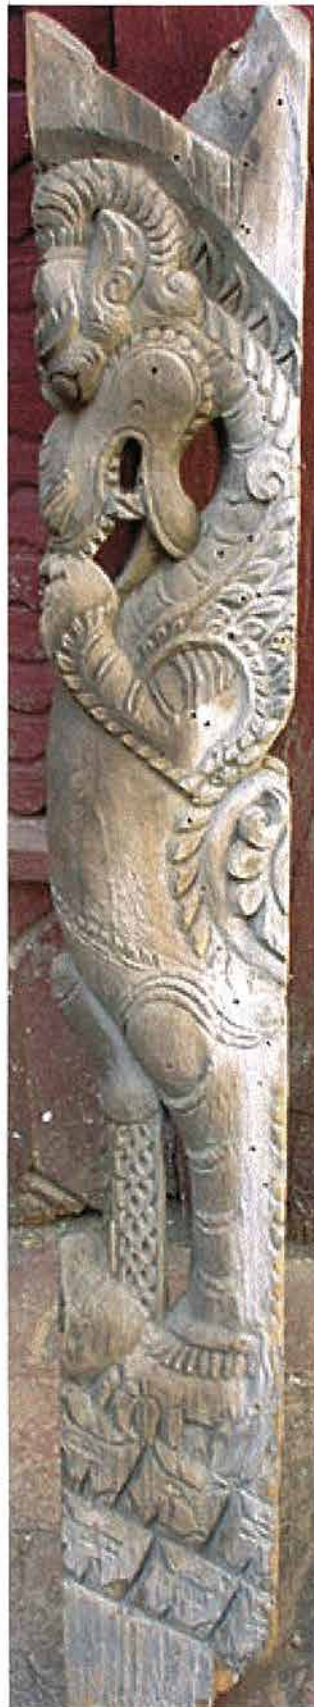
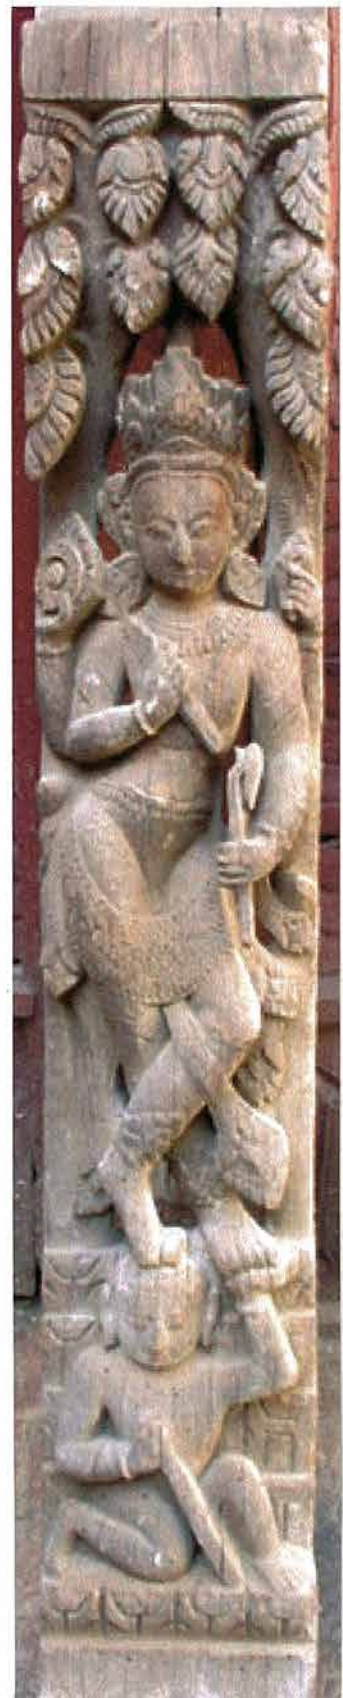
Existing roof struts from middle level

recovered from the pile of debris at the base of the temple are examples of this condition. Few of the carved features were discernable and the struts suffered severe wet rot. The lower roof survived with the most *jhingati* available in a salvageable state, however all of the timber structural elements (rafters, purlins, and eaves boards) were badly damaged. The middle roof was completely gone except for a few timber members that show evidence the roof length before the collapse. The upper roof was considerably damaged with less than 25% of the roof remaining on the north side. Although the *jhingati* or terracotta roof tile may be salvaged, the purlins, rafters, wall plates, and eaves board are severely damaged by wet rot. The pinnacle king post (Newari: *galsi*) is in poor condition.

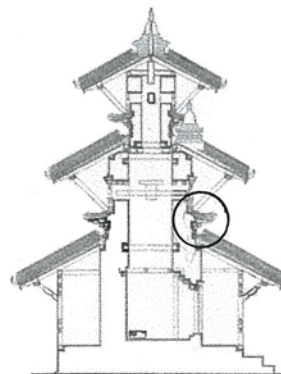
1. The corner strut rests at a point where considerable loads converge upon all three layers of the *lah-kah*. The lower and upper layer of the *lah-kah* are carved from wood. These sandwich a terra-cotta layer.
2. This shows the location of the proposed cross piece which will tie both pieces of the *lah-kah* together and , hence, increase the localised strength.
3. Location of proposed cross piece which is inserted between the timber and terracotta *lah-kah*.
4. The steel member is countersunk into the timber *lah-kah* thus keep the original proportions and configuration.

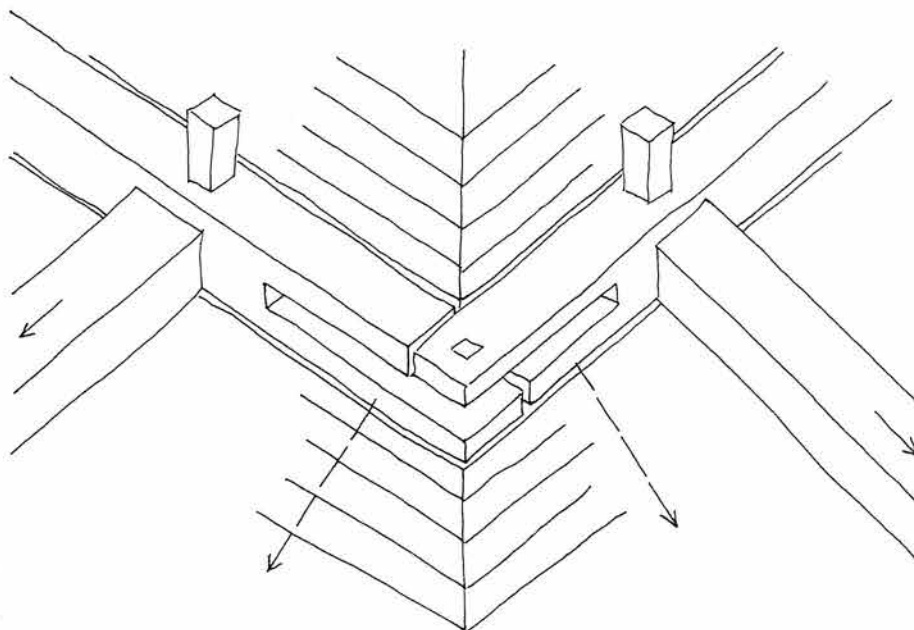
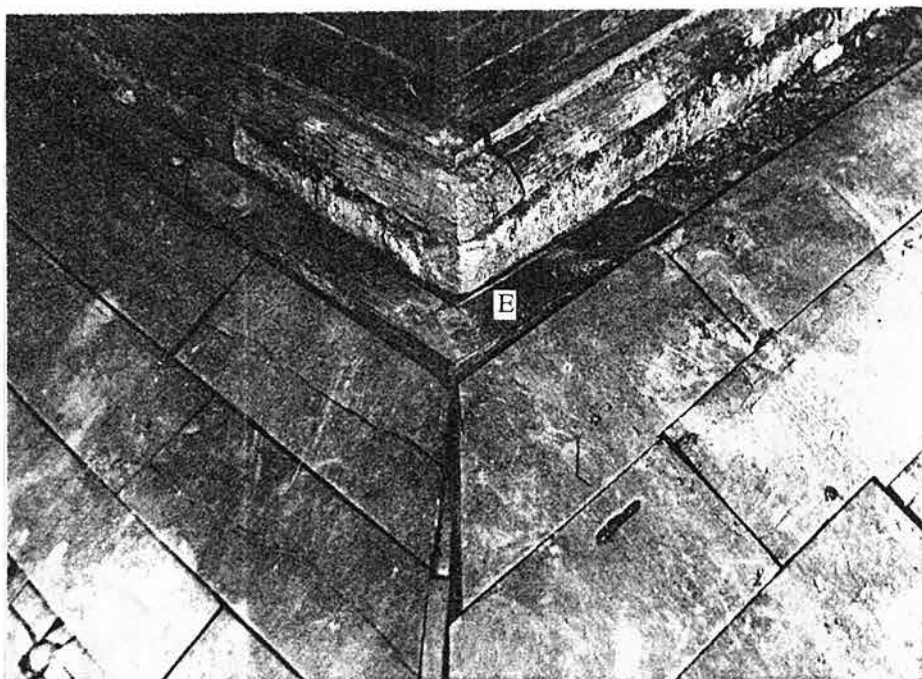
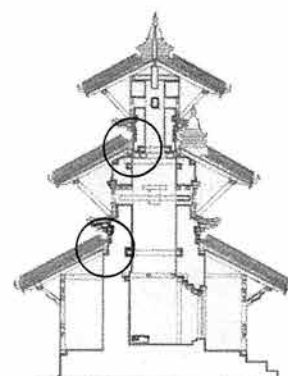
### ***Reinforcement of the corner lap joint***

1. The corner lap joint timber section is not sufficient to bear the load of the corner strut. If the corner strut is off center it is highly probable that the protruding timber end will break off easily.
2. To prevent this kind of failure a metal cross piece is attached to the joint. This improves the strength and allows the even distribution of local forces.

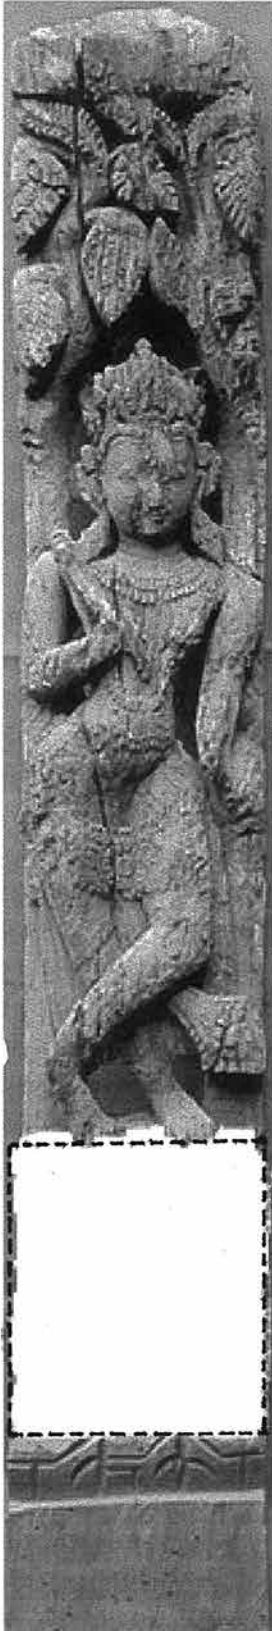
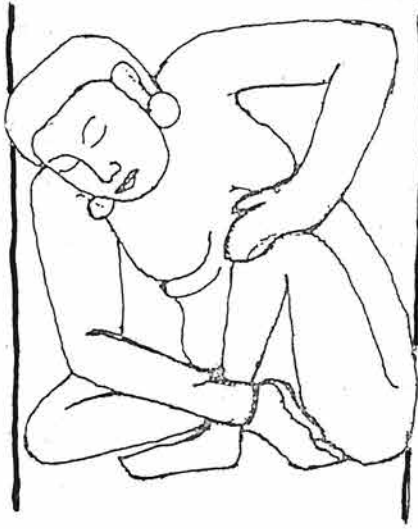
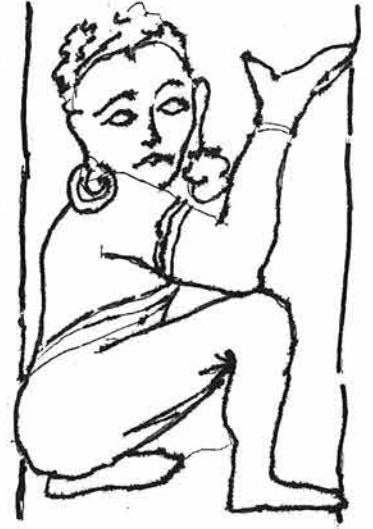
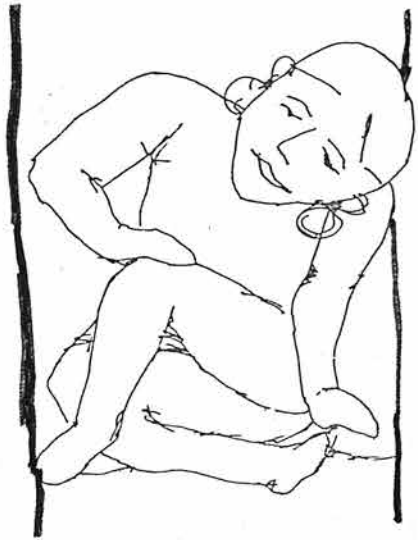
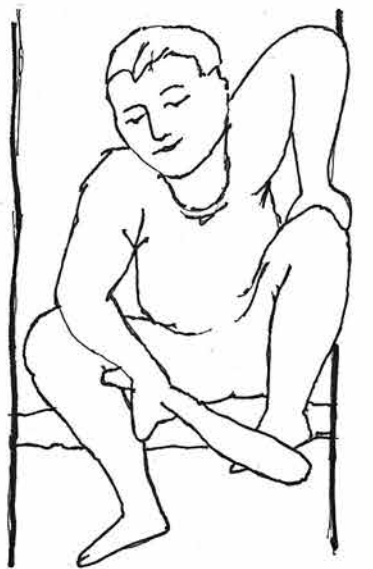
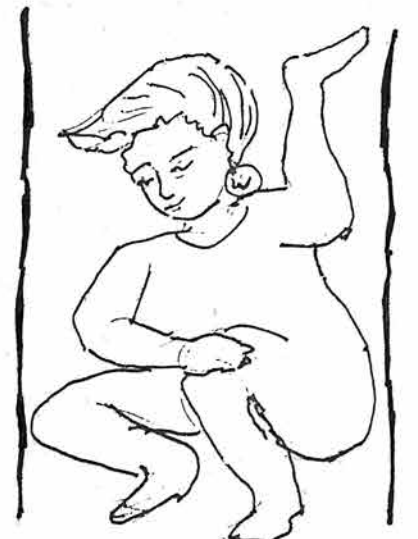
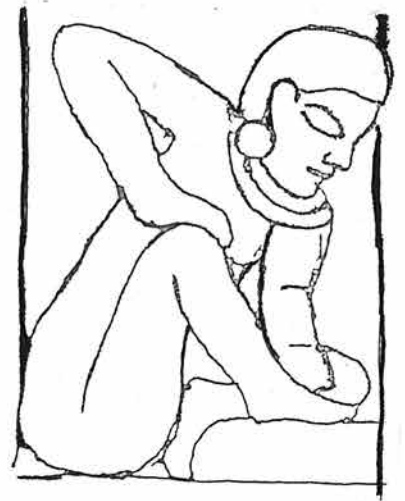
Above: examples of different variations created by Kathmandu Valley Preservation Trust with Master woodcarver Indra Kaji to fill the lower portion of the strut of indeterminate design.

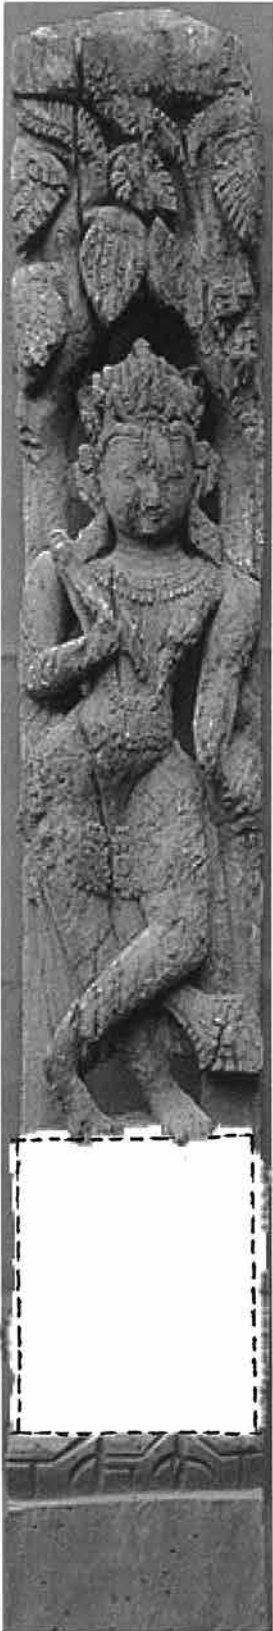
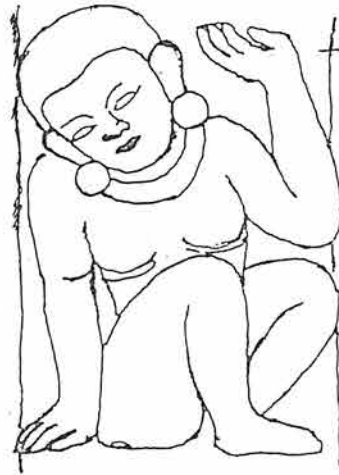
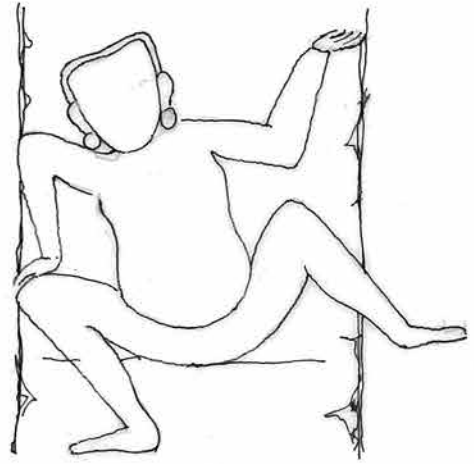
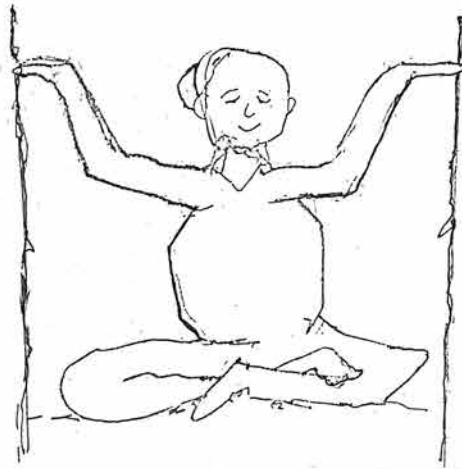
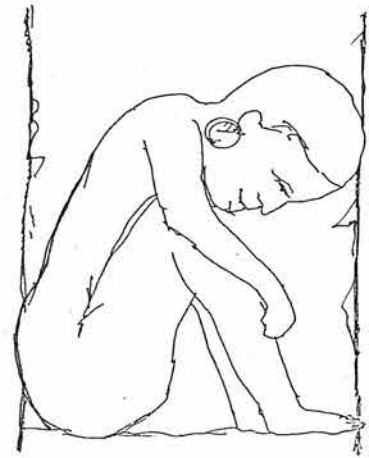
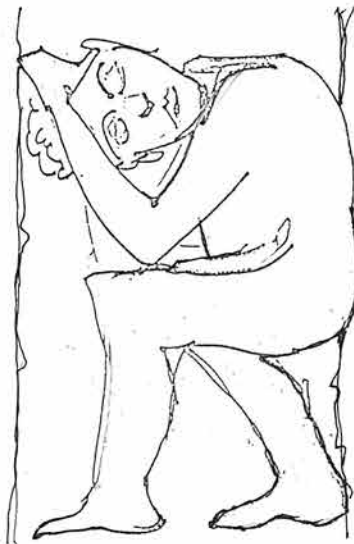
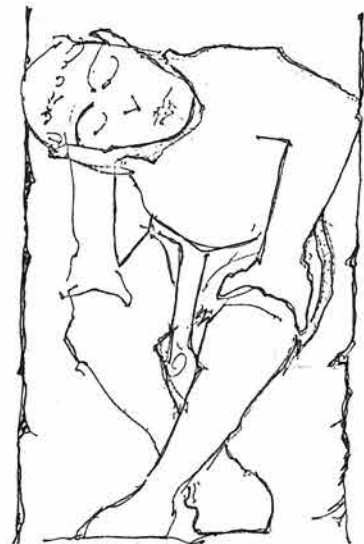
Above: examples of different variations created by Kathmandu Valley Preservation Trust with Master woodcarver Indra Kaji to fill the lower portion of the strut of indeterminate design.

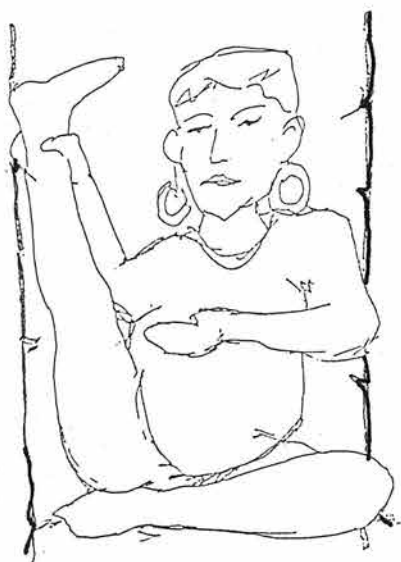
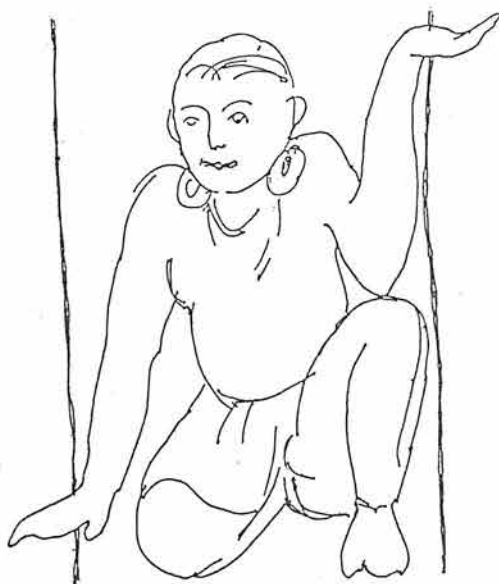
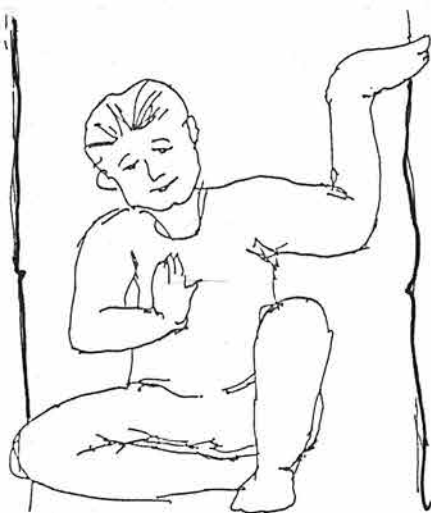
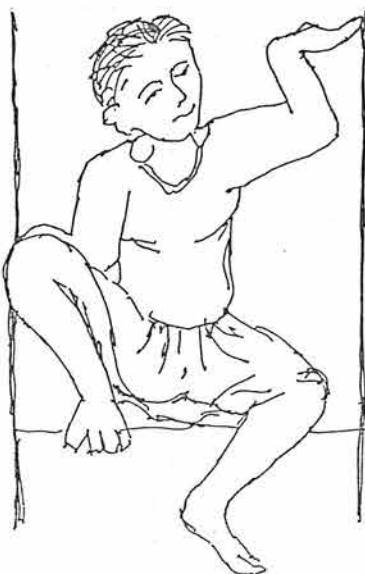
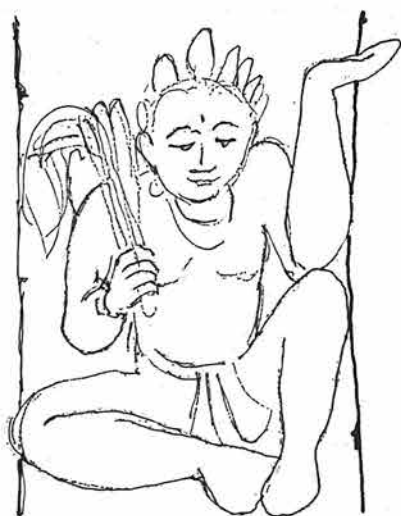
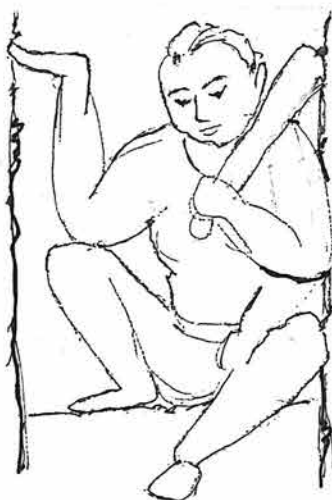
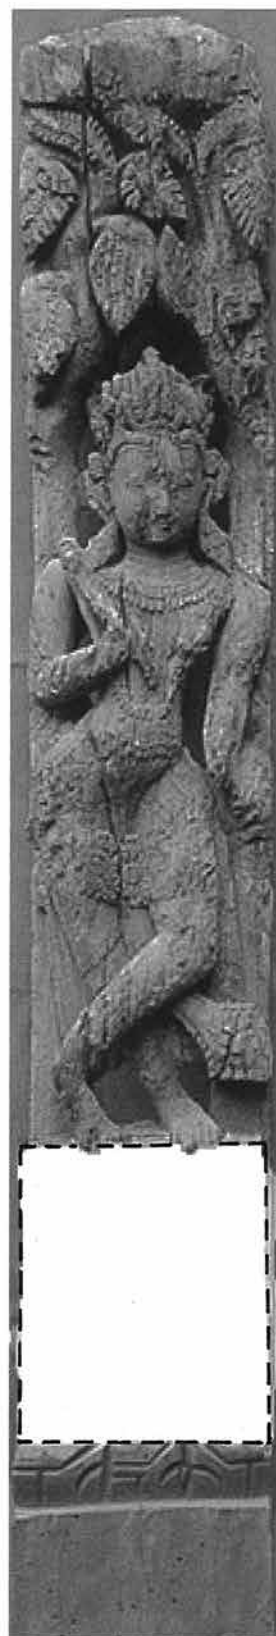
Above: examples of different variations created by Kathmandu Valley Preservation Trust with Master woodcarver Indra Kaji to fill the lower portion of the strut of indeterminate design.
